Cisco DPA 7630/7610 Voice Mail Gateway Version 1.2(1) Release Notes

May 25, 2001

78-12814-02 Rev. B0

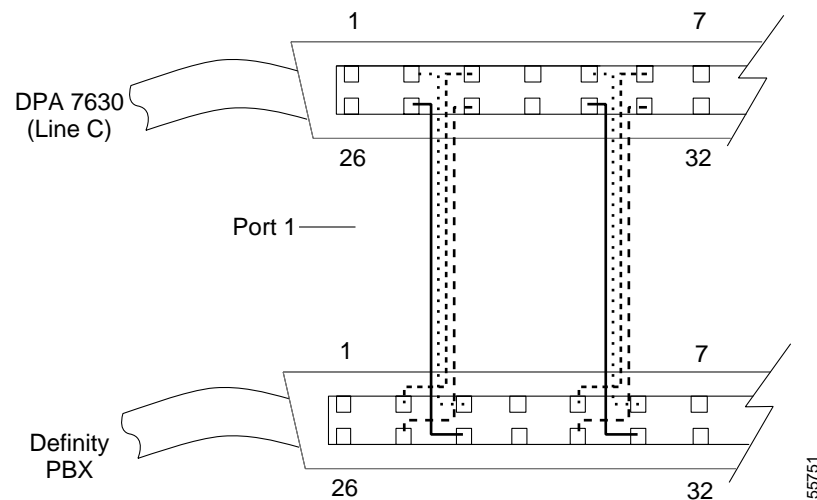
Figure 1 DPA 7630 Wiring to the Definity PBX System

Figure 1 illustrates how to connect the wires from the DPA 7630 to the Definity PBX system. Starting with port 1, you skip a port, cross the next two ports, skip a port, cross the next two ports, and so on. For example:

- Leave pair 1 unused on both the DPA 7630 and Definity PBX
- Cross pairs 2 and 3, so that Tx (transmit) from DPA 7630 connects with Rx (receive) from the Definity PBX
- Leave pair 4 unused on both the DPA 7630 and Definity PBX
- Cross pairs 5 and 6, so that Tx (transmit) from DPA 7630 connects with Rx (receive) from the Definity PBX
