Text Part Number: 78-1367-16 Rev. A0

Release Notes for Catalyst 1200 Series Switch Software Release 4.x

Network Management Processor (NMP) Flashcode Software Release 4.x Data Movement Processor (DMP) Flashcode Software Release 4.x Boot Firmware Version 1.1

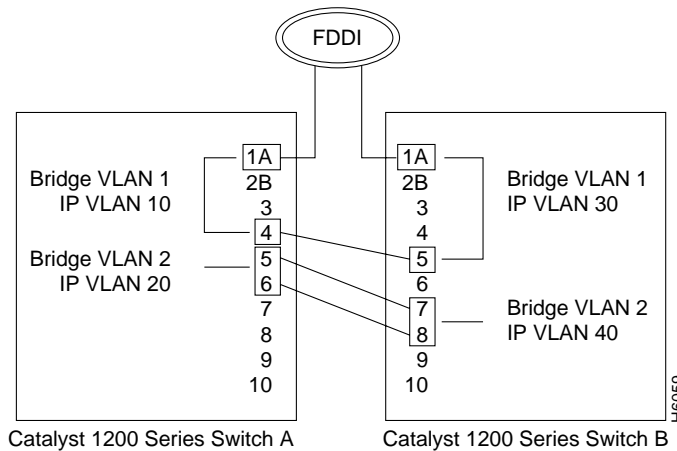
Figure 1 Example of Catalyst 1200 Series Switches in a Looped Configuration

- When Catalyst 1200 series switches are connected in a looped configuration, you must define IP VLANs and bridged VLANs identically on each Catalyst 1200 series switch. If these are not set correctly, the switches might not route properly.

Catalyst 1200 series switch A has ports 1 and 4 in bridge VLAN 1 and ports 5 and 6 in bridge VLAN 2. This same switch has ports 1 and 4 in IP VLAN 10 and ports 5 and 6 in IP VLAN 20. This switch is connected in a looped configuration to Catalyst 1200 series switch B.

Catalyst 1200 series switch B has ports 1 and 5 in bridge VLAN 1 and ports 7 and 8 in bridge VLAN 2. This same switch has ports 1 and 5 in IP VLAN 30 and ports 7 and 8 in IP VLAN 40.
