# Release Notes for the Cisco 6100 Release 2.3.0

These release notes discuss features, resolved problem reports, and unresolved problem reports for the Cisco 6100 advanced digital subscriber line access multiplexer (DSLAM) supported in Cisco 6100 Release 2.3.0.

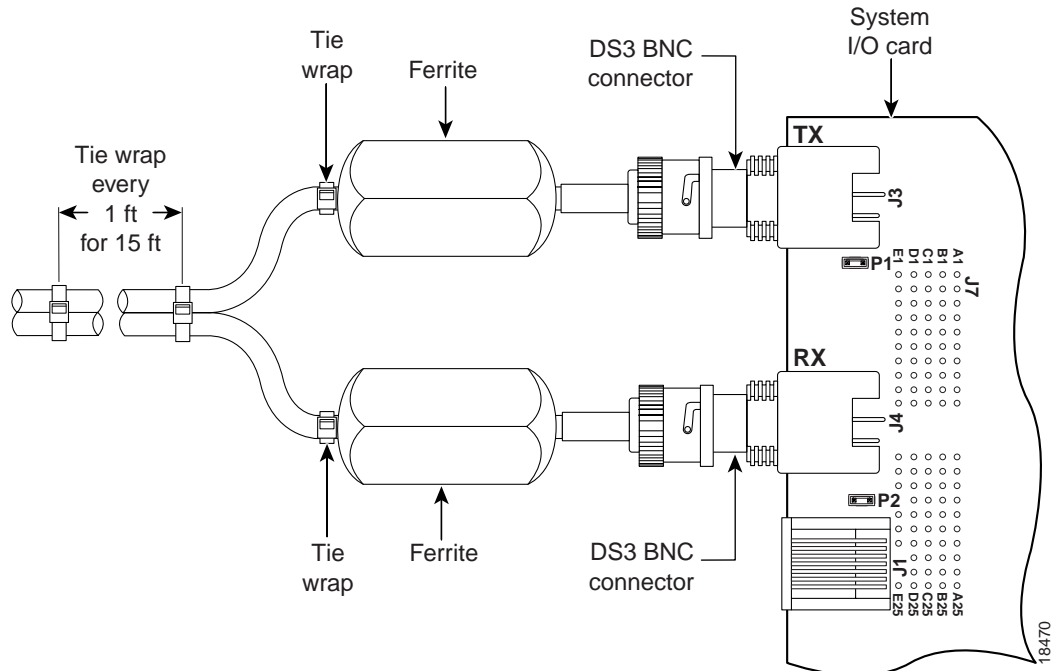
Use the following procedures to add ferrites to the DS3 system I/O card on the rear panel of the MC. Figure 1 illustrates the attachment of the ferrites.

- Step 1** Attach coax cables to the two DS3 BNC connectors (J3 and J4) on the left side of the system I/O card.
- Step 2** Attach one ferrite (36-0087-01 quantity 2) to each of the cables as close to the connectors as possible.
- Step 3** Place one tie wrap (51-202060 quantity 18) immediately behind each ferrite.
- Step 4** Place another tie wrap around both cables just behind the ferrite tie wraps and at one foot intervals for 15 feet down the cables.

**Figure 1 DS3 System I/O Card Ferrites**

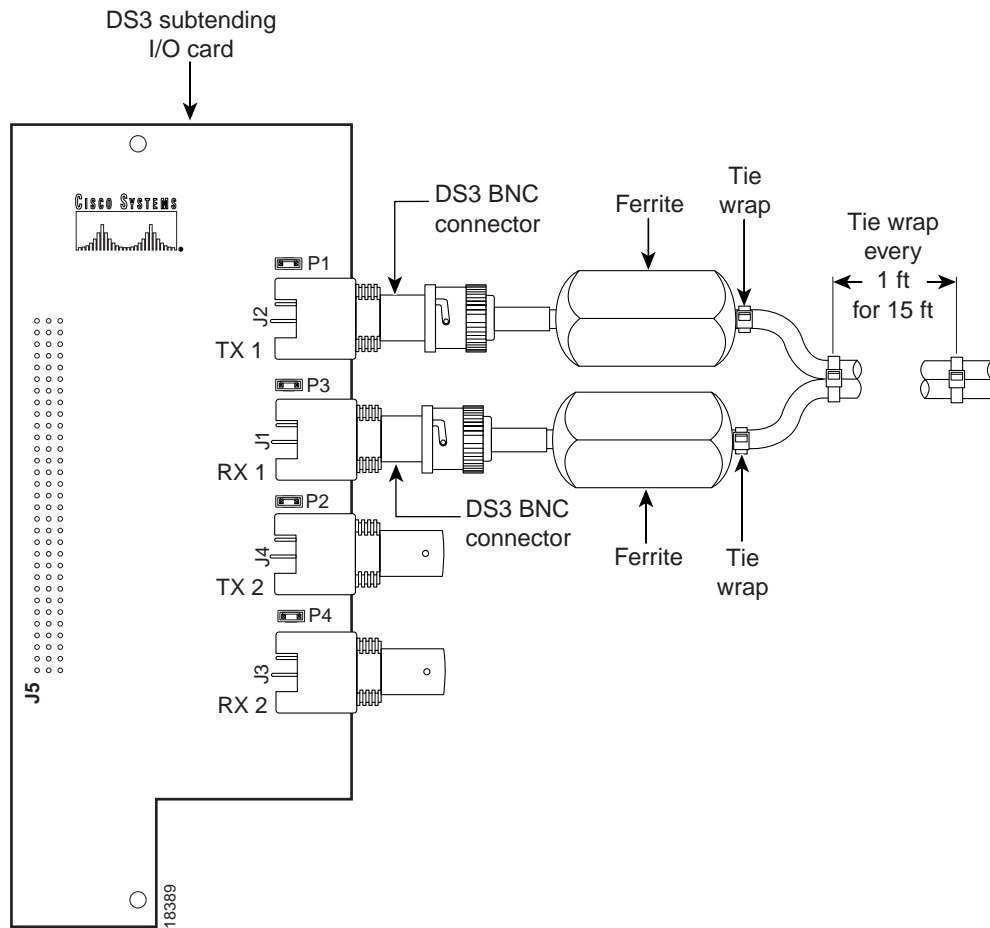
If you have a subtended network, use the following procedures to add ferrites to the DS3 subtend I/O card on the rear panel of the MC. Figure 2 illustrates the attachment of the ferrites.

- Step 1** Attach coax cables to the four DS3 BNC connectors (J1 through J4) on the right side of the subtend I/O card.
- Step 2** Attach one ferrite (36-0087-01 quantity 4) to each of the cables as close to the connectors as possible.
- Step 3** Place one tie wrap (51-202060 quantity 36) immediately behind each ferrite.
- Step 4** Place another tie wrap around both cables just behind the ferrite tie wraps and at one foot intervals for 15 feet down the cables.

**Figure 2 DS3 Subtend I/O Card Ferrites**

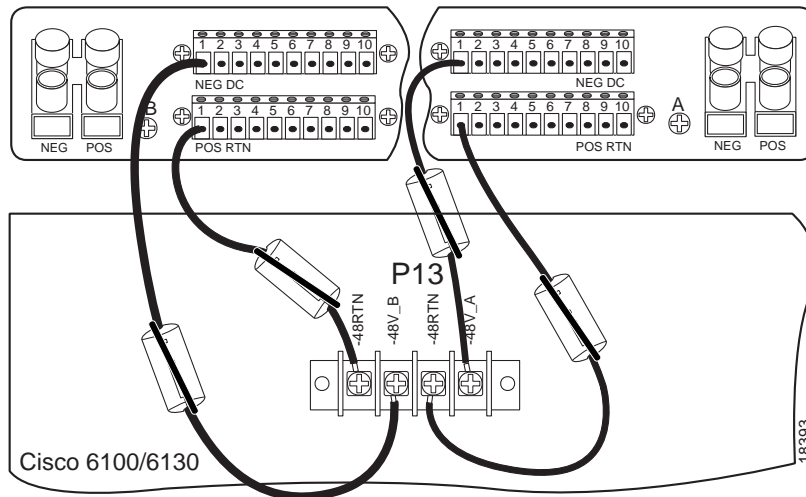
- Step 1** Attach cables from the power connector (P13) -48V\_B and -48RTN on the rear panel of the MC to the NEG DC and POS RTN connectors fuse and alarm panel for a dual power feed connection.
- Step 2** Attach one ferrite (36-0087-01 quantity 4) to each of the cables closer to the connectors.

**Figure 3 Dual Power Feed Ferrites**

Use the following procedures to add ferrites to the cables connecting the power feed connector on the rear panel of the MC to the fuse and alarm panel of the CO. The next three figures illustrate the attachment of the ferrites to the power feeds.

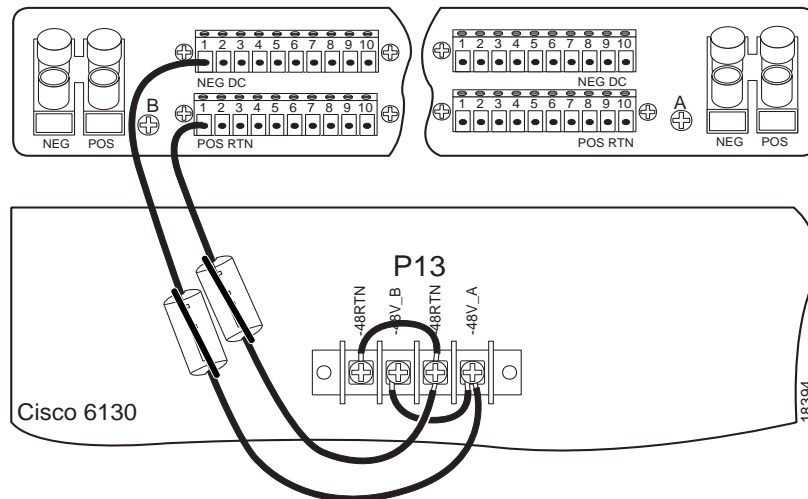
- Step 3** Attach cables from the power connector (P13) -48V\_B and -48RTN on the rear panel of the MC to the NEG DC and POS RTN connectors fuse and alarm panel for a dual power feed connection. Then connect the -48RTNs to each other and the -48V\_A and -48V\_B to each other.

**Step 4** Attach one ferrite (36-0087-01 quantity 4) to each of the cables going to the fuse and alarm panel closer to the connectors.

**Figure 4** Single Power Feed Ferrites

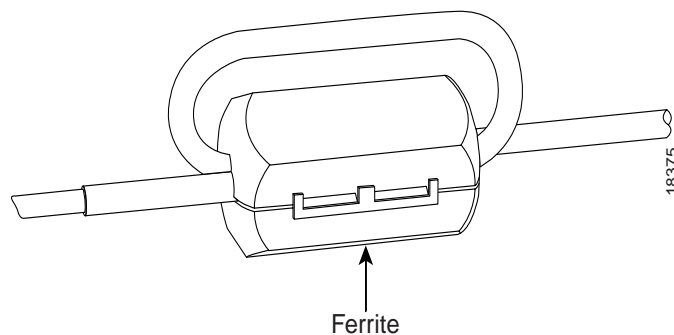
**Step 5** Loop the cable around the ferrite and back through the center for a proper fit.

**Figure 5** Loop the Cable Through the Ferrites
