# Upgrading DSLAMs for NI-2 Card and APS Link Redundancy

This document provides procedures for installing an additional second generation network interface (NI-2) card and upgrading NI-2 cards to support NI-2 card cold redundancy and automatic protection switching (APS) link redundancy on Cisco 6130, Cisco 6160, and Cisco 6260 digital subscriber line access multiplexers (DSLAMs).

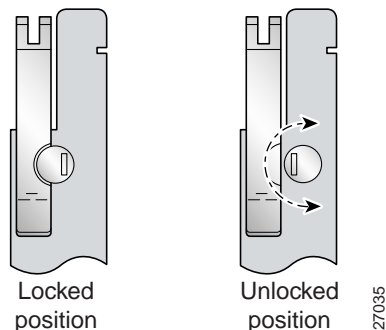
**Figure 1** Positioning the NI-2 Card Locking Tabs

**Step 3** Use a flat-head screwdriver to move both locking tabs on the NI-2 card from the locked to the unlocked position. Be sure to turn the locking tabs so that they do not overlap the NI-2 card locking levers, as shown in [Figure 1](#).

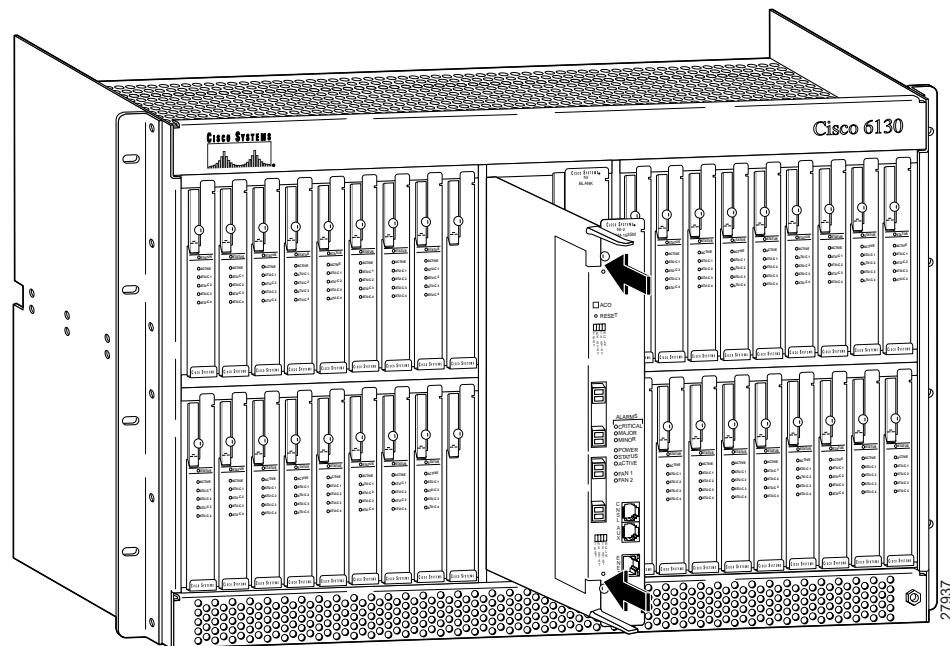
**Figure 2** NI-2 Card Installation

[Figure 2](#) shows the NI-2 installation in slot 10 of a Cisco 6130 chassis. The installation procedures will be the same for other chassis and for both slots 10 and 11.

**Step 5** Lift up on the locking levers and gently apply pressure to the bottom of the faceplate while pushing the card into the slot.

**Step 6** Push on the faceplate of the card to fully seat it.

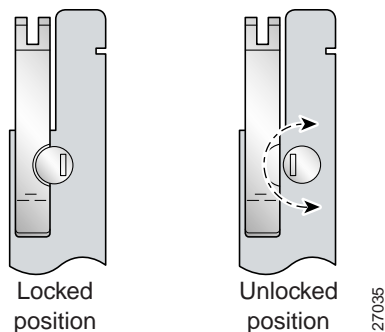
Figure 3 Positioning the NI-2 Card Locking Tabs

**Step 8** Lock both NI-2 card locking tabs. Use a flat-head screwdriver to turn the locking tabs so that they overlap the NI-2 card locking levers to prevent inadvertent dislodging, as shown in [Figure 3](#).

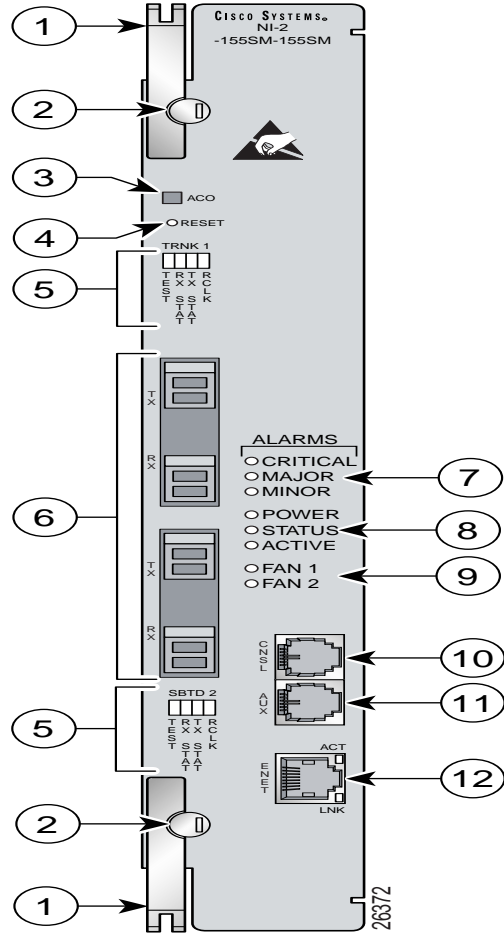
**Figure 4 Network Interface Connection**

- Step 11** Attach the receive fiber from the ATM switch to the transmit connector in the inset on the faceplate of the NI-2 card in slot 11 (trunk 1 interface connector TX). See Figure 4 for the network interface connection location.

**Note** [Figure 4](#) shows an OC-3c/OC-3c NI-2 card; the trunk receive and transmit connections will be the same for OC-3c/2DS3 NI-2 cards.

The transmit connector is the one closest to the top of the faceplate. The receive connector is closer to the bottom of the faceplate. The connector IDs are silkscreened on the NI-2 card faceplate.

- Step 12** Attach the transmit fiber from the ATM switch to the receive connector in the inset on the faceplate of the NI-2 card (trunk 1 interface connector RX). See [Figure 4](#) for the network interface connection location.

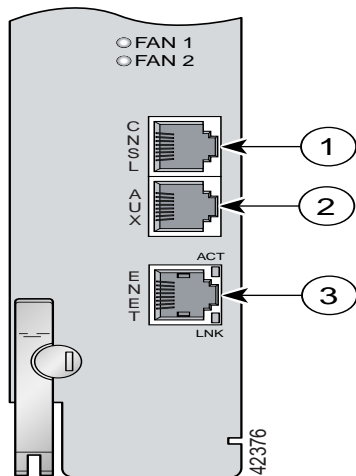
**Figure 5** CNSL, AUX, and ENET RJ-45 Receptacles on the NI-2 Card

**Step 13** Connect a VT100-compatible terminal to the system console port (CNSL) on the NI-2 card. [Figure 5](#) shows where to connect the console cable. Connect the terminal to a power source and set it up using the values that are shown in [Table 4](#).

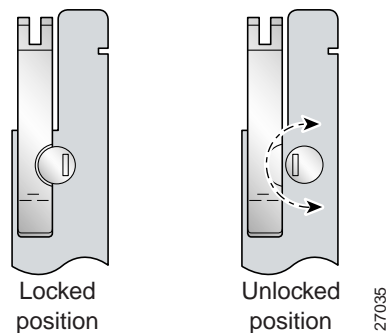
**Figure 6** Positioning the NI-2 Card Locking Tabs

**Step 3** Use a flat-head screwdriver to move both locking tabs on the NI-2 card from the locked to the unlocked position. Be sure to turn the locking tabs so that they do not overlap the NI-2 card locking levers, as shown in [Figure 6](#).

- Step 4** Use a flat-head screwdriver to turn the locking tabs so that they overlap the NI-2 card locking levers to prevent inadvertent dislodging, as shown in [Figure 6](#).
- Verify that the STATUS LED on the NI-2 card is solid green (where applicable).
- The power-on self-test procedure may take several minutes. If the STATUS LED is not green after the self-test, refer to the “[Troubleshooting](#)” section on page 32.
- Step 5** Repeat [Step 1](#) through [Step 4](#) to reseat the NI-2 card in slot 11.

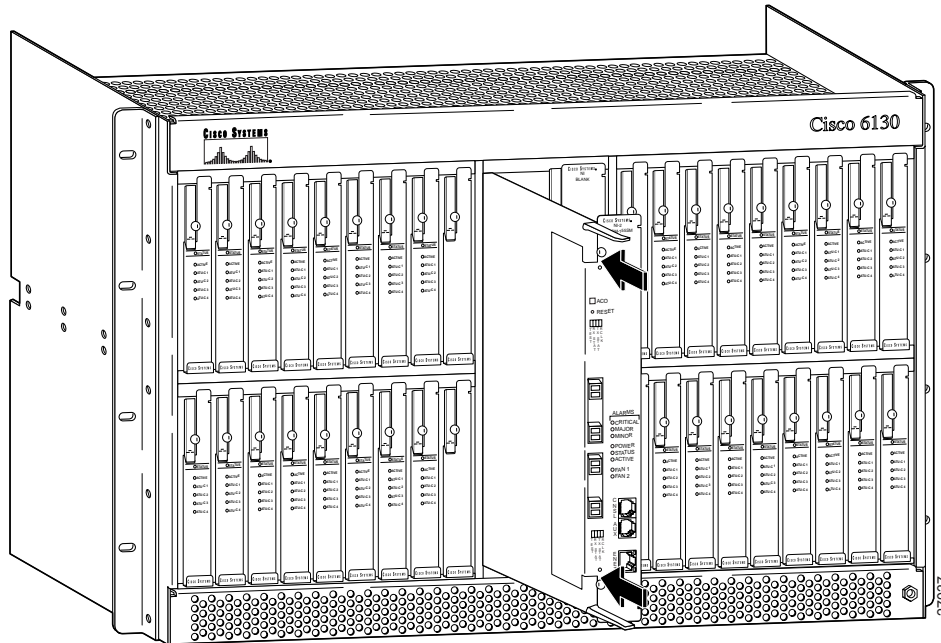
Figure 7 NI-2 Card Installation

[Figure 7](#) shows the NI-2 installation in slot 10 for a Cisco 6130 chassis. The installation procedures will be the same for the other chassis and for both slots 10 and 11.

- Step 5 Lift up on the locking levers and gently apply pressure to the bottom of the faceplate while pushing the card into the slot.
- Step 6 Push on the faceplate of each card to fully seat the card.
- Step 7 Press down on the locking levers to secure the card and connect it to the backplane.
- Step 8 Lock both NI-2 card locking tabs. Use a flat-head screwdriver to turn the locking tabs so that they overlap the NI-2 card locking levers to prevent inadvertent dislodging, as shown in [Figure 8](#).

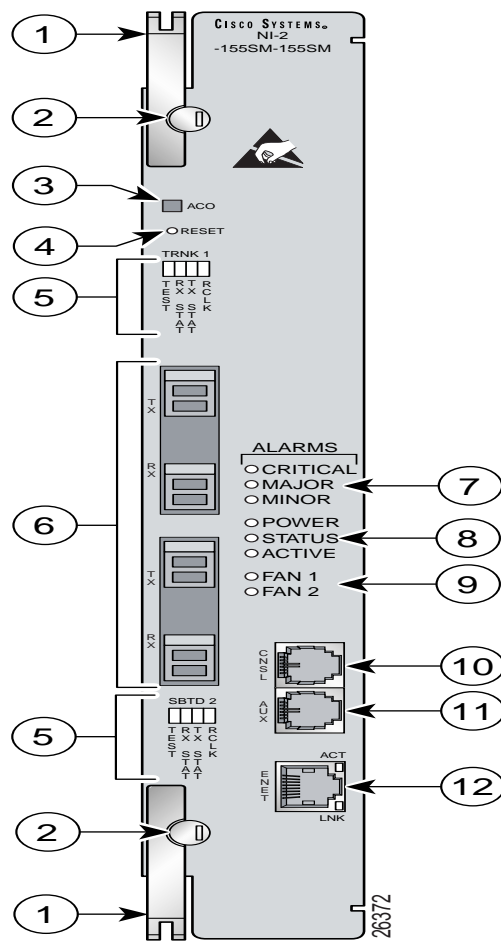
**Figure 9 Network Interface Connection**

**Step 11** Attach the receive fiber from the ATM switch to the transmit connector in the inset on the faceplate of the NI-2 card in slot 11 (trunk 1 interface connector TX). See Figure 9 for the network interface connection location.

**Note** Figure 9 shows an OC-3c/OC-3c NI-2 card; the trunk receive and transmit connections will be the same for OC-3c/2DS3 NI-2 cards.

The transmit connector is the one closest to the top of the faceplate. The receive connector is closer to the bottom of the faceplate. The connector IDs are silkscreened on the NI-2 card faceplate.

**Step 12** Attach the transmit fiber from the ATM switch to the receive connector in the inset on the faceplate of the NI-2 card (trunk 1 interface connector RX). See Figure 9 for the network interface connection location.

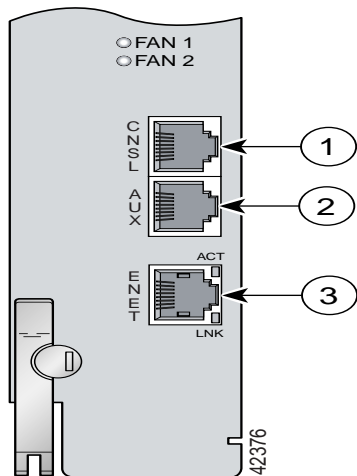
**Figure 10** CNSL, AUX, and ENET RJ-45 Receptacles on the NI-2 Card

**Step 13** Connect a VT100-compatible terminal to the system console port (CNSL) on the NI-2 card. [Figure 10](#) shows where to connect the console cable. Connect the terminal to a power source and set it up using the values that are shown in [Table 6](#).
