## Cisco ONS 15327 Troubleshooting Guide

Product and Documentation Release 3.4  
April 2003

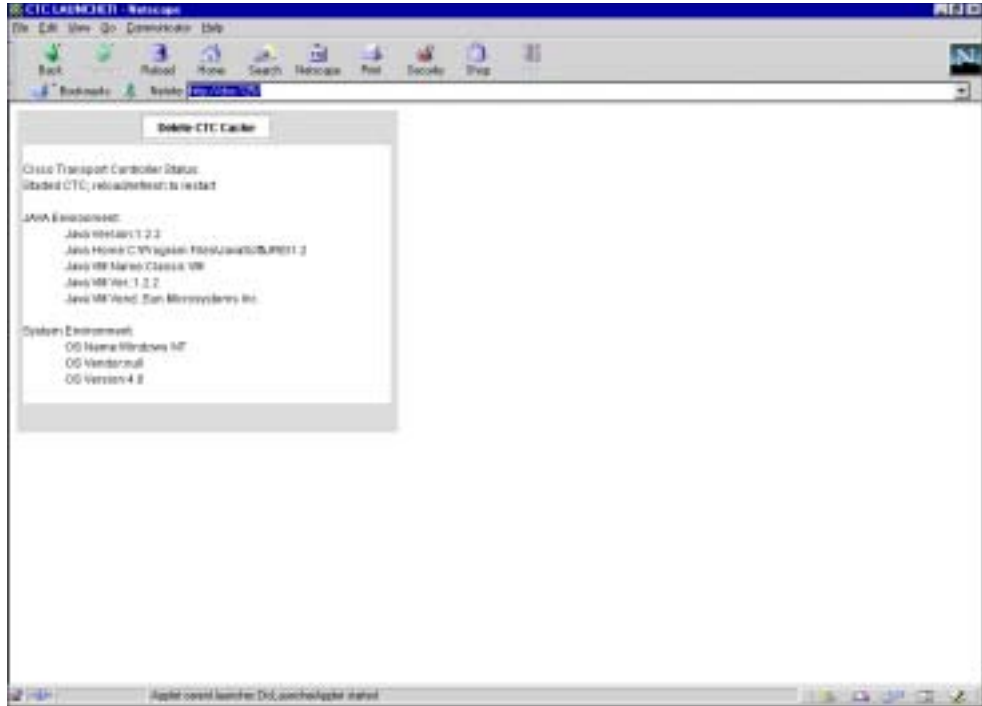
Figure 1-22 Deleting the CTC Cache

- 
- Step 1 Enter an ONS 15327 IP address in the browser URL field. The initial browser window shows a **Delete CTC Cache** button.
  - Step 2 Close all open CTC sessions and browser windows. The PC operating system does not allow you to delete files that are in use.
  - Step 3 Click the **Delete CTC Cache** button on the initial browser window to clear the CTC cache. [Figure 1-22 on page 1-56](#) shows the Delete CTC Cache window.
