Release Notes for Cisco ONS 15454

Release 2.3.4

Release Notes address closed (maintenance) issues, caveats, and new features for the Cisco ONS 15454. For detailed information regarding features, capabilities, hardware, and software, refer to *Cisco ONS 15454 User Documentation, Release 2.2.1*.

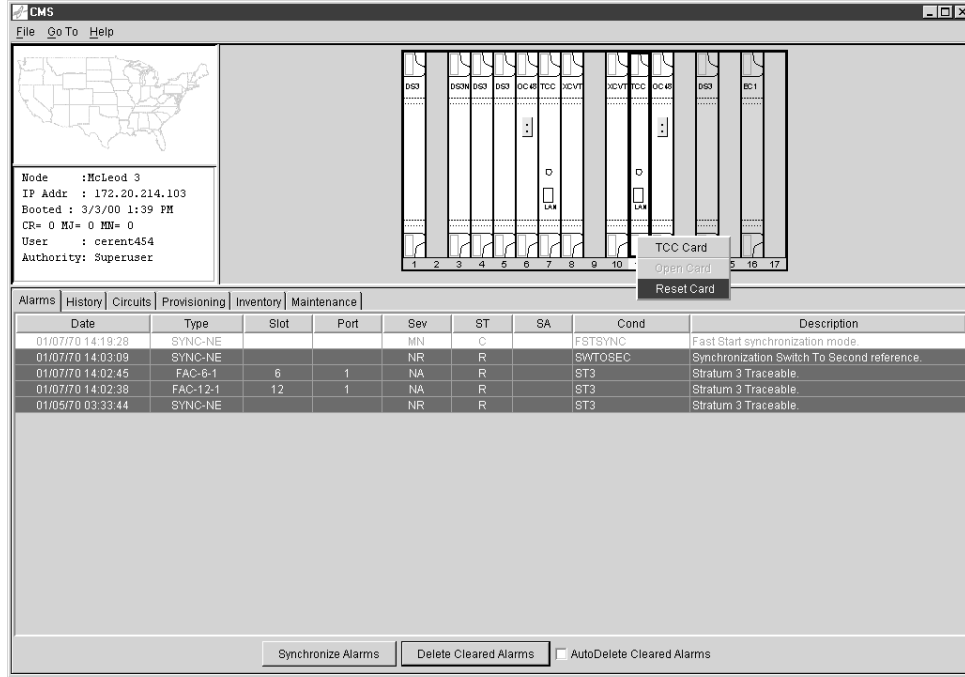
Figure 1

-
- Step 1** Display the node view in CTC.
 - Step 2** Right-click the standby TCC card to reveal a pull down menu.
 - Step 3** Click **Reset Card** (see Figure 1). The “Are You Sure” dialog box appears.
 - Step 4** Click **Yes**.

- Step 5** Confirm that the TCC returns to standby mode after the reset.
- Step 6** Right-click the active TCC card to reveal a pull-down menu.
- Step 7** Click **Reset Card** (see Figure 1). The “Are You Sure” dialog box appears.
- Step 8** Click **Yes**. The “Lost Connection to Node, Changing to Network View” dialog box appears.
- Step 9** Click **OK**.
