Release Notes for Cisco ONS 15454

Release 2.2.2

Release Notes address closed (maintenance) issues, caveats, and new features for the Cisco ONS 15454. For detailed information regarding features, capabilities, hardware, and software, refer to *Cisco ONS 15454 User Documentation, Release 2.2.1*.

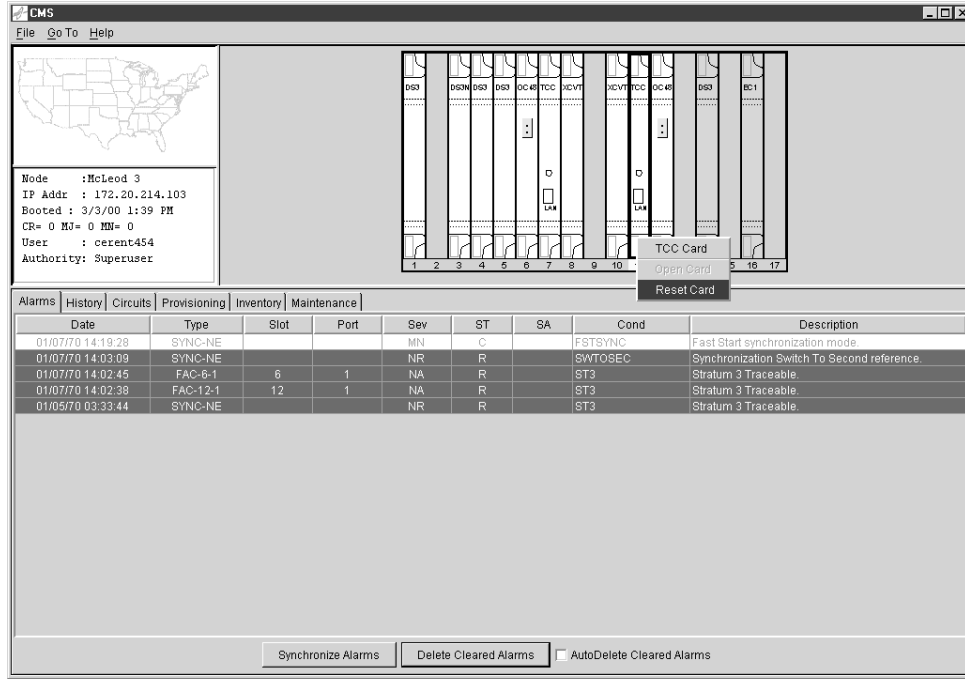
Figure 1

-
- Step 1** Display the node view in CTC.
 - Step 2** Right-click the standby TCC card to reveal a pull down menu.
 - Step 3** Click **Reset Card** (see Figure 1). The “Are You Sure” dialog box appears.

- Step 5 Confirm that the TCC returns to standby mode after the reset.
- Step 6 Right-click the active TCC card to reveal a pull-down menu.
- Step 7 Click **Reset Card** (see Figure 1). The “Are You Sure” dialog box appears.
- Step 8 Click **Yes**. The “Lost Connection to Node, Changing to Network View” dialog box appears.
- Step 9 Click **OK**.

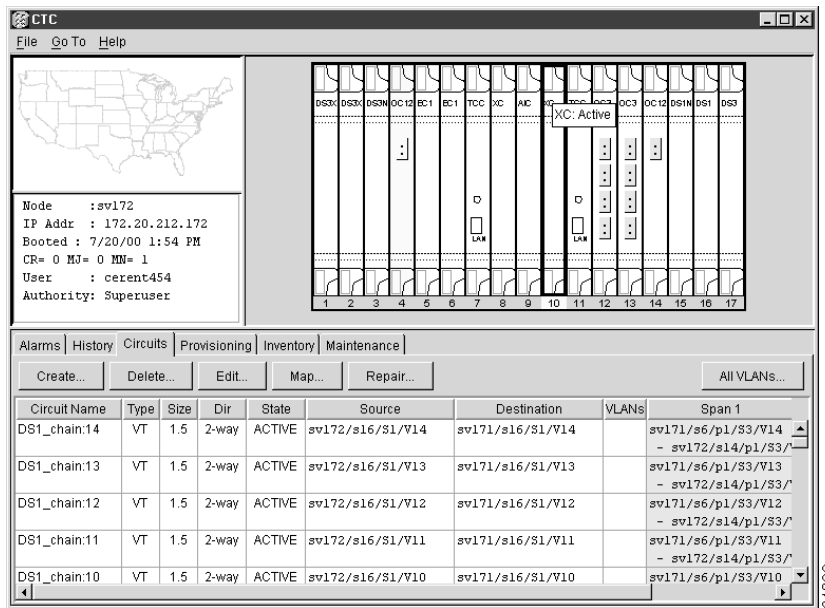
Figure 2

Note You can also place the cursor over the card graphic to display a tooltip identifying the card as active or standby.
