## **Cisco ONS 15454 Troubleshooting and Maintenance Guide**

Product and Documentation Release 3.2  
Last Updated: December 27, 2004

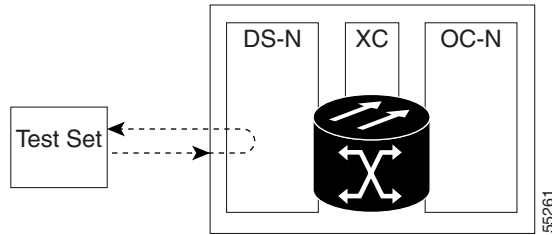
**Figure 2-1 The facility loopback process on a DS-N card**

A facility loopback tests the line interface unit (LIU) of a card, the EIA (electrical interface assembly), and related cabling. After applying a facility loopback on a card, use a test set to run traffic over the loopback. A successful facility loopback eliminates the LIU, the EIA, or cabling plant as the potential cause of a network problem. [Figure 2-1](#) shows a facility loopback on a DS-N card.

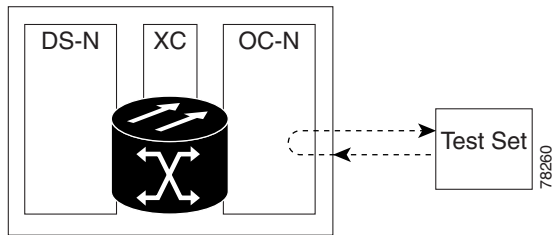
**Figure 2-2 The facility loopback process on an OC-N card**

Figure 2-2 shows a facility loopback on an OC-N card.

Before performing a facility loopback on an OC-N card, make sure the card contains at least two SDCC paths to the node where the card is installed. A second SDCC path provides a non-looped path to log into the node after the loopback is applied, thus enabling you to remove the facility loopback. Ensuring a second SDCC is not necessary if you are directly connected to the ONS 15454 containing the loopback OC-N card.

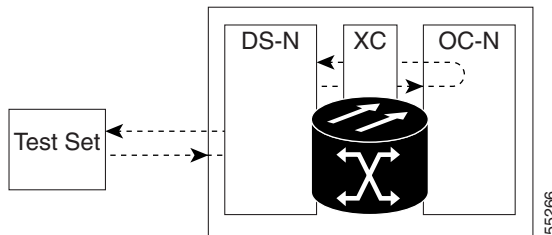
**Figure 2-3 The terminal loopback process on an OC-N card**

A terminal loopback tests a circuit path as it passes through the cross-connect card (XC, XCVT, or XC10G) and as it loops back from the card being tested. Figure 2-3 shows a terminal loopback on an OC-N card. The test-set traffic comes in on the DS-N card and goes through the cross-connect card to the OC-N card. The terminal loopback on the OC-N card turns the signal around before it reaches the LIU and sends it through the cross-connect card to the DS-N card. This test verifies that the cross-connect card and circuit paths are valid, but does not test the LIU on the OC-N card.

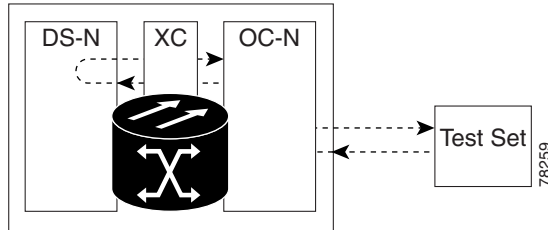
**Figure 2-4** The terminal loopback process on a DS-N card

To test the LIU on an OC-N card, connect an optical test set to the OC-N card ports and perform a facility loopback or use a loopback or hairpin on a card that is farther along the circuit path. Figure 2-4 shows a terminal loopback on a DS-N card. The test-set traffic comes in on the OC-N card and goes through the

cross-connect card to the DS-N card. The terminal loopback on the DS-N card turns the signal around before it reaches the LIU and sends it through the cross-connect card to the OC-N card. This test verifies that the cross-connect card and circuit paths are valid, but does not test the LIU on the DS-N card.

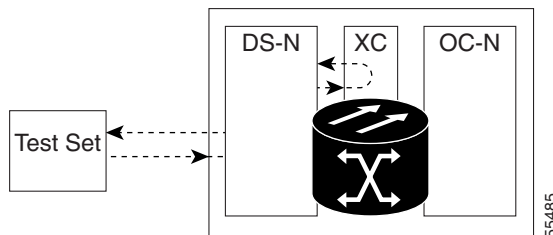
**Figure 2-5** The hairpin circuit process on an OC-N card

A hairpin circuit brings traffic in and out on a DS-N port rather than sending the traffic onto the OC-N card. A hairpin loops back only the specific STS or VT circuit and does not cause an entire OC-N port to loop back, thus preventing a drop of all traffic on the OC-N port. The hairpin allows you to test a circuit on nodes running live traffic.

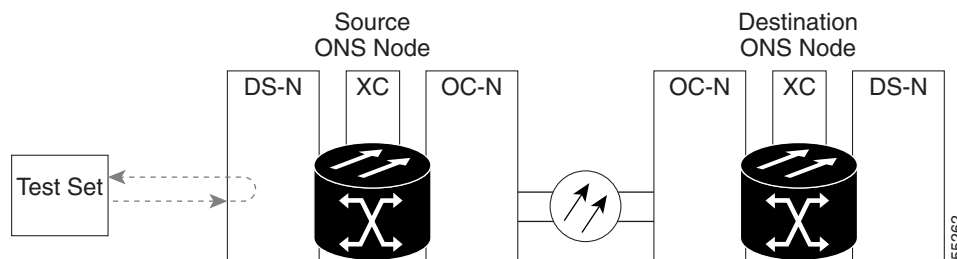
**Figure 2-6** A facility loopback on a circuit source DS-N card

The facility loopback test is performed on the source card in the network circuit, in this example, the DS-N card in the source node. Completing a successful facility loopback on this card eliminates the cabling, the DS-N card, and the EIA as possible failure points. Figure 2-6 shows an example of a facility loopback on a source DS-N card.

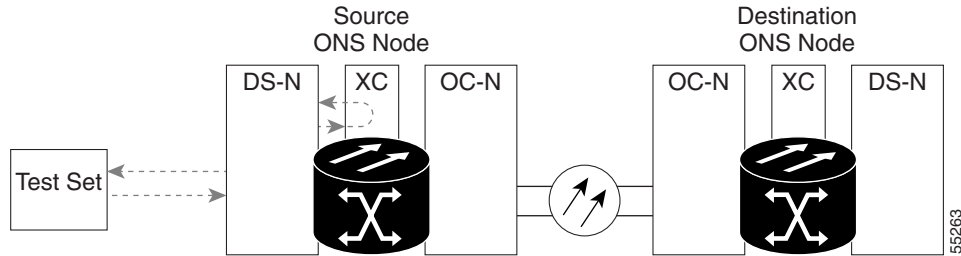
Figure 2-7 Hairpin on a source node

The hairpin test is performed on the cross-connect card in the network circuit. A hairpin circuit uses the same port for both source and destination. Completing a successful hairpin through the card eliminates the possibility that the cross-connect card is the cause of the faulty circuit. [Figure 2-7](#) shows an example of a hairpin loopback on a source node.

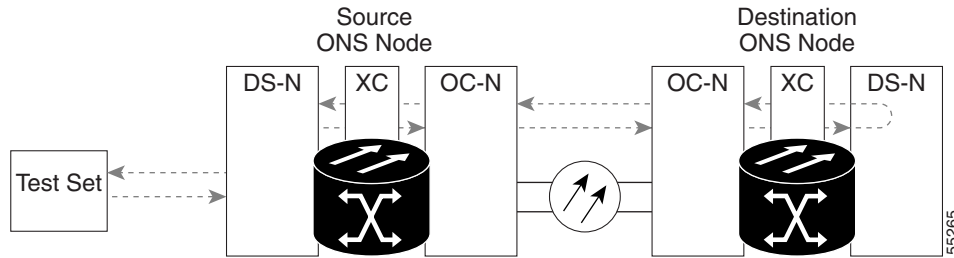
Figure 2-8 Terminal loopback on a destination DS-N card

This test is a terminal loopback performed on the destination line card in the circuit, in the following example the DS-N card in the destination node. First, create a bidirectional circuit that starts on the source node DS-N port and terminates on the destination node DS-N port. Then proceed with the terminal loopback test. Completing a successful terminal loopback to a destination node DS-N card verifies that the circuit is good up to the destination DS-N. [Figure 2-8](#) shows an example of a terminal loopback on a destination DS-N card.

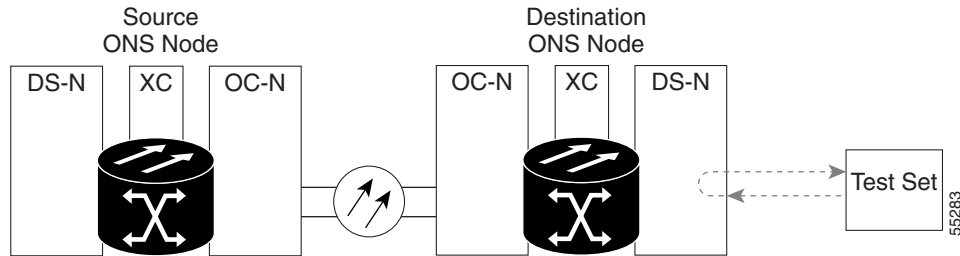
Figure 2-9 Facility loopback on a destination DS-N card

The final test is a facility loopback performed on the last card in the circuit, in this case the DS-N card in the destination node. Completing a successful facility loopback on this card eliminates the possibility that the destination node cabling, DS-N card, LIU, or EIA is responsible for a faulty circuit. [Figure 2-9](#) shows an example of a facility loopback on a destination DS-N card.

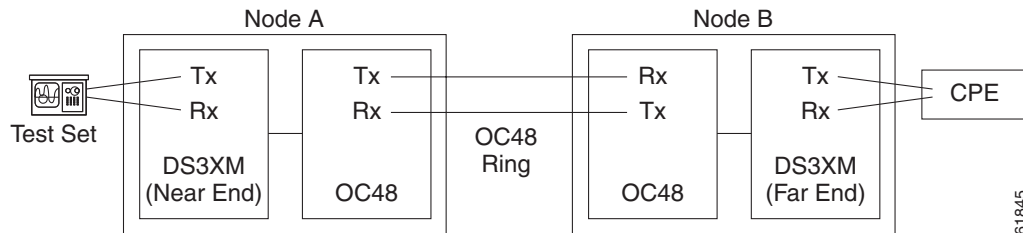
Figure 2-11 Diagram of far end action code

The far end in FEAC refers to the piece of equipment that is connected to the DS3XM-6 card and not the far end of a circuit. In Figure 2-11, if a DS3XM-6 (near-end) port is configured to send a Line Loop Code, the code will be sent to the connected test set, not the DS3XM-6 (far-end) port.

The Send Code column on the maintenance tab of a DS3XM-6 port only applies to in-service ports configured for CBIT framing. The column lets a user select No Code (the default) or Line Loop Code. Selecting Line Loop Code inserts a line loop activate FEAC (Far End Alarm and Control) in the CBIT overhead transmitting to the connected facility. This code initiates a loopback from the facility to the ONS 15454. Selecting No Code sends a line-loop-deactivate FEAC code to the connected equipment, which will remove the loopback. You can also insert a FEAC for the 28 individual DS-1 circuits transmuted into a DS-3 circuit.

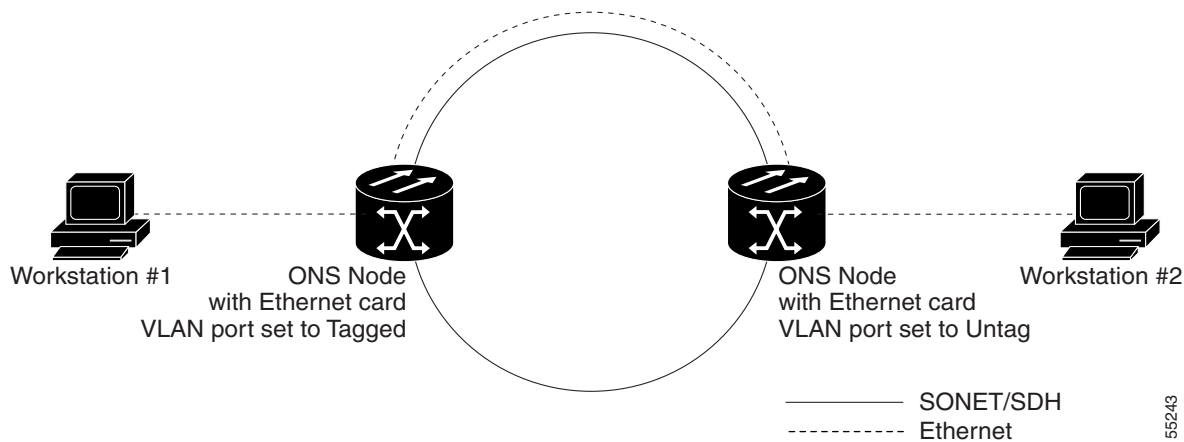
**Figure 2-14** A VLAN with Ethernet ports at Tagged and Untag

**Symptom:** Networks that have a VLAN with one ONS 15454 Ethernet card port set to Tagged and one ONS 15454 Ethernet card set to Untag may have difficulty implementing Address Resolution Protocol (ARP) for a network device attached to the Untag port ([Figure 2-14](#)). They may also see a higher than normal runt packets count at the network device attached to the Untag port.

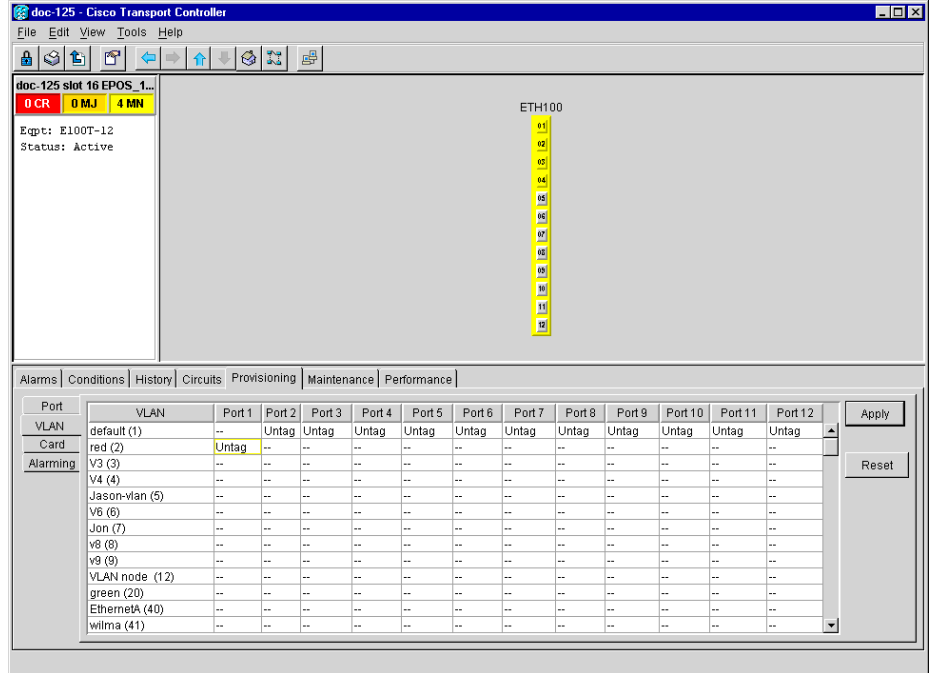
Figure 2-15 Configuring VLAN membership for individual Ethernet ports

- 
- Step 1** Display the CTC card view for the Ethernet card involved in the problem VLAN.
- Step 2** Click the **Provisioning > VLAN** tabs ([Figure 2-15](#)).

- Step 3** If the port is set to **Tagged**, continue to look at other cards and their ports in the VLAN until you find the port that is set to **Untag**.
- Step 4** At the VLAN port set to **Untag**, click the port and choose **Tagged**.

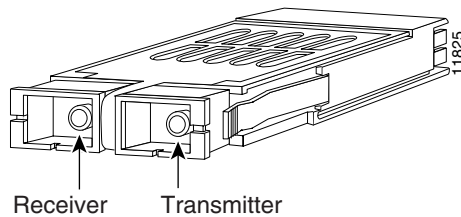
**Figure 2-16** A gigabit interface converter (GBIC)

GBICs can be installed or removed while the card and shelf assembly are powered and running. GBIC transmit failure is characterized by a steadily blinking Fail LED on a Gigabit Ethernet (E1000-2/E1000-2-G or G1000-4) card. [Figure 2-16](#) shows a GBIC.

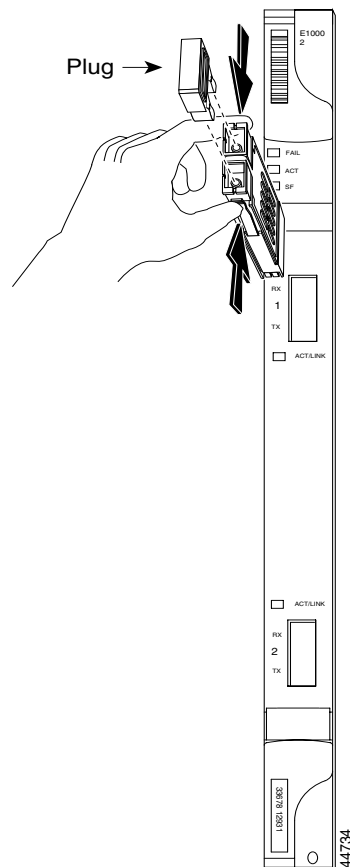
**Figure 2-17** Installing a GBIC on the E1000-2/E1000-2-G card

**Note** GBICs are keyed to prevent incorrect installation.

- Step 7** Slide the GBIC through the front flap until you hear a click. The click indicates that the GBIC is locked into the slot.
- Step 8** When you are ready to attach the network interface fiber-optic cable, remove the protective plug from the GBIC and save the plug for future use.

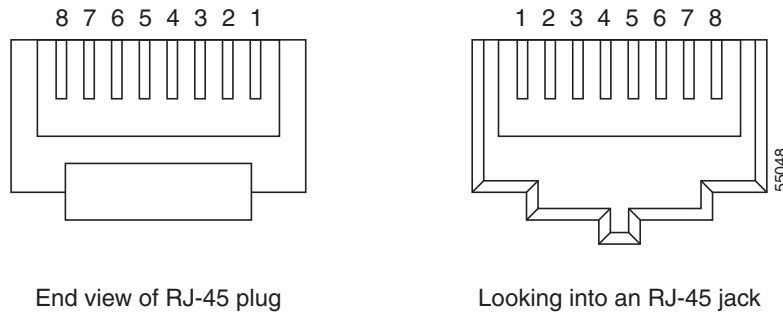
**Figure 2-18 RJ-45 pin numbers**

End view of RJ-45 plug

Looking into an RJ-45 jack

You can crimp your own CAT-5 cables for use with the ONS 15454. Use a cross-over cable when connecting an ONS 15454 to a hub, LAN modem, or switch, and use a straight-through cable when connecting an ONS 15454 to a router or workstation. Use CAT 5 cable RJ-45 T-568B, Color Code (100 Mbps), and a crimping tool. [Figure 2-18](#) shows the layout of an RJ-45 connector. [Figure 2-19](#) shows the layout of a straight-through cable and [Figure 2-20](#) shows the layout of a cross-over cable.

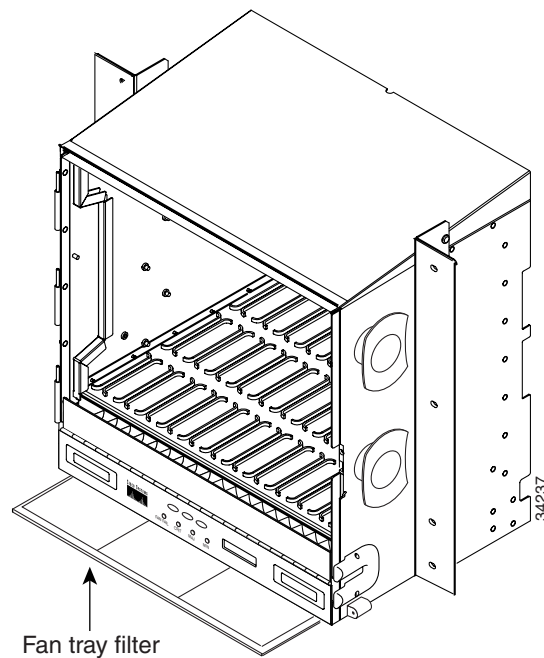
**Figure 3-1** A reusable fan-tray air filter in an external filter bracket

The reusable filter is made of a gray, open-cell, polyurethane foam that is specially coated to provide fire and fungi resistance. NEBS 3E and later versions of the ONS 15454 use a reusable air filter. [Figure 3-1](#) illustrates a reusable fan-tray air filter in an external filter bracket. When the filter is dirty, remove the filter and clean it by either vacuuming the filter or running water through it. Because the filter material is delicate, only a very low-power vacuum should be used. If you are cleaning with water, make sure the filter is completely dry (dry time is at least eight hours) before replacing it in the fan-tray assembly. Spare filters should be kept in stock.

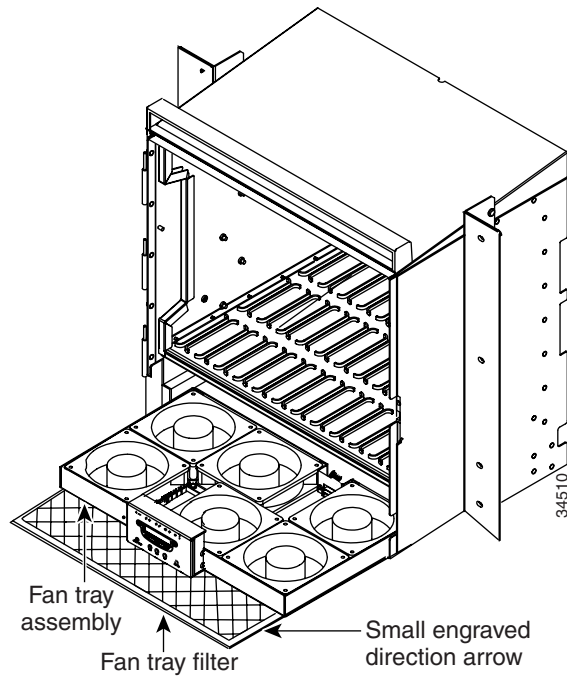
**Figure 3-2** Inserting or removing the fan-tray assembly

- Step 1** Remove the front door of the shelf assembly.
- Step 2** Open the front covers of the fiber management area.
- Step 3** Lower the hinged panels in front of the cable management tray.
- Step 4** Slide the fan-tray assembly out of the shelf assembly (see [Figure 3-2](#)).

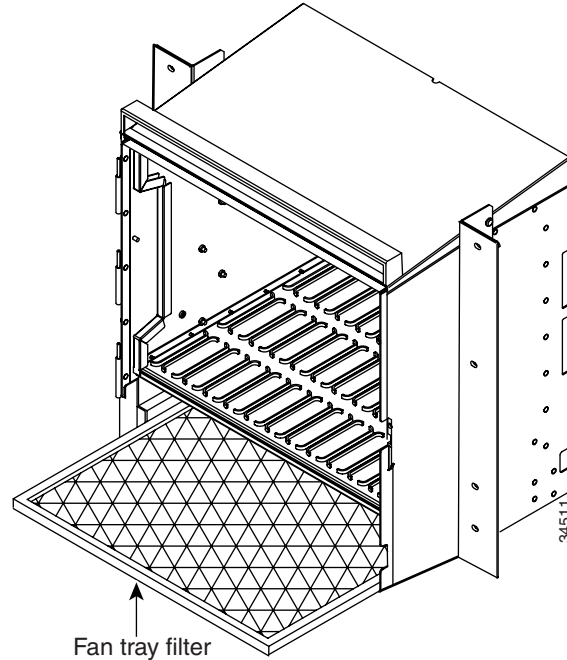
**Figure 3-3** Inserting or removing a disposable fan-tray air filter

- Step 5** Carefully slide the air filter out of the shelf assembly (see [Figure 3-3](#)). Be careful not to dislodge any dust that may have collected on the filter.
- Step 6** Visually inspect the white filter material for dirt and dust.
- Step 7** If the air filter shows a heavy concentration of dirt and dust, replace it with a new filter by sliding the new filter into the bottom of the shelf assembly. Make sure that the front of the filter is flush with the front of the shelf assembly and that the air flow indicators on the filter point upwards.

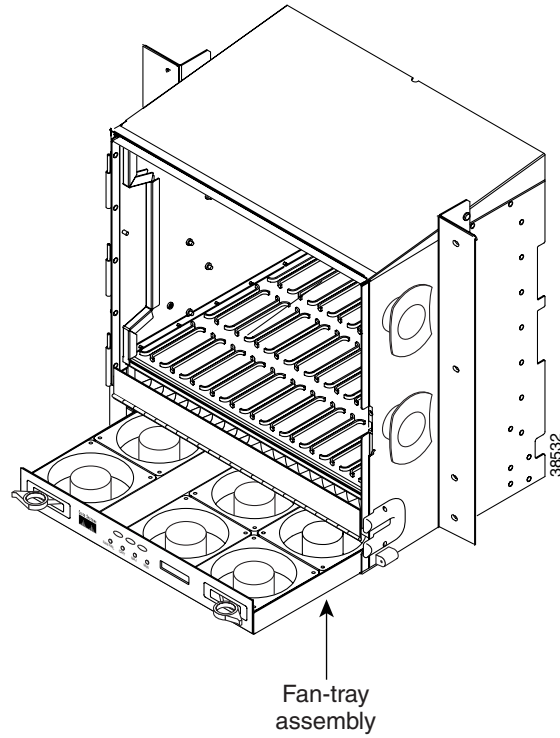
**Figure 3-4** Removing or replacing the fan-tray assembly

- 
- Step 1** Remove the front door of the shelf assembly.
- Step 2** Fold out the retractable handles at the outside edges of the fan tray.
- Step 3** Slide the fan tray out of the shelf assembly by gently pulling on the handles. [Figure 3-4](#) shows the location of the fan tray.
- Step 4** If you are replacing the fan-tray air filter and it is installed beneath the fan-tray assembly, slide the existing air filter out of the shelf assembly and replace it before replacing the fan-tray assembly.
- If you are replacing the fan-tray air filter and it is installed in the external bottom bracket, you can slide the existing air filter out of the bracket and replace it at anytime.

- Step 5** Slide the fan tray into the shelf assembly until the electrical plug at the rear of the tray plugs into the corresponding receptacle on the backplane.
- Step 6** To verify that the tray has plugged into the backplane, check that the LCD on the front of the fan tray is activated.

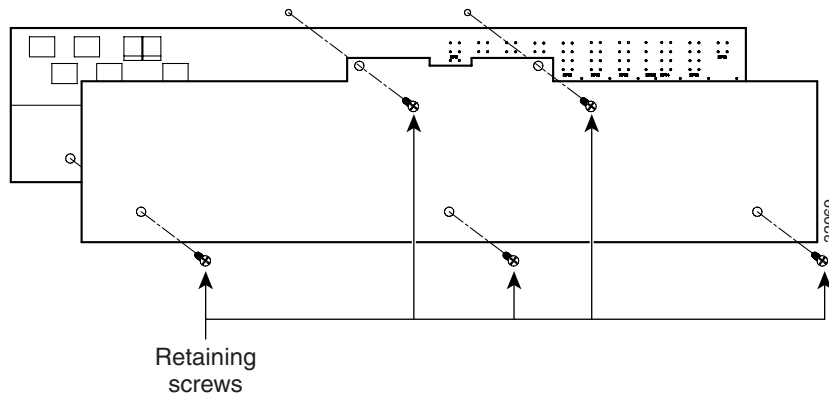
Figure 3-6 Lower backplane cover

- Step 3** Call Cisco TAC at 877-323-7368 for assistance in replacing the AIP and maintaining the original MAC address.
- Step 4** Unscrew the five screws that hold the lower backplane cover in place (Figure 3-6).
- Step 5** Grip the lower backplane cover and gently pull away from the backplane.

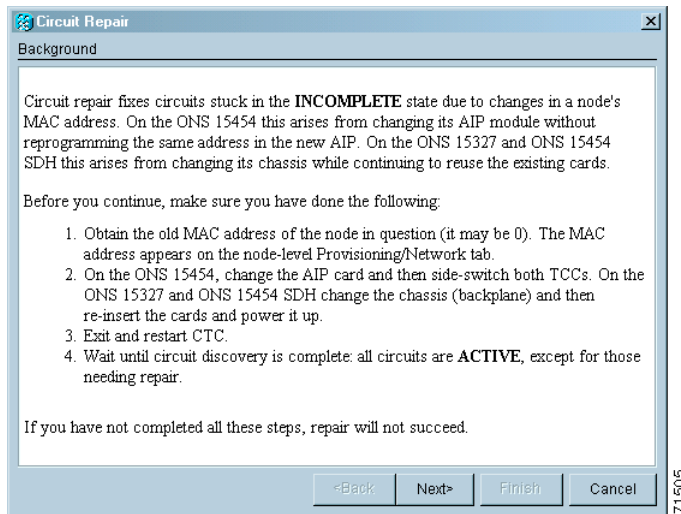
**Figure 3-8** Repairing circuits

- Step 23** Read the instructions in the Circuit Repair dialog box (Figure 3-8). If all the steps in the dialog box have been completed, click **Next>**. Ensure you have the old and new MAC addresses.

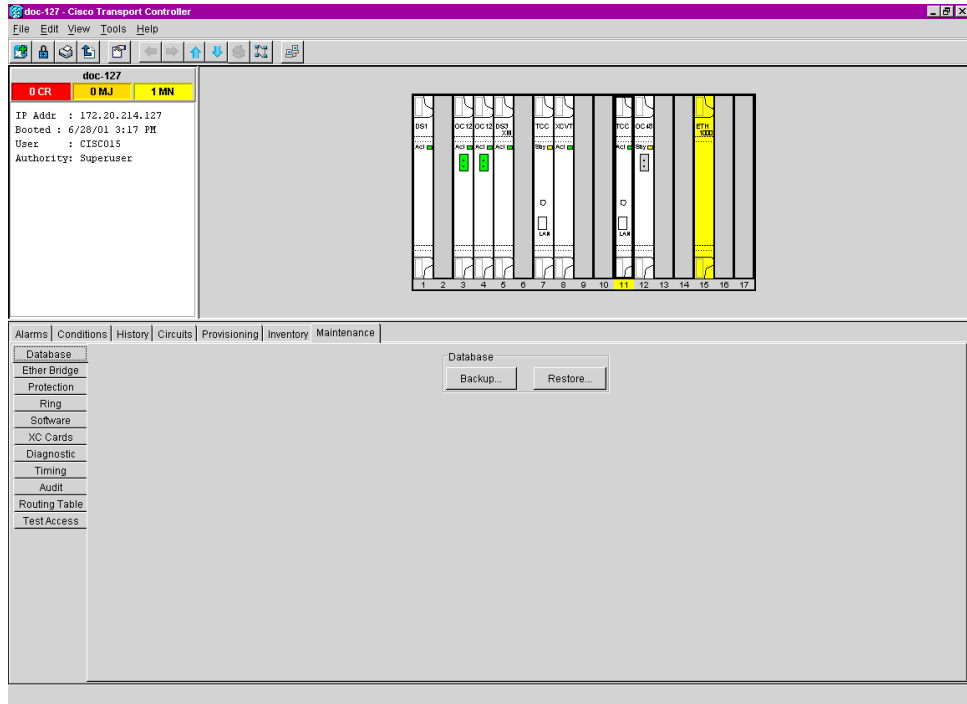
Figure 3-12 Backing up the TCC+ database

- Step 1** Log into CTC.
- Step 2** Click the **Maintenance > Database** tabs.

**Step 3** Click **Backup**.

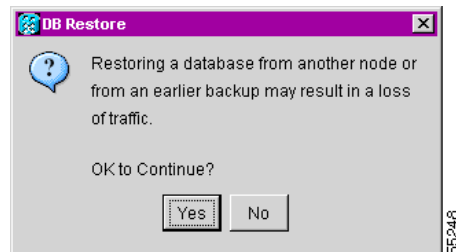
Figure 3-15 Restoring the database—traffic loss warning

The DB Restore dialog box appears. A restore from another node will affect traffic.

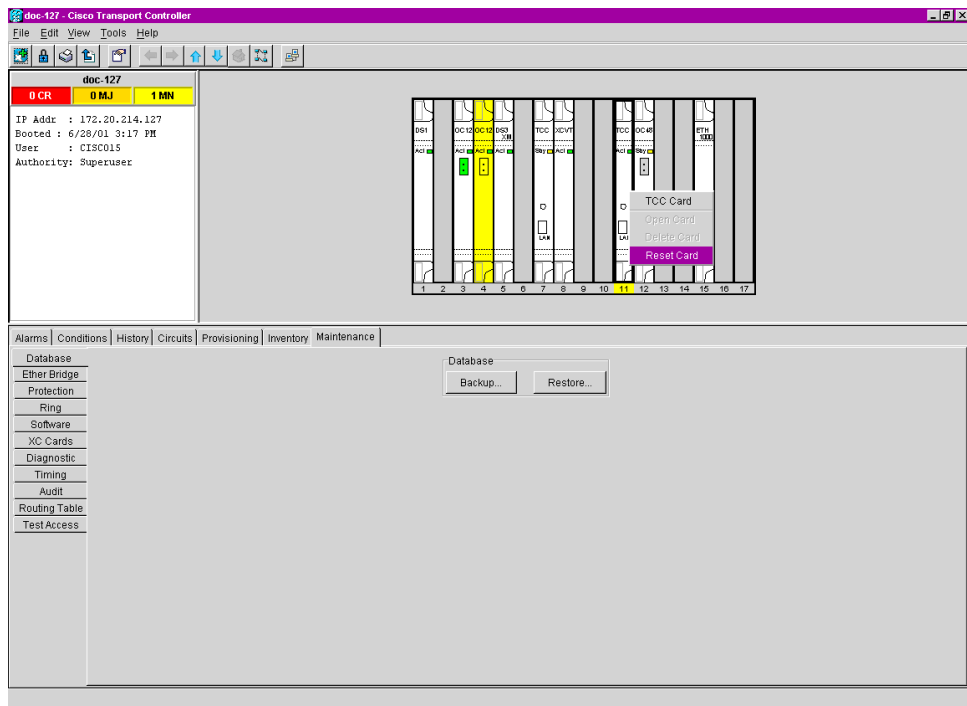
Figure 3-17 Initiating a software reset on the TCC card

- Step 2** Right click the active TCC card to reveal a pull-down menu.
- Step 3** Click **Reset Card** (Figure 3-17).

Wait for the TCC to reboot. The ONS 15454 switches the standby TCC+ card to active mode.

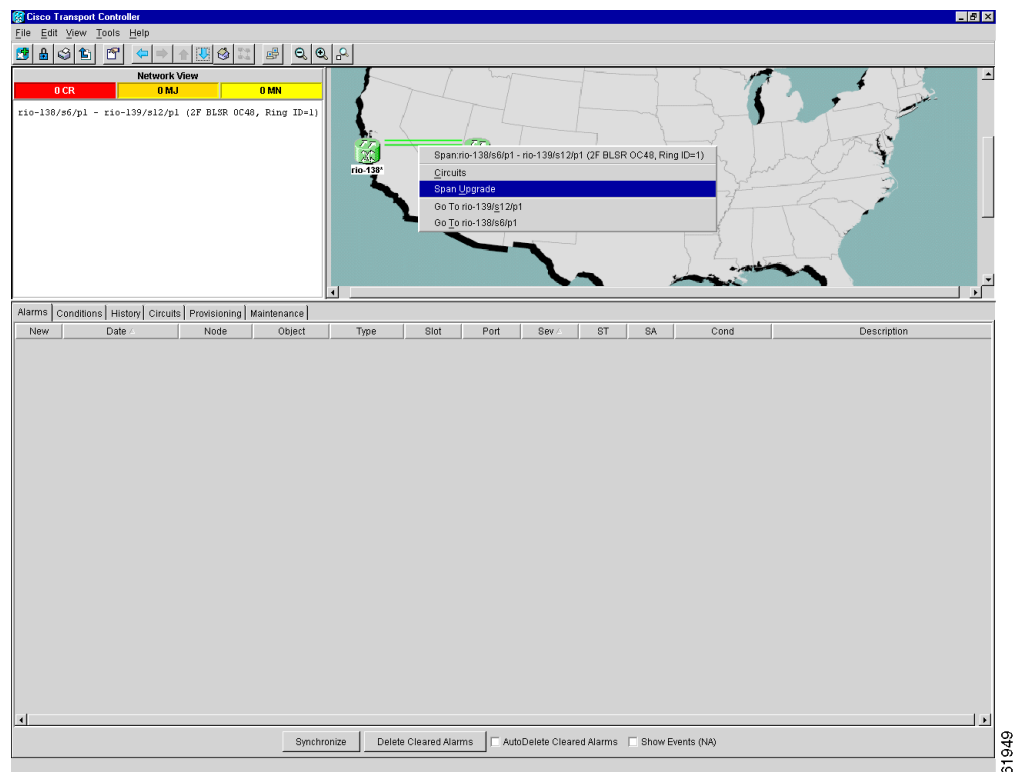
**Figure 3-18** Span pull-down menu

- Step 1** Ensure that no alarms or abnormal conditions (regardless of severity), including LOS, LOF, AIS-L, SF, SD, and FORCED-REQ-RING are present:
- a. In network view, click on the **Alarms** tab to view a list of current alarms.
  - b. In network view, click on the **Conditions** tab and click the **Retrieve Conditions** button to view a list of current conditions.
- An unresolved alarm or abnormal condition is the most probable reason for upgrade failure.
- Step 2** In network view, right-click the span you want to upgrade.
- Step 3** Choose Span Upgrade from the pull-down menu (Figure 3-18).

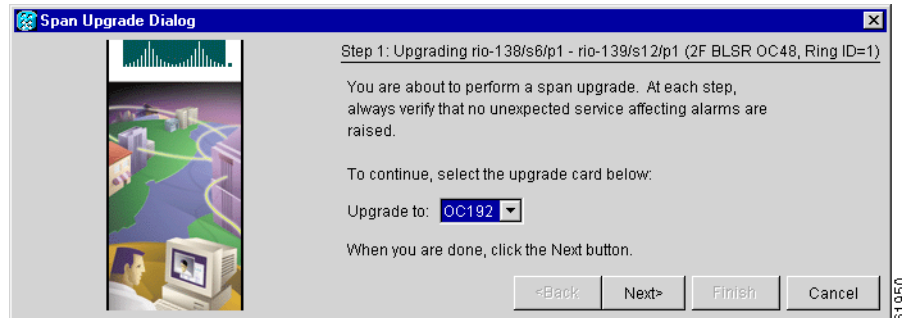
**Figure 3-19** Beginning the Span Upgrade Wizard

The first Span Upgrade Dialog box appears (Figure 3-19). Follow the instructions on the dialog box and the wizard will lead you through the rest of the span upgrade. The <Back button is only enabled on Step 2 of the wizard; because you cannot back out of an upgrade via the wizard, exit the wizard and initiate the manual procedure if you need to back out of the upgrade at any point beyond Step 2.

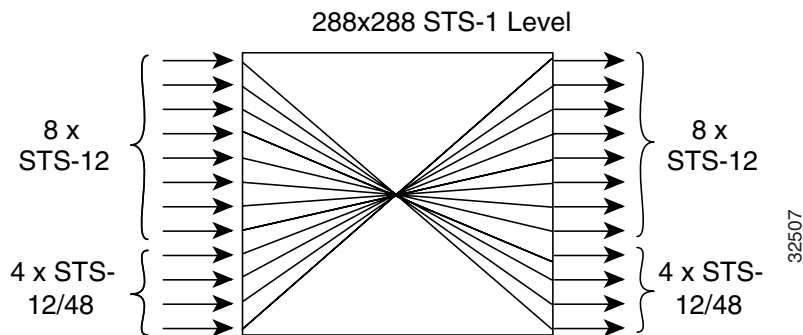
Figure 4-6 XC cross-connect matrix

The switch matrix on the XC card consists of 288 bidirectional ports. When creating bidirectional STS-1 cross-connects, each cross-connect uses two STS-1 ports. This results in 144 bidirectional STS-1 cross-connects. The switch matrix is fully crosspoint, non-blocking, and broadcast supporting. (Any STS-1 on any port can be connected to any other port, meaning that the STS cross-connections are non blocking.) This allows network operators to concentrate or groom low-speed traffic from line cards onto high-speed transport spans and to drop low-speed traffic from transport spans onto line cards.

The XC card has 12 input ports and 12 output ports. Four input and output ports operate at either STS-12 or STS-48 rates. The remaining eight input and output ports operate at the STS-12 rate. An STS-1 on any of the input ports can be mapped to an STS-1 output port, thus providing full STS-1 time slot assignments (TSA).

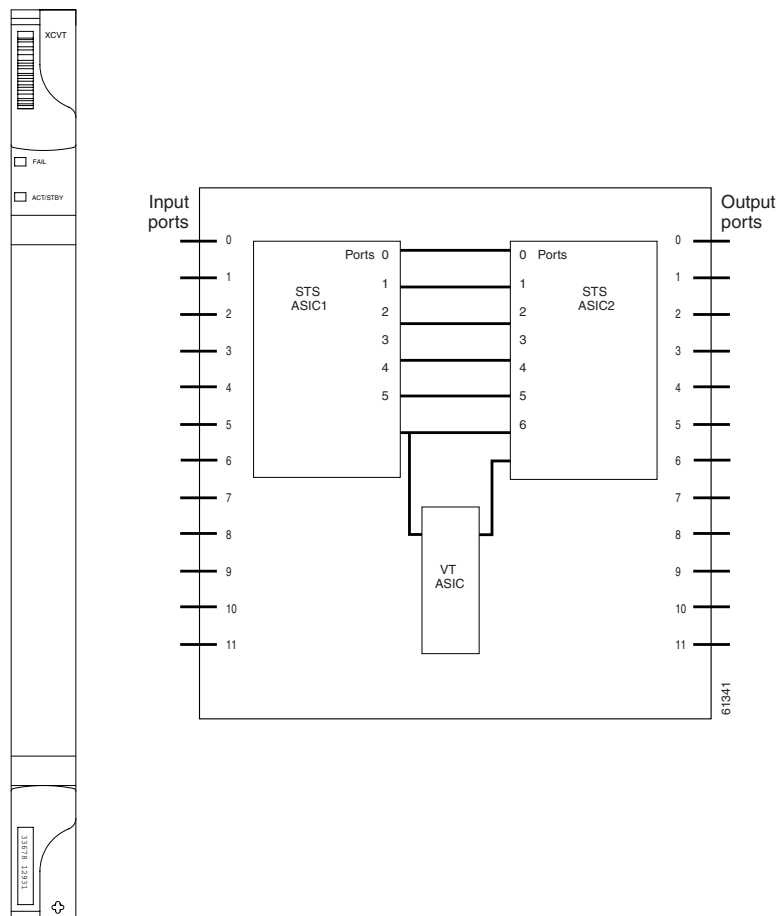
**Figure 4-7 XCVT faceplate and block diagram**

Figure 4-7 shows the XCVT faceplate and block diagram. Figure 4-8 on page 4-23 shows the cross-connect matrix.

The XCVT card works with the TCC+ card to maintain connections and set up cross-connects within the node. Either the XCVT, XC10G, or XC is required to operate the ONS 15454. You can establish cross-connect (circuit) information through CTC. The TCC+ establishes the proper internal cross-connect information and relays the setup information to the XCVT card.

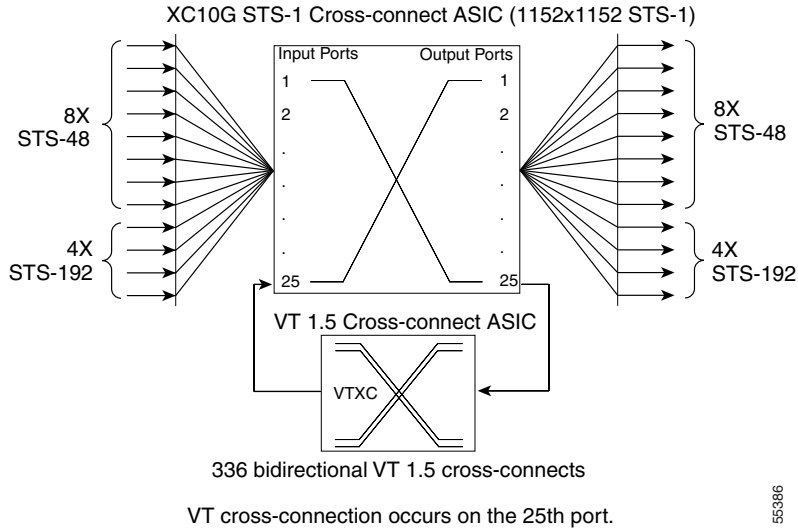
**Figure 4-10 XC10G cross-connect matrix**

The XC10G card manages up to 336 bidirectional VT1.5 ports and 576 bidirectional STS-1 ports. The TCC+ assigns bandwidth to each slot on a per STS-1 or per VT1.5 basis.

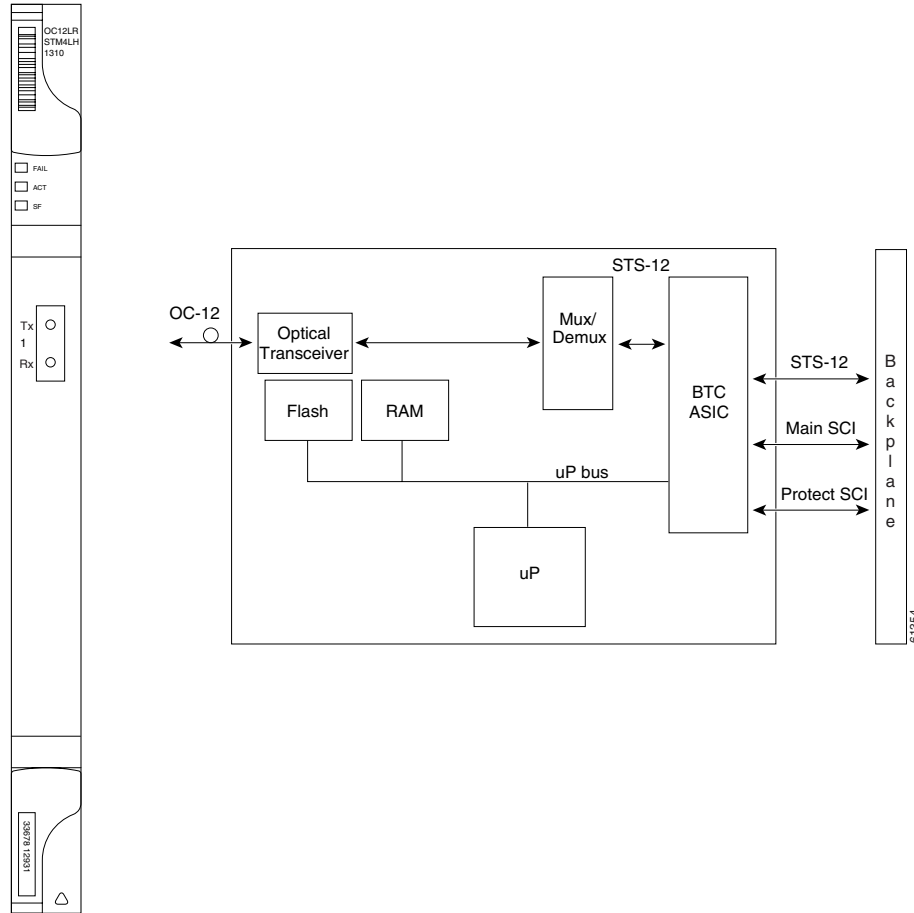
Figure 4-23 OC12 LR/STM4 LH 1310 faceplate and block diagram

The OC12 LR/STM4 LH 1310 card provides one long-range, ITU-T G.707, ITU-T G.957, and Telcordia-compliant, GR-253 SONET OC-12 port per card. The port operates at 622.08 Mbps over a single-mode fiber span. The card supports VT and non-concatenated or concatenated payloads at STS-1, STS-3c, STS-6c or STS-12c signal levels. [Figure 4-23](#) shows the OC12 LR/STM4 LH 1310 faceplate and a block diagram of the card.

You can install the OC12 LR/STM4 LH 1310 card in any multispeed or high-speed card slot and provision the card as a drop card or span card in a two-fiber BLSR (Bidirectional line switched ring), UPSR, or ADM (linear) configuration.

The OC12 LR/STM4 LH 1310 card port features a 1310 nm laser and contains a transmit and receive connector (labeled) on the card faceplate. The card uses SC optical connections supporting 1+1 unidirectional and bidirectional protection.

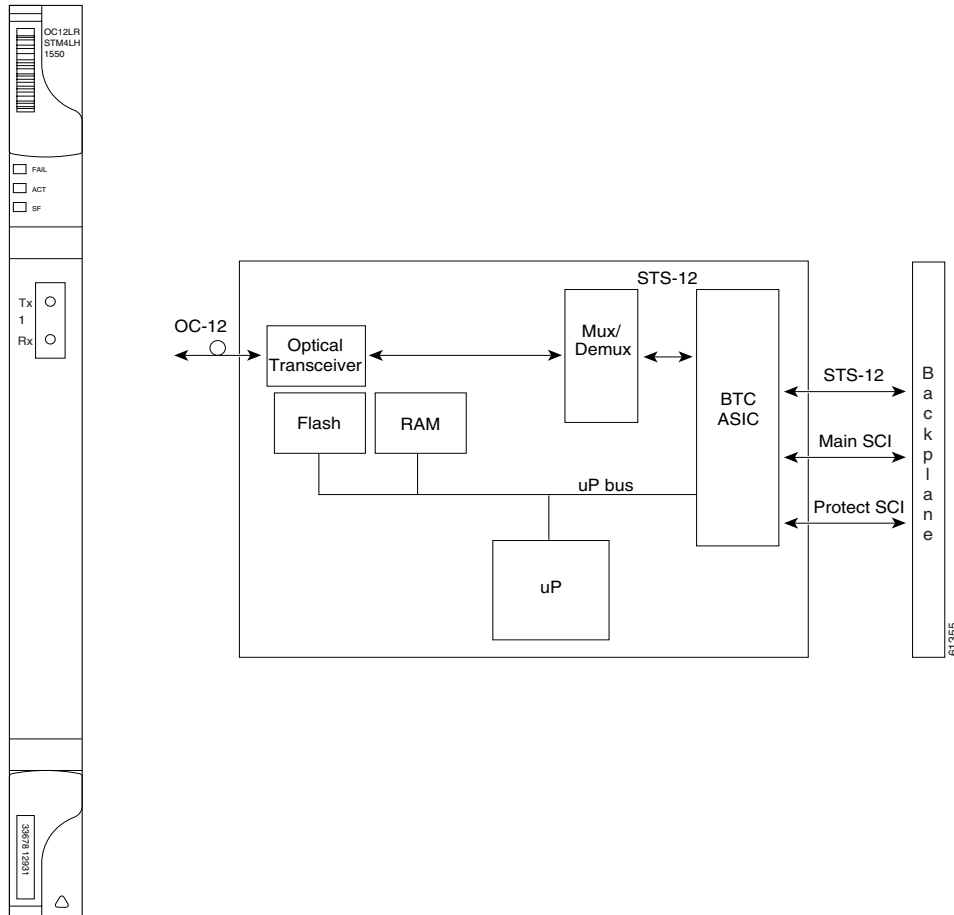
Figure 4-24 OC12 LR/STM4 LH 1550 faceplate and block diagram

The OC12 LR/STM4 LH 1550 card provides one long-range SONET/SDH OC-12 port compliant with the International Telecommunication Union's G.707, G.957, and Telcordia's GR-253. The port operates at 622.08 Mbps over a single-mode fiber span. The card supports VT and non-concatenated, or concatenated payloads at STS-1, STS-3c, STS-6c, or STS-12c signal levels. [Figure 4-24](#) shows the OC12 LR/STM4 LH 1550 faceplate and a block diagram of the card.

You can install the OC12 LR/STM4 LH 1550 card in any multispeed card slot. The OC12 LR/STM4 LH 1550 can be provisioned as part of a two-fiber BLSR, UPSR or linear ADM.

The OC12 LR/STM4 LH 1550 uses long-reach optics centered at 1550 nm and contains a transmit and receive connector (labeled) on the card faceplate. The OC12 LR/STM4 LH 1550 uses SC optical connections and supports 1+1 bidirectional or unidirectional protection switching.

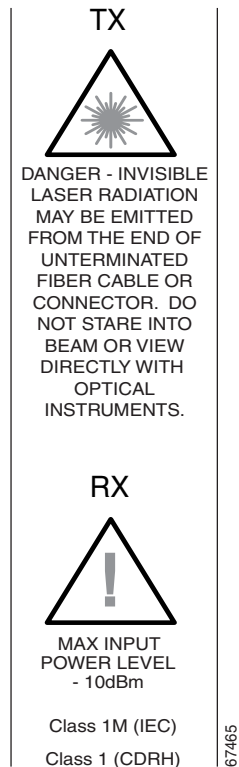
Figure 4-32 Enlarged section of the OC192 LR/STM64 LH 1550 faceplate

Figure 4-31 shows the OC192 LR/STM64 LH 1550 faceplate and a block diagram of the card. Figure 4-32 on page 4-88 shows an enlarged view of the faceplate warning.

You must use a 19 to 24 dB (20 recommended) fiber attenuator when connecting a fiber loopback to an OC192 LR/STM64 LH 1550 card. Never connect a direct fiber loopback. Using fiber loopbacks causes irreparable damage to the OC-192 card. A Tx to Rx connection that is not attenuated will damage the receiver.

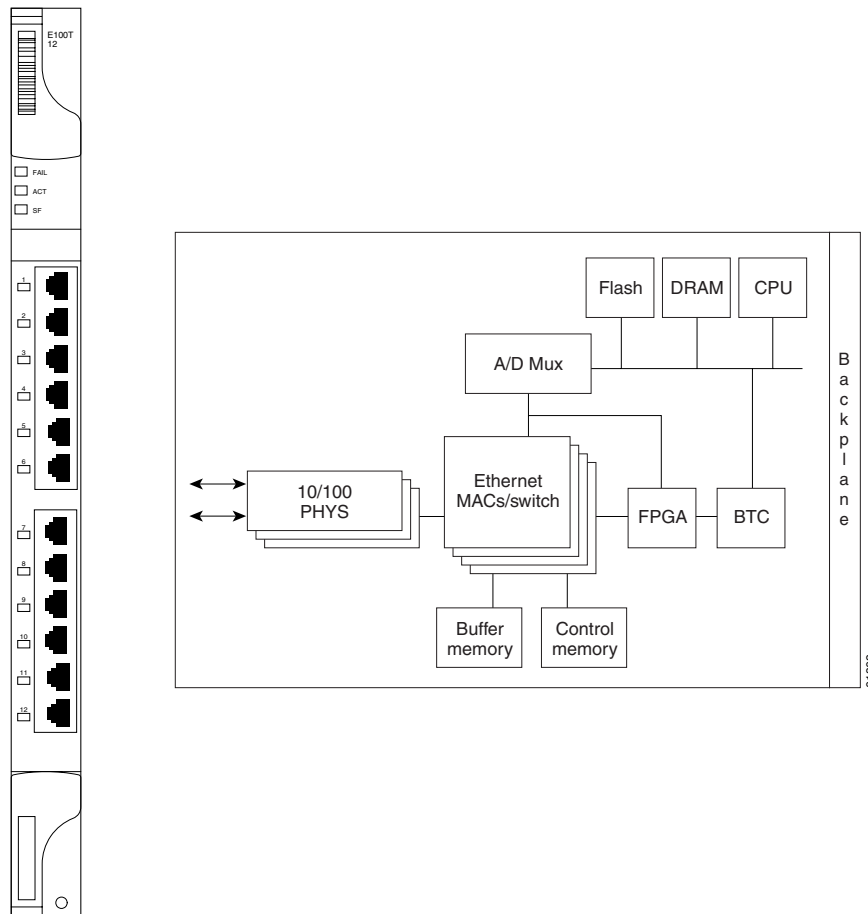
**Figure 4-33 E100T-12 faceplate and block diagram**

device (auto-sense) and automatically connect at the appropriate speed. The ports auto-configure to operate at either half or full duplex and determine whether to enable or disable flow control. You can also configure Ethernet ports manually. Figure 4-33 shows the faceplate and a block diagram of the card.

The E100T-12 Ethernet card provides high-throughput, low-latency packet switching of Ethernet traffic across a SONET network while providing a greater degree of reliability through SONET “self-healing” protection services. This Ethernet capability enables network operators to provide multiple 10/100 Mbps access drops for high-capacity customer LAN interconnects, Internet traffic, and cable modem traffic aggregation. It enables the efficient transport and co-existence of traditional TDM traffic with packet-switched data traffic.

Each E100T-12 card supports standards-based, wire-speed, layer 2 Ethernet switching between its Ethernet interfaces. The 802.1Q tag logically isolates traffic (typically subscribers). 802.1Q also supports multiple classes of service.

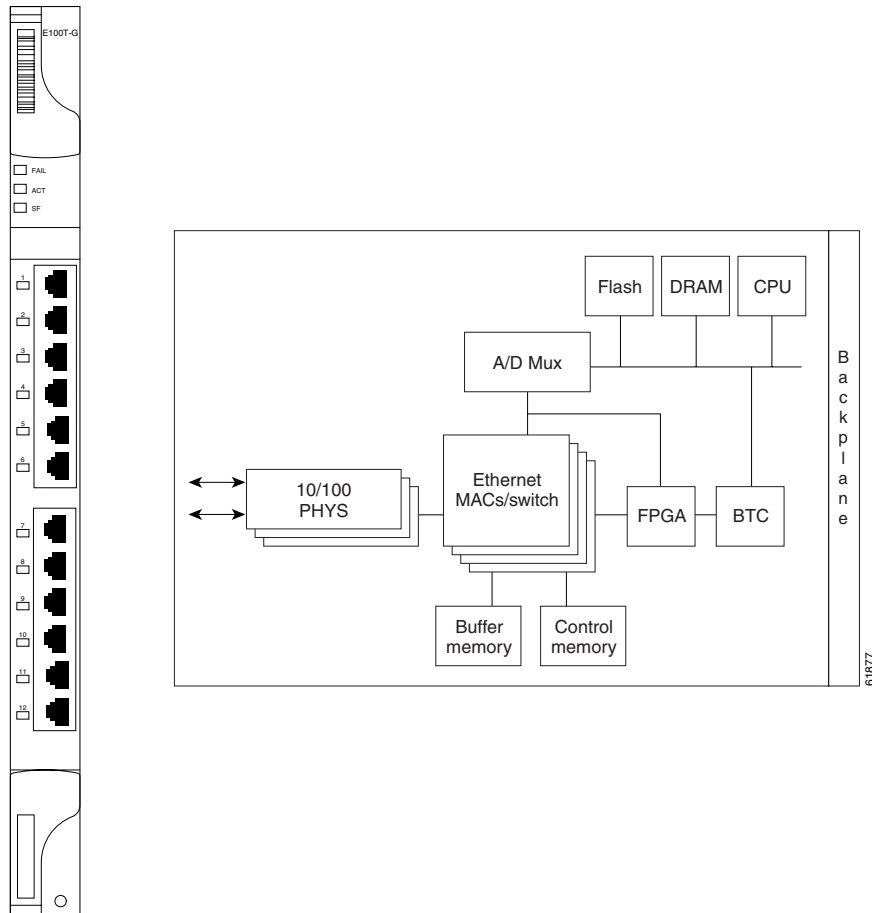
Figure 4-34 E100T-G faceplate and block diagram

Use the E100T-G when the XC10G cross-connect card is in use. The ONS 15454 uses E100T-G cards for Ethernet (10 Mbps) and Fast Ethernet (100 Mbps). Each card provides 12 switched, IEEE 802.3-compliant, 10/100 Base-T Ethernet ports that can independently detect the speed of an attached device (auto-sense) and automatically connect at the appropriate speed. The ports auto-configure to operate at either half or full duplex and determine whether to enable or disable flow control. You can also configure Ethernet ports manually. [Figure 4-34](#) shows the faceplate and a block diagram of the card.

The E100T-G Ethernet card provides high-throughput, low-latency packet switching of Ethernet traffic across a SONET network while providing a greater degree of reliability through SONET “self-healing” protection services. This Ethernet capability enables network operators to provide multiple 10/100 Mbps access drops for high-capacity customer LAN interconnects, Internet traffic, and cable modem traffic aggregation. It enables the efficient transport and co-existence of traditional TDM traffic with packet-switched data traffic.

Each E100T-G card supports standards-based, wire-speed, layer 2 Ethernet switching between its Ethernet interfaces. The 802.1Q tag logically isolates traffic (typically subscribers). 802.1Q also supports multiple classes of service.
