SS7 Subsystem Troubleshooting

This chapter provides procedures that isolate problems that you have already determined to reside in the SS7 Subsystem. The chapter is organized with the following topics:

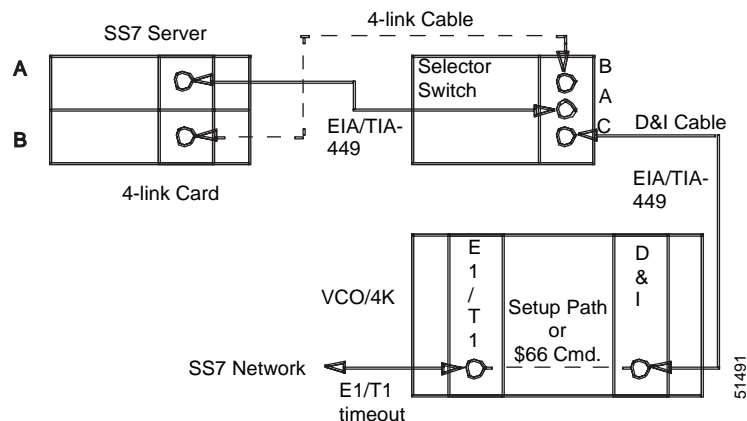
Figure 5-1 SS7 Link Problem Overview

The SS7 link signal starts at the miniature connector of the 4-link card, goes into the Selector (Fallback) Switch (on a redundant system), and then into the back of the Drop & Insert (D&I) card. The signal is EIA/TIA-449 up to this point. The signal is cross-connected to an E1 or T1 using the Set Up Path feature of the VCO system (or a \$66 command from the Host). It is then carried in one particular time slot of this E1 or T1 into the SS7 network. Figure 5-1 shows this overview.
