Release Notes for Cisco IOS Release 12.2(12)DA3 for Cisco DSLAMs with NI-2 Cards

These release notes describe features and caveats in Cisco IOS Release 12.2(12)DA3 for the Cisco 6015, Cisco 6160, and Cisco 6260 digital subscriber line access multiplexers (DSLAMs).

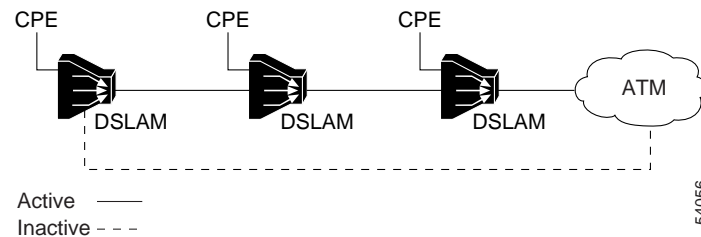
Figure 1 SPVCs Prior to Failure

Ring topology is achieved when a node in the subtend tree is attached to the ATM access to provide a physically redundant loop. Thus, when the primary ATM access or one of the ATM trunks in the subtend tree fails, the soft permanent virtual circuits (SPVCs) can be dynamically rerouted through the use of Private Network-Network Interface (PNNI) (Figure 1).

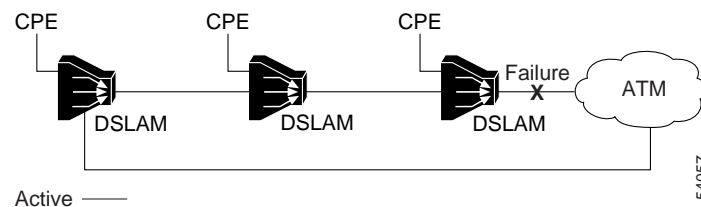
Figure 2 SPVCs Dynamically Rerouted

This redundancy requires the use of SPVCs. If you use permanent virtual circuits (PVCs) or permanent virtual paths (PVPs), redundancy cannot be provided. The use of the SPVCs allows traffic to be rerouted around the failed access point, because SPVCs leverage this feature of PNNI. When the failure occurs, the SPVCs are disconnected and dynamically reconnected across the new path (Figure 2).
