Doc. No. OL-3880-01

Cisco LocalDirector Version 1.6.7 Release Notes

May, 1998

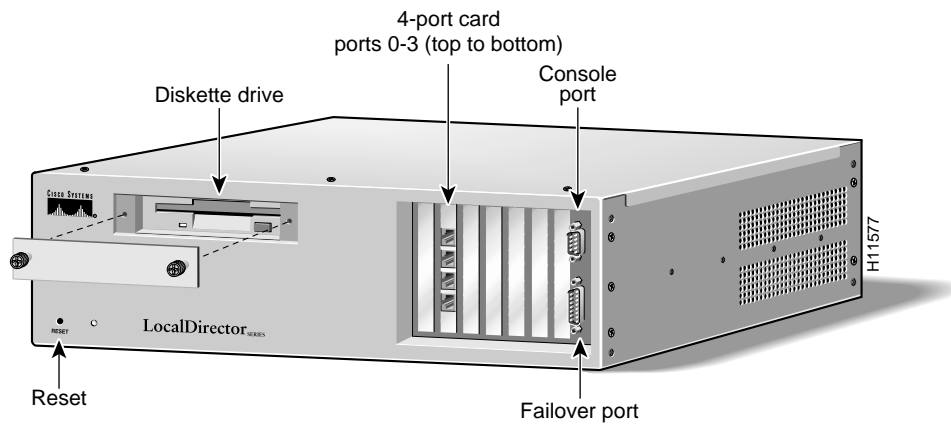
Figure 1 LocalDirector 420 Front Panel

The front panel of the LocalDirector 420 is shown in Figure 1. Note that the diskette drive, interfaces, console port, and failover port are accessed from the front panel.

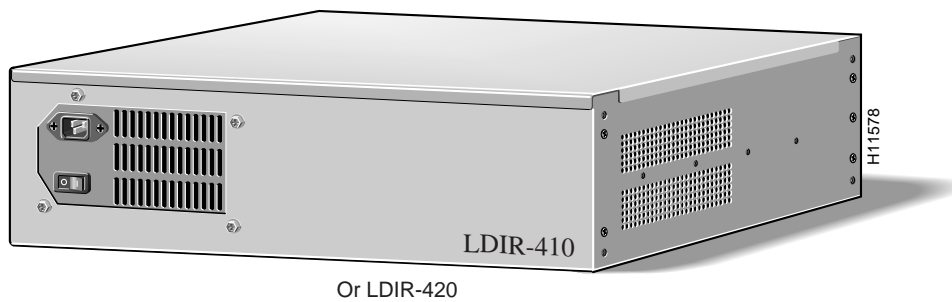
Figure 2 LocalDirector 420 and 410 Back Panel

The back panel of the LocalDirector 420 is shown in Figure 2. The power cord receptacle and power switch are located at the back of the unit.

The LocalDirector 410 back panel is the same as the LocalDirector 420, shown in Figure 2.

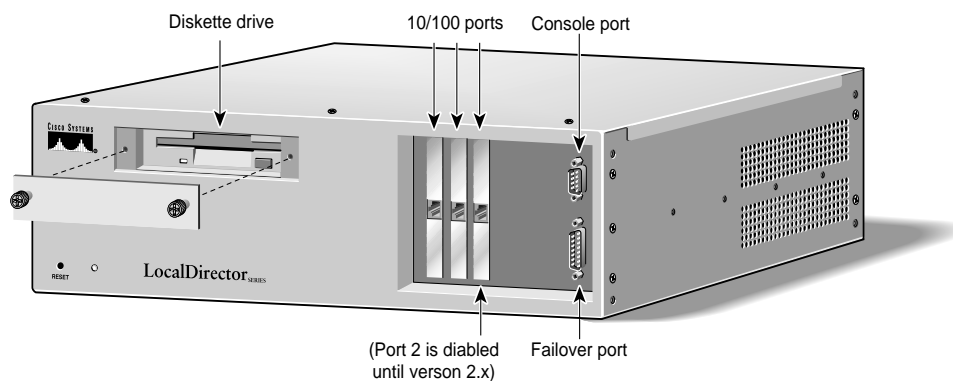
Figure 3 LocalDirector 410 Front Panel

The front panel of the LocalDirector 410 is shown in Figure 3:

LocalDirector version 1.6.5 and later supports two of the 10/100 interfaces on the LocalDirector 410. The ports are numbered 0 to 2 from the left to the right, and port 2 on the third interface is disabled until version 2.x.

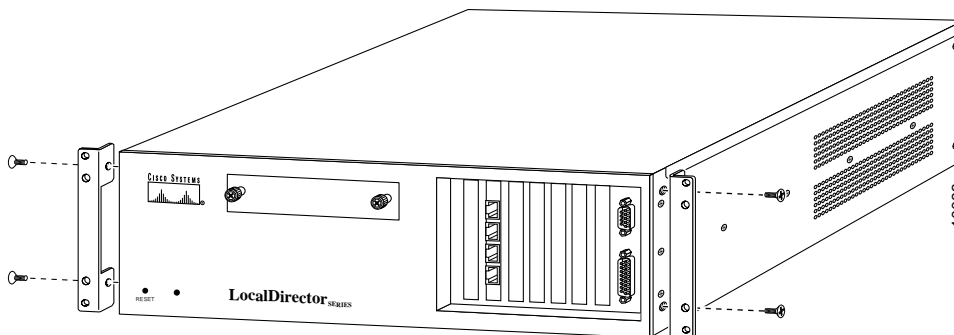
Figure 4 Attaching Rackmount Brackets

Rackmount brackets are optional on the LocalDirector 420 and 410. To attach the rackmount brackets, refer to Figure 4:
