# Troubleshooting 10-Gbps ITU Trunk Card Problems

This chapter describes how to troubleshoot 10-Gbps ITU trunk card problems. This chapter includes the following sections:

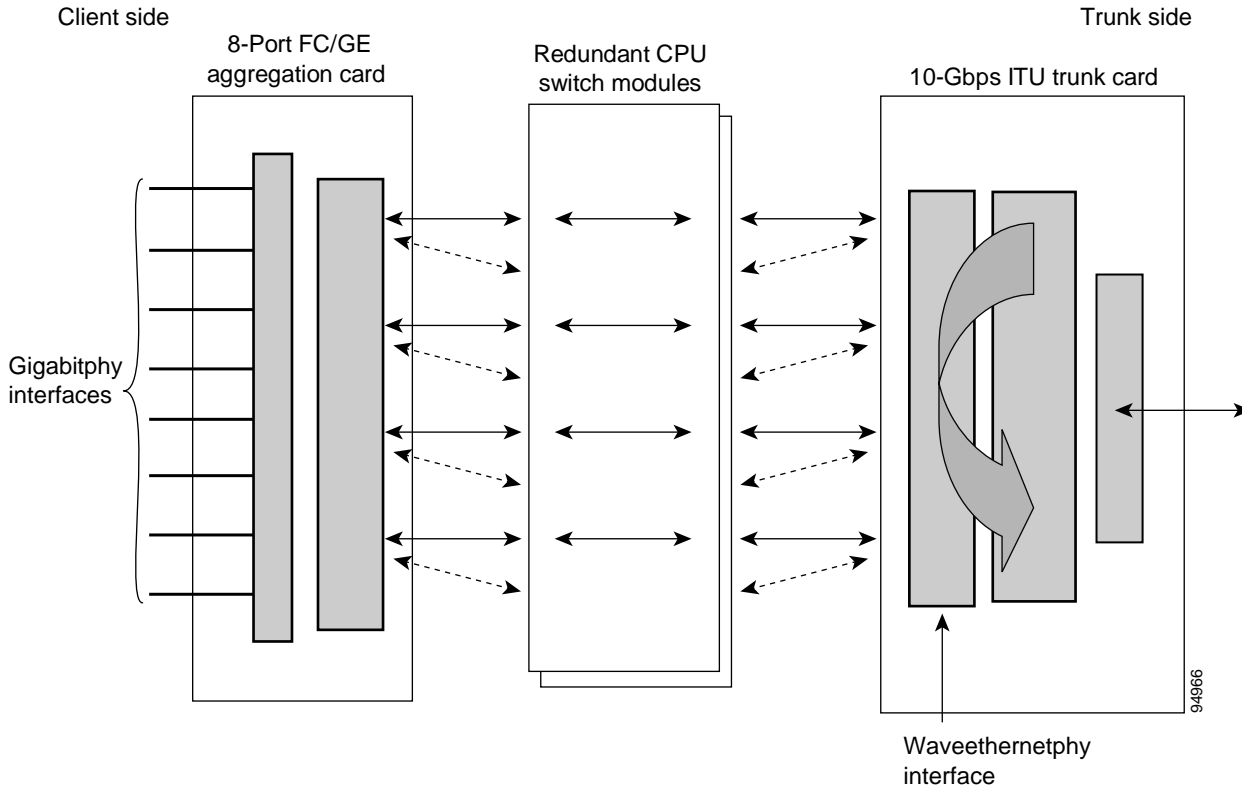
Figure 9-3 Facility Loopback Example on a 10-Gbps ITU Trunk Card

A facility loopback verifies the functioning of the 10-Gbps ITU trunk card from the trunk side (see [Figure 9-3](#)).

To create a facility loopback

- 
- Step 1** Issue a **loopback facility** command on the waveethernetphy interface.
  - Step 2** Check that the signal reaches the system at the far end.
  - Step 3** If the signal does not reach the far end, check the trunk fiber and the interfaces along the signal path. If the fiber is intact, replace the card.
-

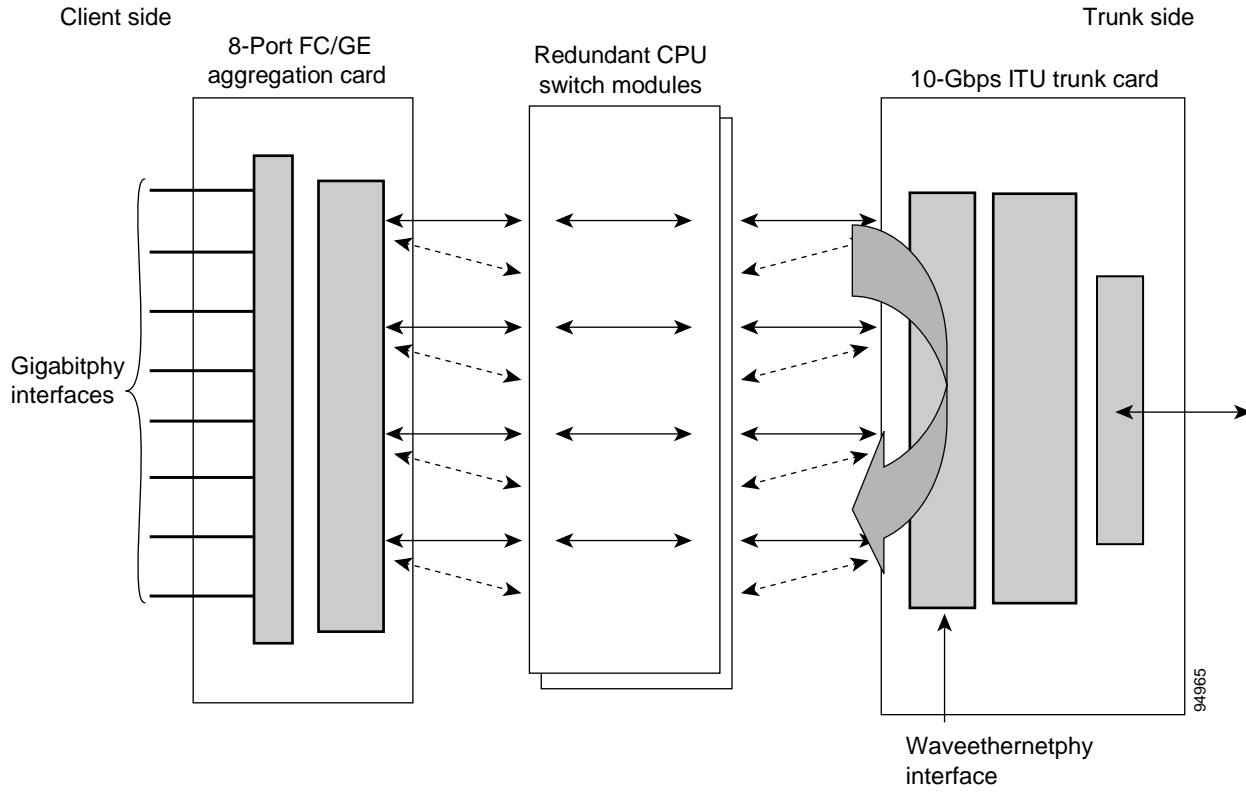
Figure 9-4 Terminal Loopback Example on a 10-Gbps ITU Trunk Card

A terminal loopback verifies the functioning of the 10-Gbps ITU trunk card from the switch fabric side (see [Figure 9-4](#)).

To create a terminal loopback:

- 
- Step 1** Issue a **loopback terminal** command on the waveethernetphy interface.
  - Step 2** Check that the traffic is reaching the client equipment.
  - Step 3** If the signal does not reach the client equipment, replace the card.
-
