Troubleshooting 10-Gbps Uplink Card Problems

This chapter describes how to troubleshoot 10-Gbps uplink card problems. This chapter includes the following sections:

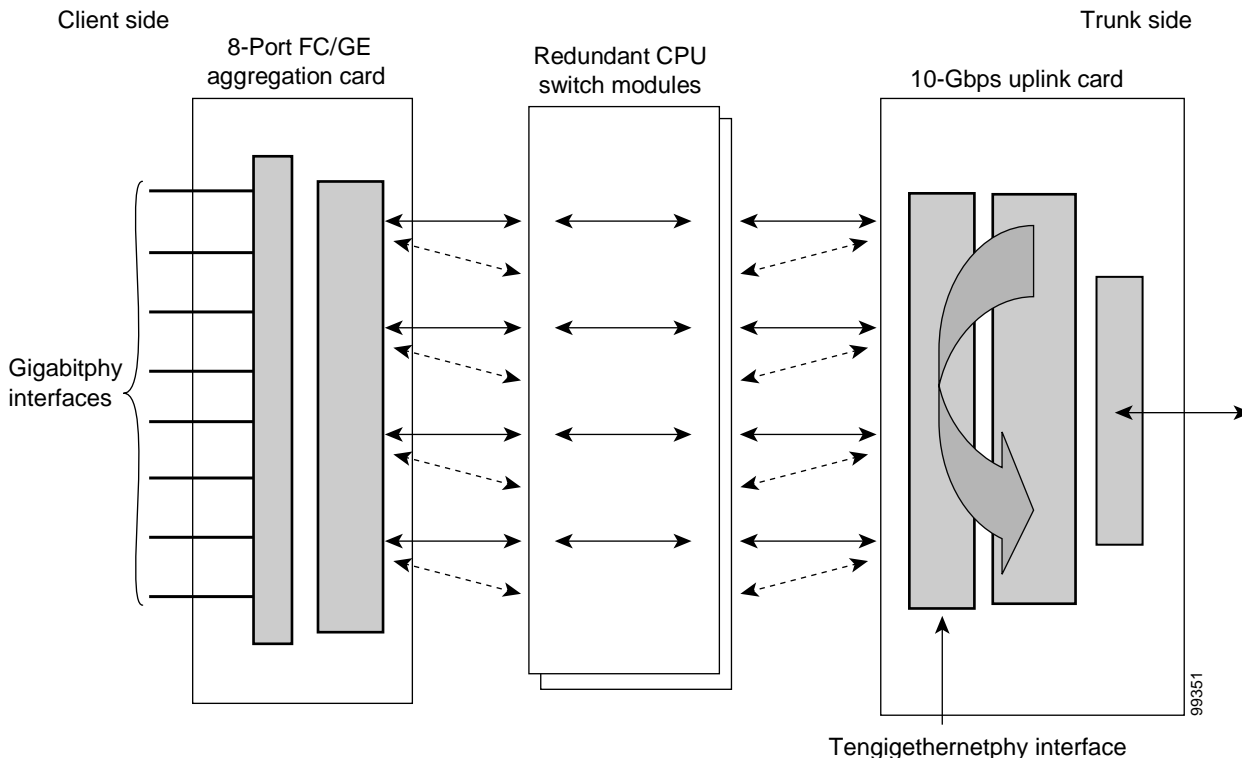
Figure 11-2 Facility Loopback Example on a 10-Gbps Uplink Card

A facility loopback verifies the functioning of the 10-Gbps uplink card from the trunk side (see [Figure 11-2](#)).

-
- Step 1** Issue a **loopback facility** command on the tengigethernephy interface.
 - Step 2** Check that the signal reaches the system at the far end.
 - Step 3** If the signal does not reach the far end, check the trunk fiber and the interfaces along the signal path. If the fiber is intact, replace the card.
-
