Troubleshooting 4-Port 1-Gbps/2-Gbps FC Aggregation Card Problems

This chapter describes how to troubleshoot 4-port 1-Gbps/2-Gbps FC (Fibre Channel) aggregation card interface problems. This chapter includes the following sections:

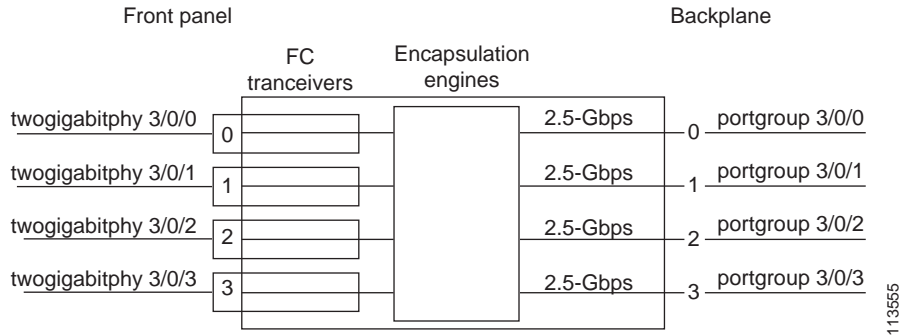
Figure 5-1 Interfaces for a 4-port 1-Gbps/2-Gbps FC Aggregation Card

[Figure 5-1](#) shows an example path of a client signal through the Cisco ONS 15530 and the associated interfaces.

The 4-port 1-Gbps/2-Gbps FC aggregation card uses up to four SFP (small form-factor pluggable) optical transceivers to support client traffic. Each client interface can be configured using the CLI (command-line interface) for FC, FICON (fiber connection), or ISC (InterSystem Channel) traffic at a 1-Gbps or 2-Gbps rate.

The 4-port 1-Gbps/2-Gbps FC aggregation card connects four 2.5-Gbps electric signals, or portgroup interfaces, to the switch fabric. The client port data streams must be mapped to one of these portgroup interfaces, using the CLI. Only two 1-Gbps client interfaces or one 2-Gbps client interface can be mapped into a single portgroup interface.

The signal on the portgroup interfaces connects through the backplane and the switch fabric on the active CPU switch module to a 2.5-Gbps ITU trunk card, a 10-Gbps ITU trunk card, 10-Gbps ITU tunable trunk card, or a 10-Gbps uplink card, where the signal is converted to, and from, an ITU channel. The cross connections between the two cards through the backplane and switch fabrics are configured using the CLI.

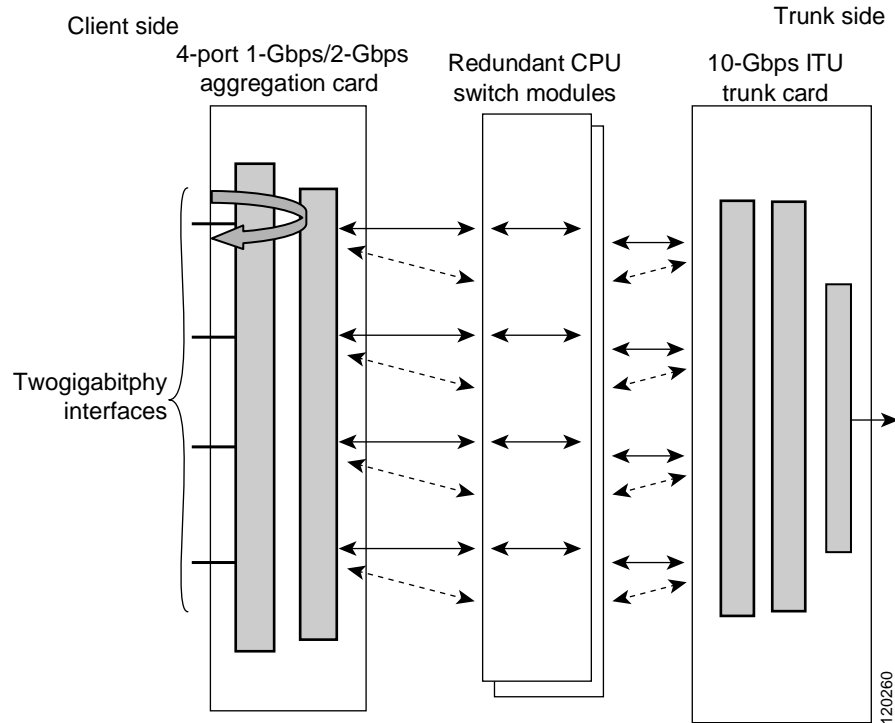
Figure 5-2 Facility Loopback Example

Facility loopbacks on 4-port 1-Gbps/2-Gbps FC aggregation cards verify the functioning of the SFP optics from the client side (see [Figure 5-2](#)).

-
- Step 1 Issue a **loopback facility** command on the twogigabitphy interface.
 - Step 2 Check that the traffic is reaching the client equipment.
 - Step 3 If the signal does not reach the client equipment, replace the SFP optics.
-

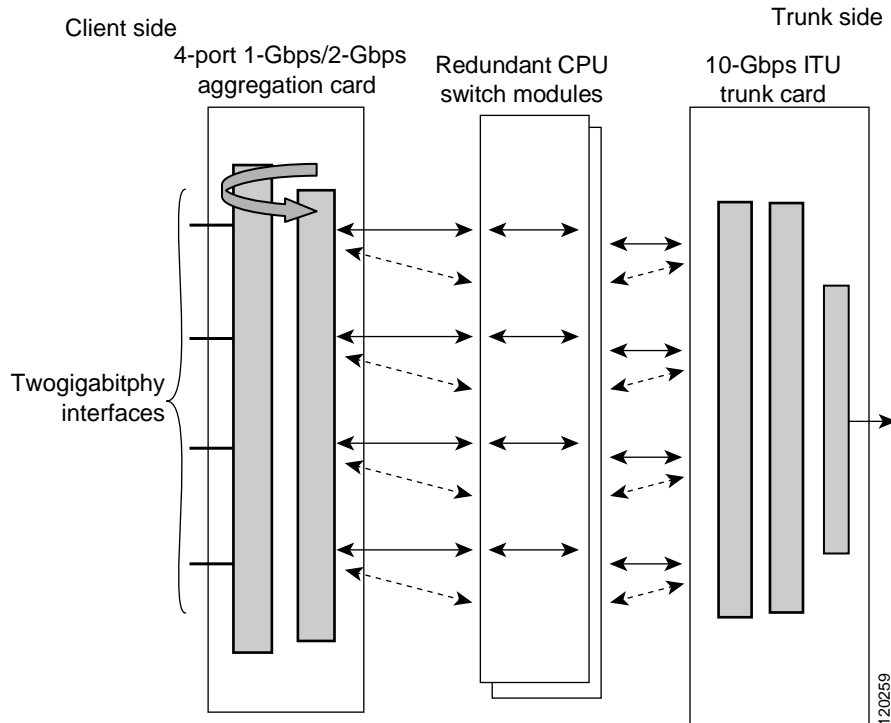
Figure 5-3 Terminal Loopback Example

Terminal loopbacks verify the functioning of the 4-port 1-Gbps/2-Gbps FC aggregation cards from the trunk side (see [Figure 5-3](#)).

-
- Step 1 Issue a **loopback terminal** command on the twogigabitphy interface.
 - Step 2 Check that the traffic is reaching the client equipment.
 - Step 3 If the signal does not reach the far end, check the trunk fiber and the interfaces along the signal path. If the fiber is intact, replace the card.
-
