# Troubleshooting 2.5-Gbps ITU Trunk Card Problems

This chapter describes how to troubleshoot 2.5-Gbps ITU trunk card problems. This chapter includes the following sections:

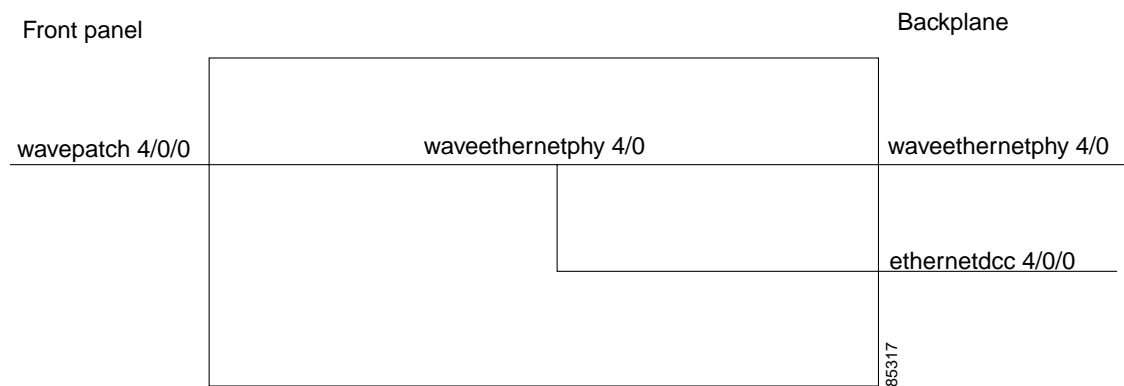
**Figure 8-2** *Nonsplitter 2.5-Gbps ITU Trunk Card Interfaces*

The 2.5-Gbps ITU trunk card converts an aggregated 2.5-Gbps signal to an ITU-compliant wavelength, or channel. The Cisco ONS 15530 supports two types of 2.5-Gbps ITU trunk cards:

- Splitter—Sends the channels to two OADM modules.
- Nonsplitter—Sends the channel to only one OADM module.

[Figure 8-1](#) and [Figure 8-2](#) show the interface models for the two versions of the 2.5-Gbps ITU trunk card, splitter and nonsplitter.

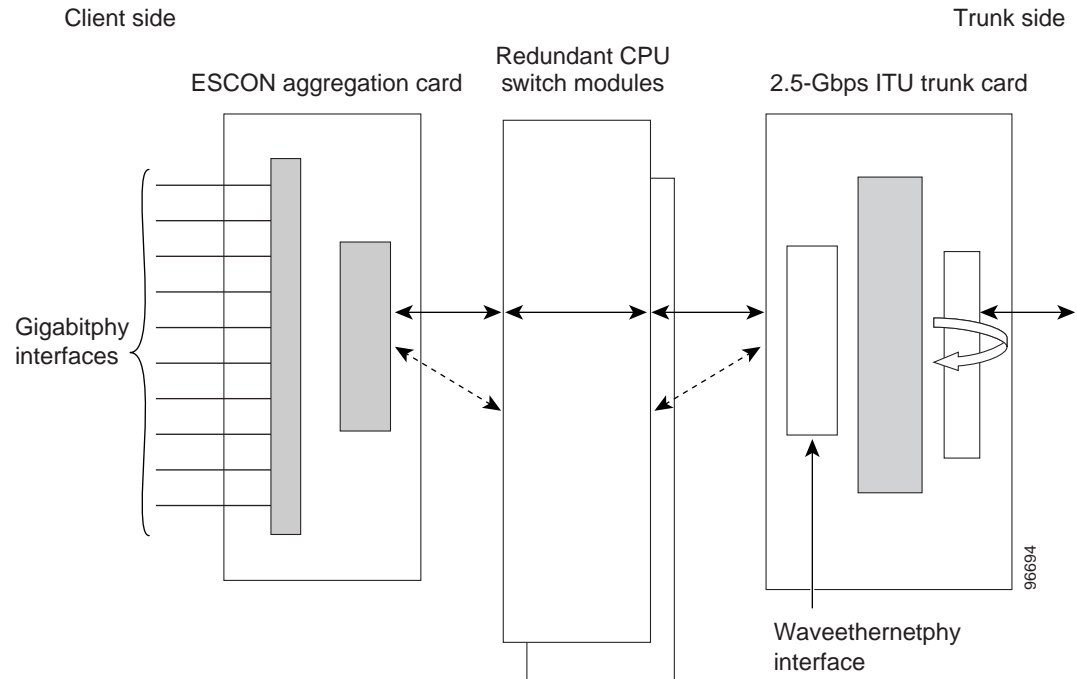
A terminal loopback verifies the functioning of the 2.5-Gbps ITU trunk card from the switch fabric side (see [Figure 8-4](#)).

**Figure 8-4** *Terminal Loopback Example on a 2.5-Gbps ITU Trunk Card*

- 
- Step 1** Issue a **loopback terminal** command on the waveethernetphy interface.
  - Step 2** Check that the traffic is reaching the client equipment.
  - Step 3** If the signal does not reach the client equipment, replace the card.
-
