Troubleshooting 10-Gbps ITU Tunable Trunk Card Problems

This chapter describes how to troubleshoot 10-Gbps ITU tunable trunk card problems. This chapter includes the following sections:

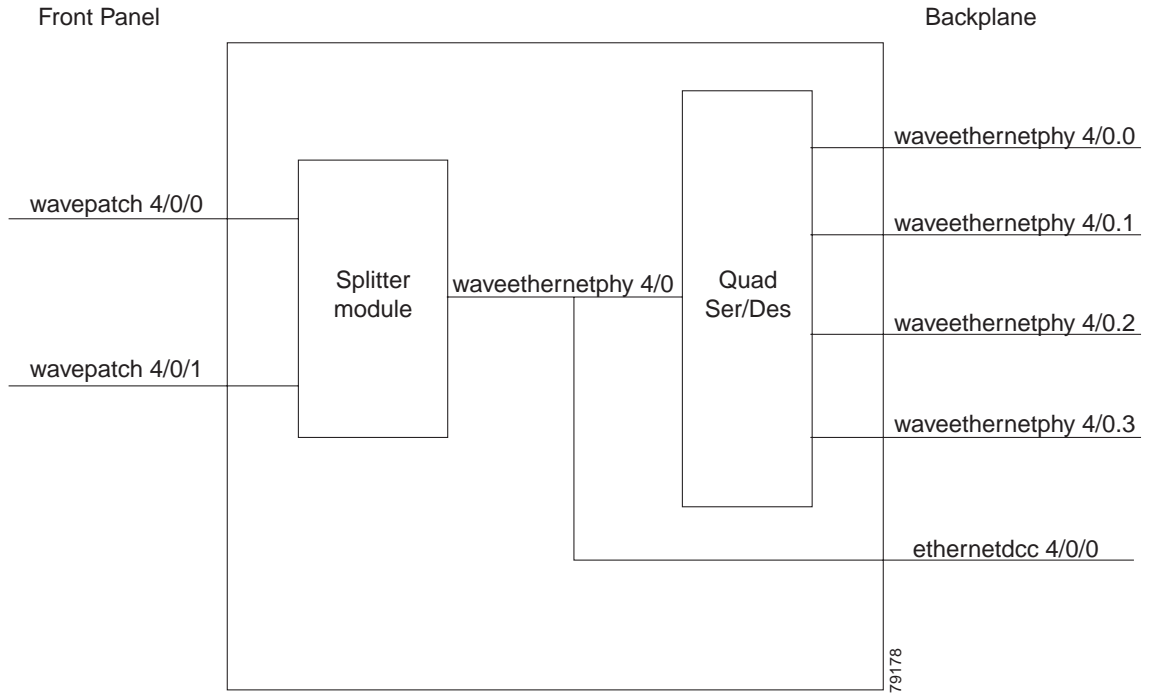
Figure 10-1 *Splitter 10-Gbps ITU Tunable Trunk Card Interfaces*

The 10-Gbps ITU tunable trunk card converts up to four aggregated signals to an ITU-compliant wavelength, or channel.

[Figure 10-1](#) shows the interfaces for the splitter 10-Gbps ITU tunable trunk card. [Figure 10-2](#) shows the interfaces for the nonsplitter 10-Gbps ITU tunable trunk card.

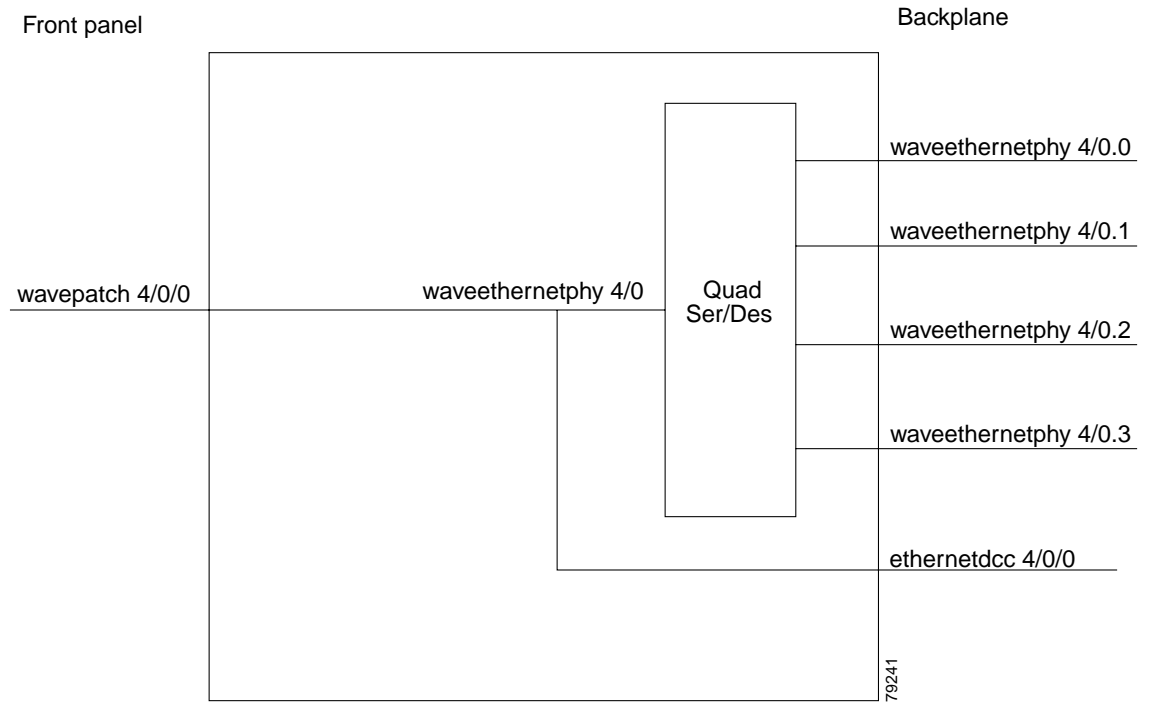
Figure 10-2 *Nonsplitter 10-Gbps ITU Tunable Trunk Card Interfaces*

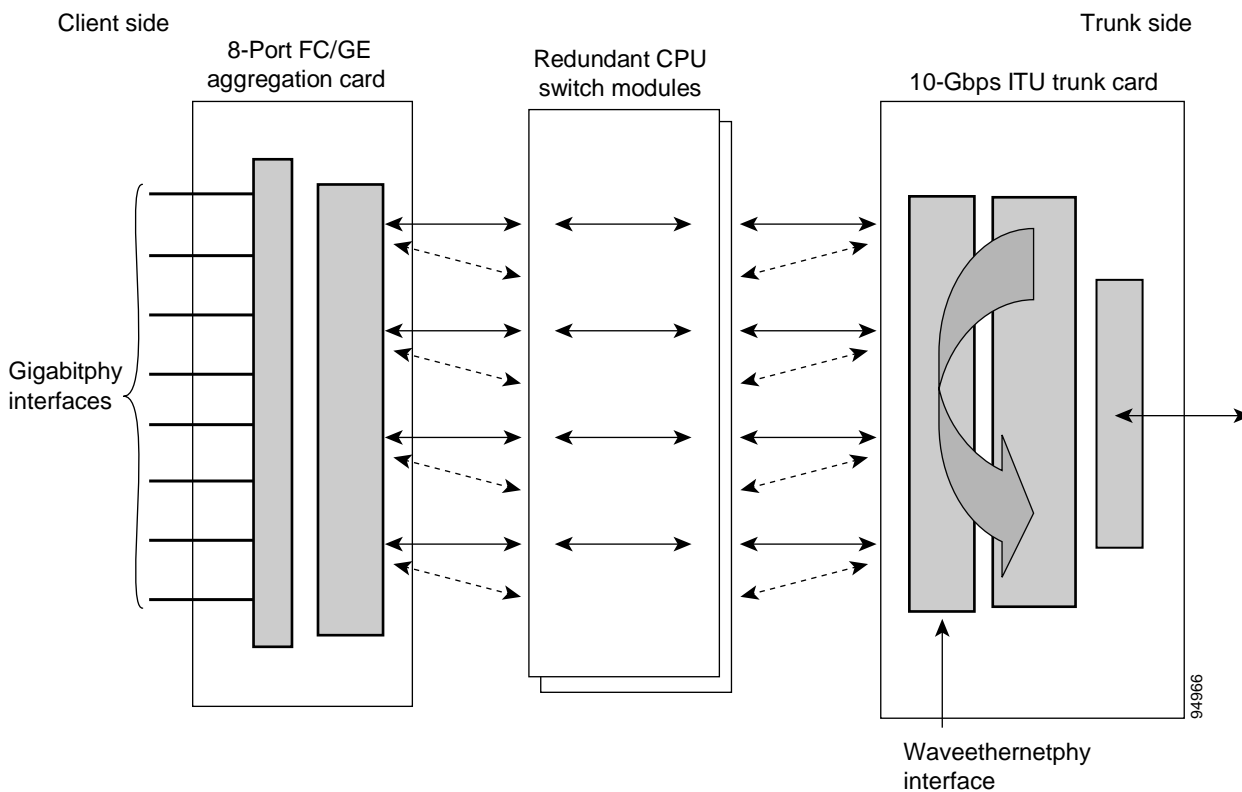
A facility loopback verifies the functioning of the 10-Gbps ITU tunable trunk card from the trunk side (see Figure 10-3).

Figure 10-3 Facility Loopback Example on a 10-Gbps ITU Tunable Trunk Card

-
- Step 1 Issue a **loopback facility** command on the waveethernetphy interface.
 - Step 2 Check that the signal reaches the system at the far end.

- Step 3** If the signal does not reach the far end, check the trunk fiber and the interfaces along the signal path. If the fiber is intact, replace the card.

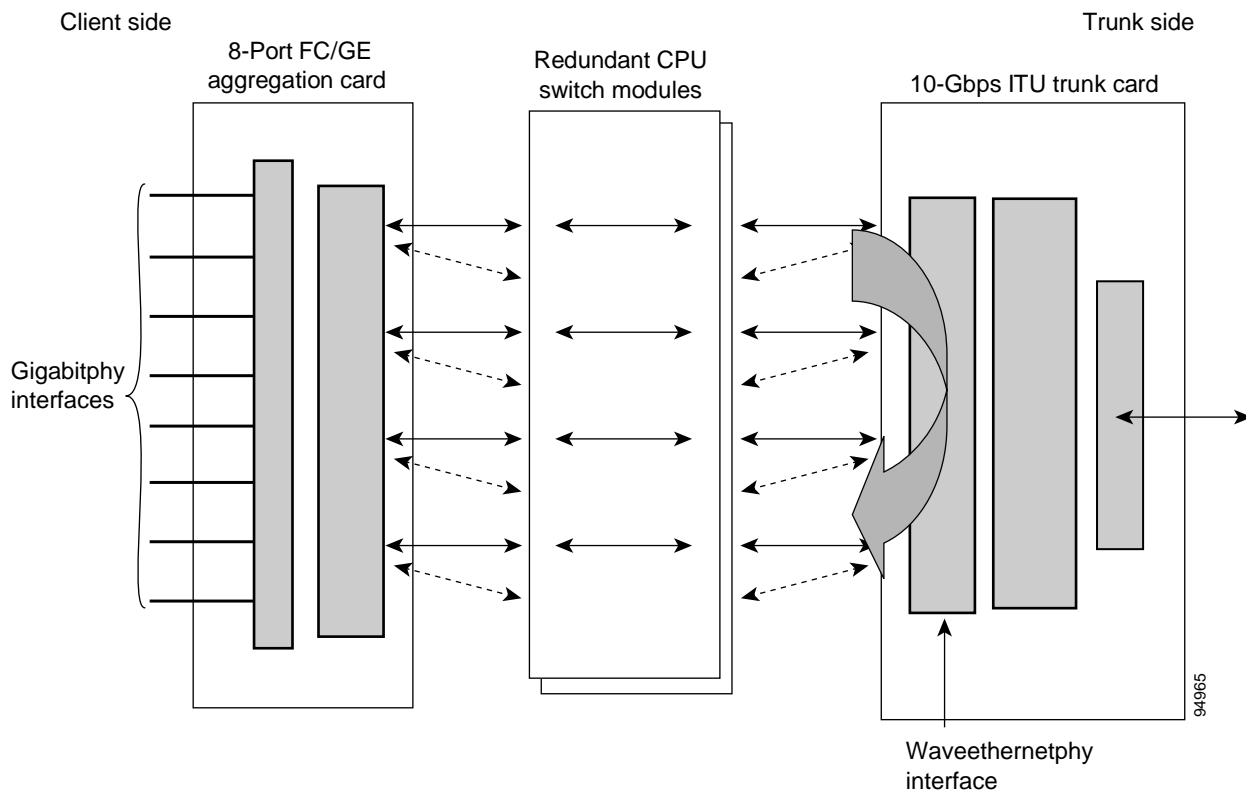
A terminal loopback verifies the functioning of the 10-Gbps ITU tunable trunk card from the switch fabric side (see [Figure 10-4](#)).

Figure 10-4 Terminal Loopback Example on a 10-Gbps ITU Tunable Trunk Card

- Step 1** Issue a **loopback terminal** command on the waveethernetphy interface.
- Step 2** Check that the traffic is reaching the client equipment.
- Step 3** If the signal does not reach the client equipment, replace the card.
