Troubleshooting ESCON Aggregation Card Problems

This chapter describes how to troubleshoot ESCON aggregation card problems. This chapter includes the following sections:

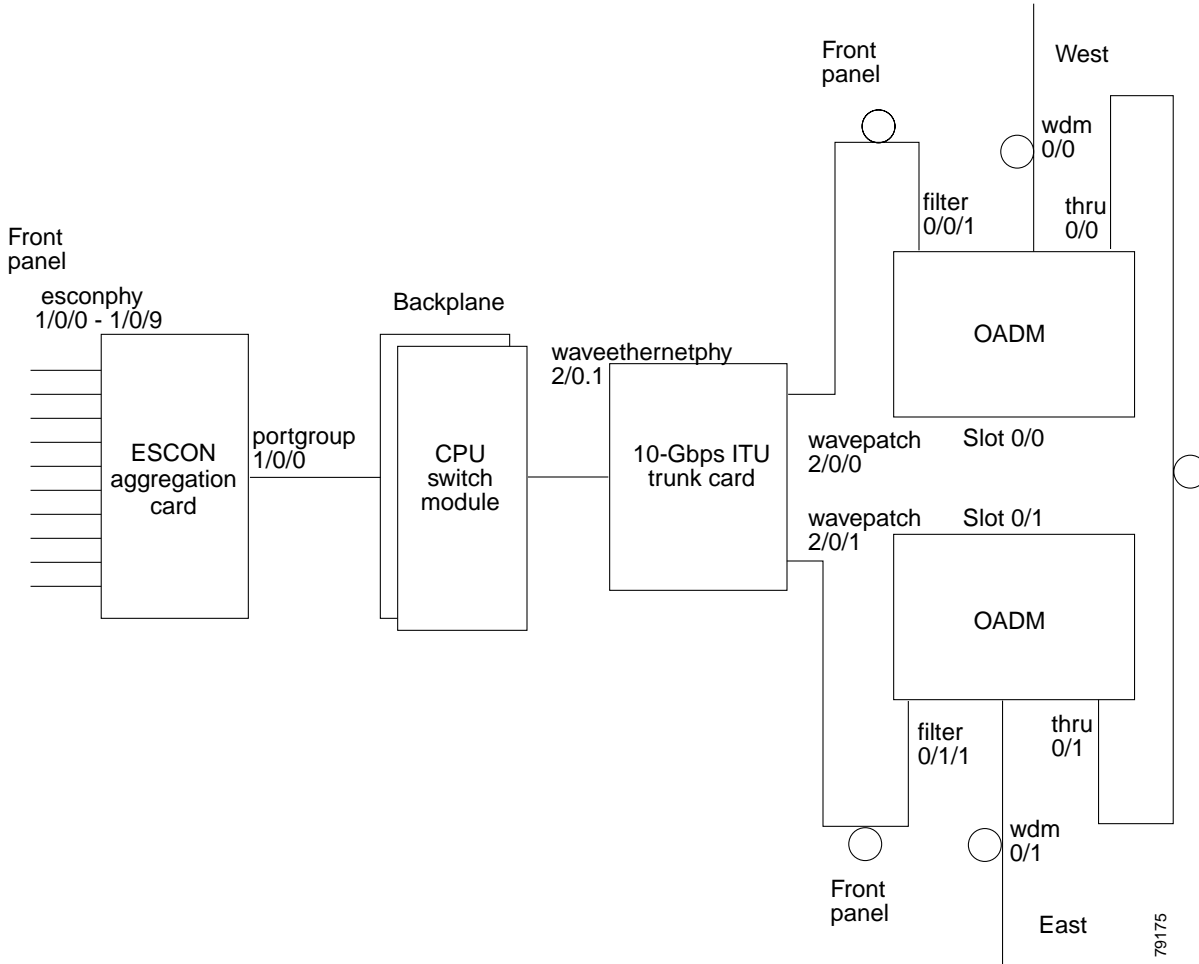
Figure 4-1 Interface Model for ESCON Aggregation

[Figure 4-1](#) shows an example path of an ESCON signal through the Cisco ONS 15530 and the associated interfaces.

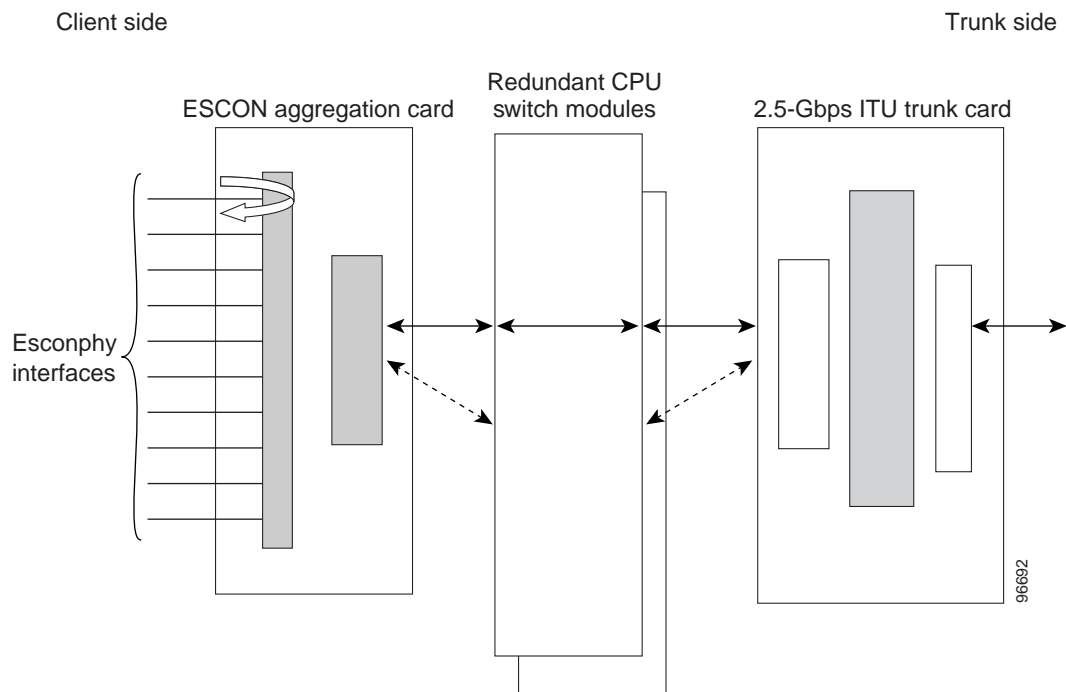
Figure 4-2 Client Signal Loopback Example

Client signal loopbacks on ESCON aggregation cards verify the functioning of the SFP optics (see [Figure 4-2](#)).

Procedure: Create a Client Signal Loopback

-
- Step 1 Issue a **loopback** command on the esconphy interface.
 - Step 2 Check that the traffic is reaching the client equipment.

Step 3 If the signal does not reach the client equipment, check the optical cables for breaks. If there are no breaks, replace the SFP optics.
