Troubleshooting 8-Port FC/GE Aggregation Card Problems

This chapter describes how to troubleshoot 8-port FC/GE aggregation card interface problems. This chapter includes the following sections:

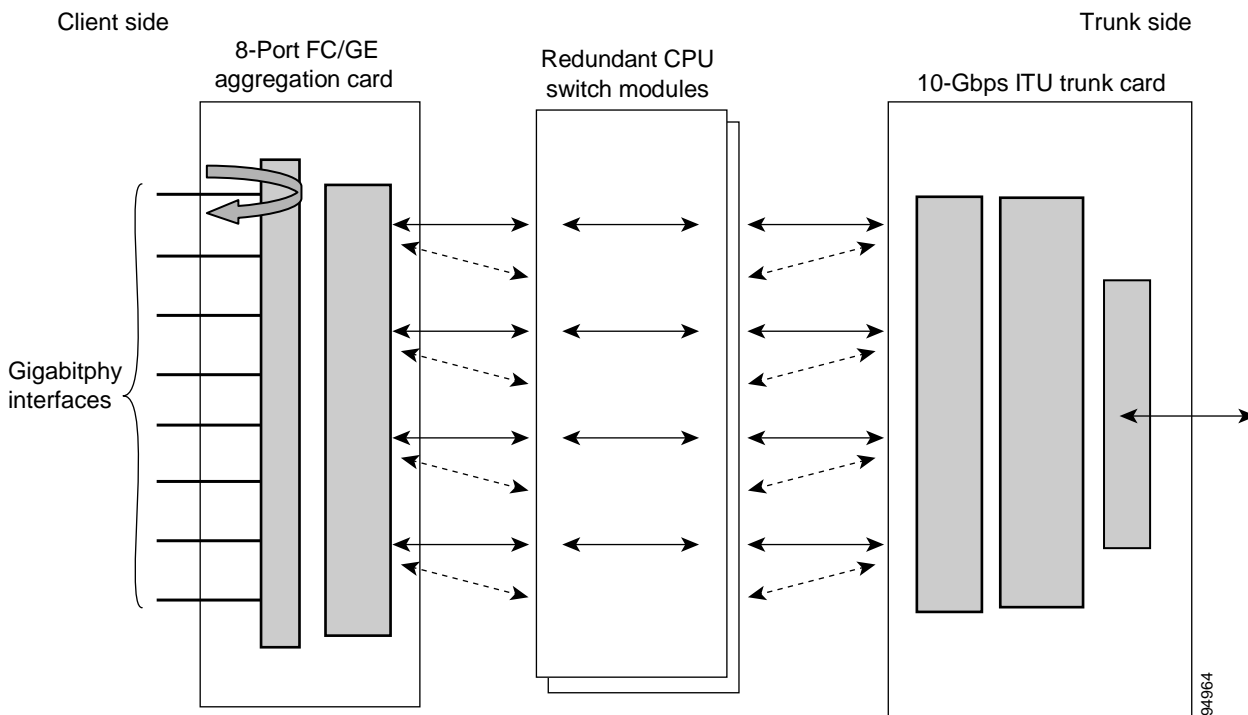
Figure 6-2 Facility Loopback Example

Facility loopbacks on 8-port FC/GE aggregation cards verify the functioning of the SFP optics from the client side (see [Figure 6-2](#)).

To create a facility loopback:

- Step 1** Issue a **loopback facility** command on the gigabitphy interface.
- Step 2** Check that the traffic is reaching the client equipment.

Step 3 If the signal does not reach the client equipment, replace the SFP optics.

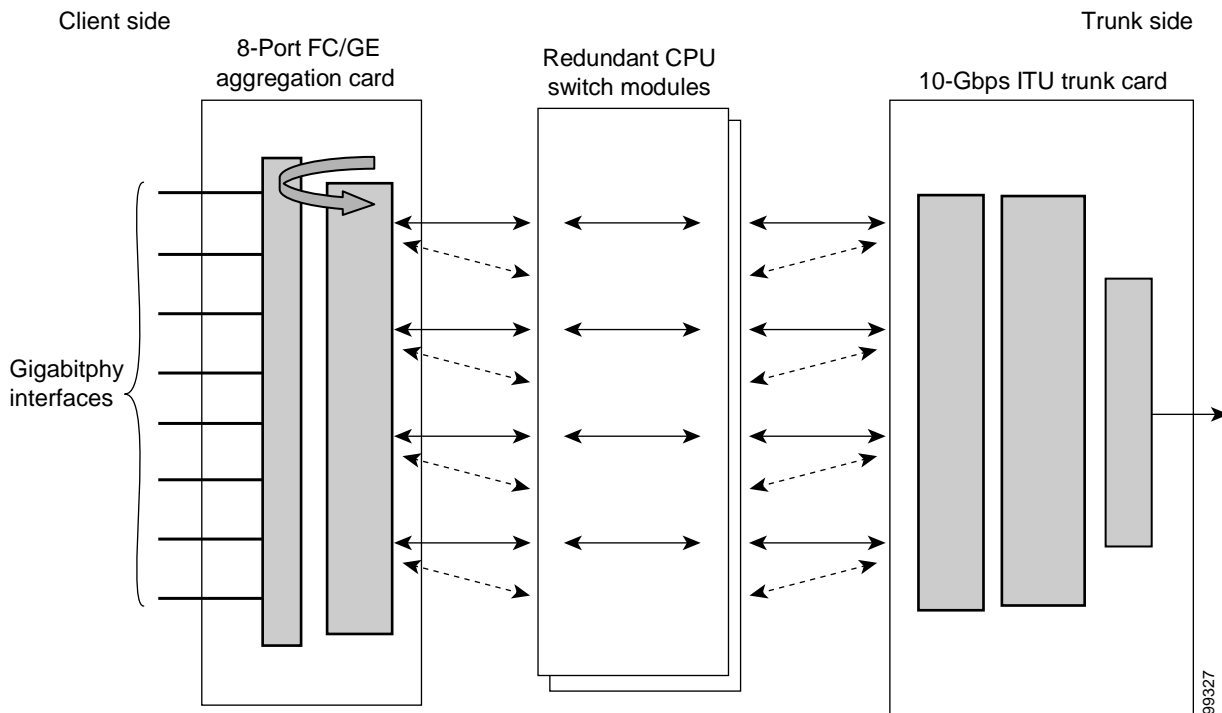
Figure 6-3 Terminal Loopback Example

Terminal loopbacks verify the functioning of the 8-port FC/GE aggregation cards from the trunk side (see [Figure 6-3](#)).

To create a terminal loopback:

- Step 1** Issue a **loopback terminal** command on the gigabitphy interface.
- Step 2** Check that the traffic is reaching the client equipment.
- Step 3** If the signal does not reach the far end, check the trunk fiber and the interfaces along the signal path. If the fiber is intact, replace the card.
