Troubleshooting 8-Port Multi-Service Muxponder Problems

This chapter describes how to troubleshoot 8-port multi-service muxponder problems. This chapter includes the following sections:

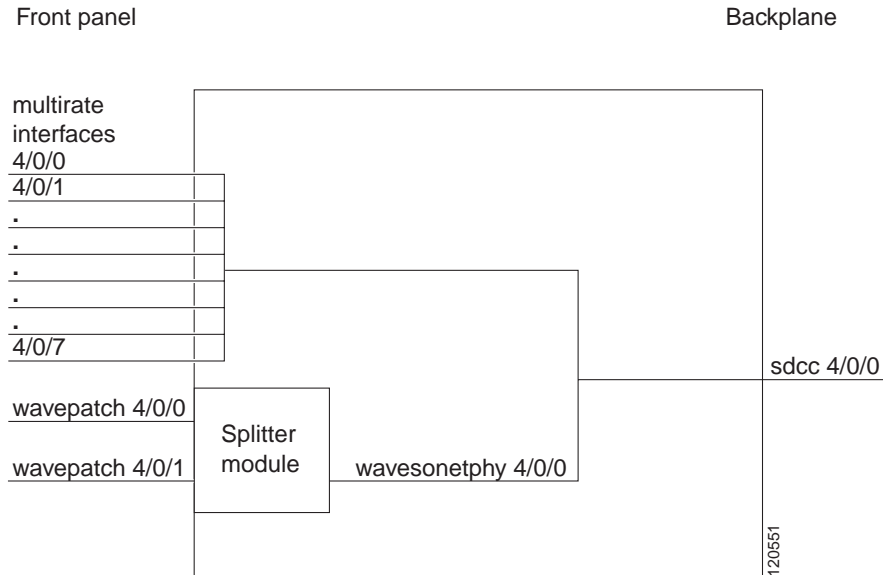
[Figure 7-1](#) shows the interfaces of the 8-port multi-service muxponder.

Figure 7-1 8-Port Multi-Service Muxponder Interfaces (Splitter Shown)

The 8-port multi-service muxponder aggregates up to eight ports of client traffic into a 2.5-Gbps DWDM trunk circuit. The muxponder transports a mix of different protocols among sites in a metropolitan DWDM network. The protocols that can be aggregated and transported range from high-speed services such as Fibre Channel and Gigabit Ethernet to low-speed services such as OC-3, Fast Ethernet, or even T1 or E1.

The 8-port multi-service muxponder uses SFPs for the client signals. There are no restrictions on populating the line card with SFPs. For example, you can mix a single-mode SFP with a multimode SFP on the same muxponder.

Although the 8-port multi-service muxponder uses a SONET-like framing structure to aggregate multiple client data streams, it is not SONET compliant on the optical trunk output. The muxponder ITU compliant optical trunk output must be used in an end-to-end configuration and cannot be connected to a SONET/SDH OADM.

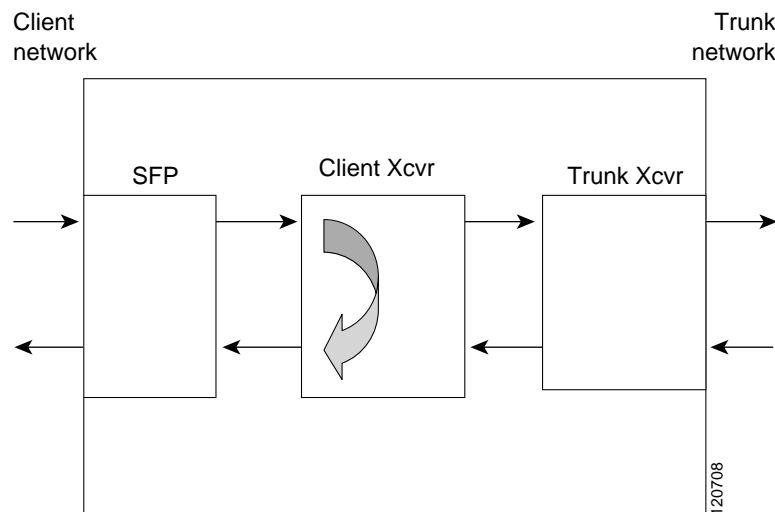
Client-side facility loopbacks on 8-port multi-service muxponders verify the functioning of the SFP optics from the client side (see [Figure 7-2](#)).

Figure 7-2 Client-Side Facility Loopback Example

Note For T1 and E1 encapsulations the loopback is performed on the SFP, not the client Xcvr.

- Step 1** Issue a **loopback facility** command on the multirate interface.
- Step 2** Check that the traffic is reaching the client equipment.
- Step 3** If the signal does not reach the client equipment, replace the SFP optics.

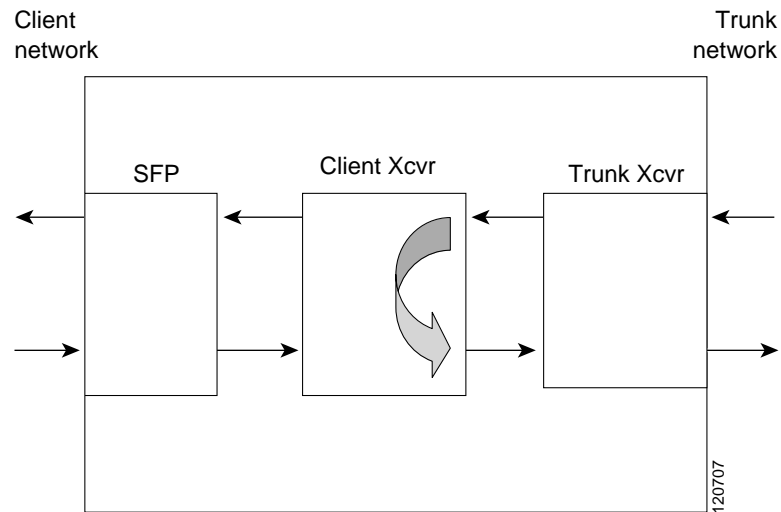
Client-side terminal loopbacks verify the functioning of the 8-port multi-service muxponders from the trunk side (see [Figure 7-3](#)).

Figure 7-3 Client-Side Terminal Loopback Example

Note For T1 and E1 encapsulations the loopback is performed on the SFP, not the client Xcvr.

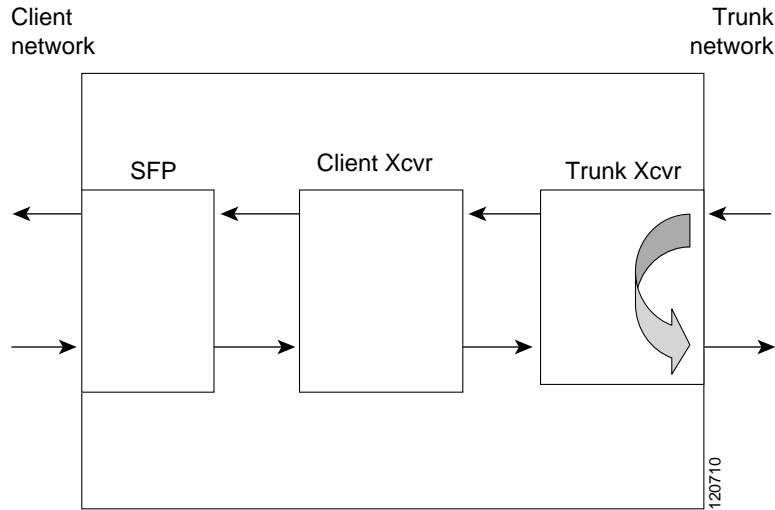
Trunk-side facility loopbacks on the wavesonetphy interface of the 8-port multi-service muxponders verify the functioning of the trunk optics from the trunk side (see [Figure 7-4](#)).

Figure 7-4 Trunk-Side Facility Loopback Example

-
- Step 1** Issue a **loopback facility** command on the wavesonetphy interface.
 - Step 2** Check that the traffic is reaching the remote client equipment.
 - Step 3** If the signal does not reach the far end, check the trunk fiber and the interfaces along the signal path. If the fiber is intact, replace the 8-port multi-service muxponder.
-

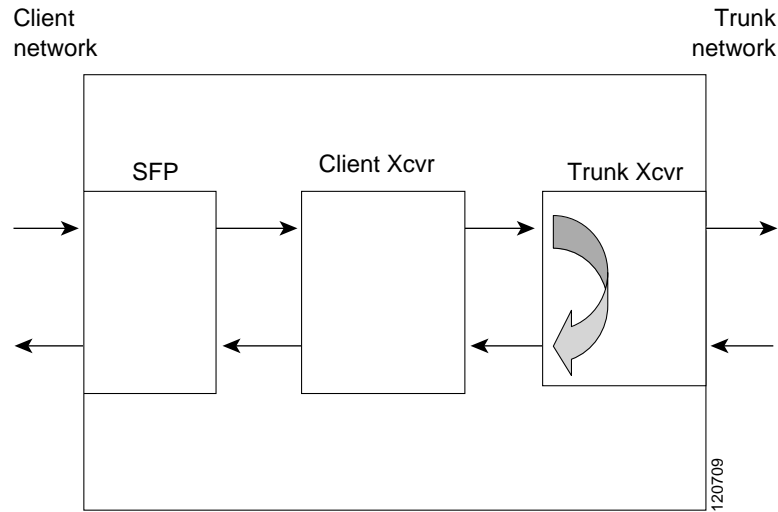
Trunk-side terminal loopbacks verify the functioning of the 8-port multi-service muxponders from the client side, up to the trunk side (see [Figure 7-5](#)).

Note Trunk side optics are not tested.

Figure 7-5 Trunk-Side Terminal Loopback Example

-
- Step 1** Issue a **loopback terminal** command on the wavesonetphy interface.
 - Step 2** Check that the traffic is reaching the client equipment.
 - Step 3** If the signal does not reach the client equipment check the cables for bends and breaks, and if necessary, replace the SFP optics.
-

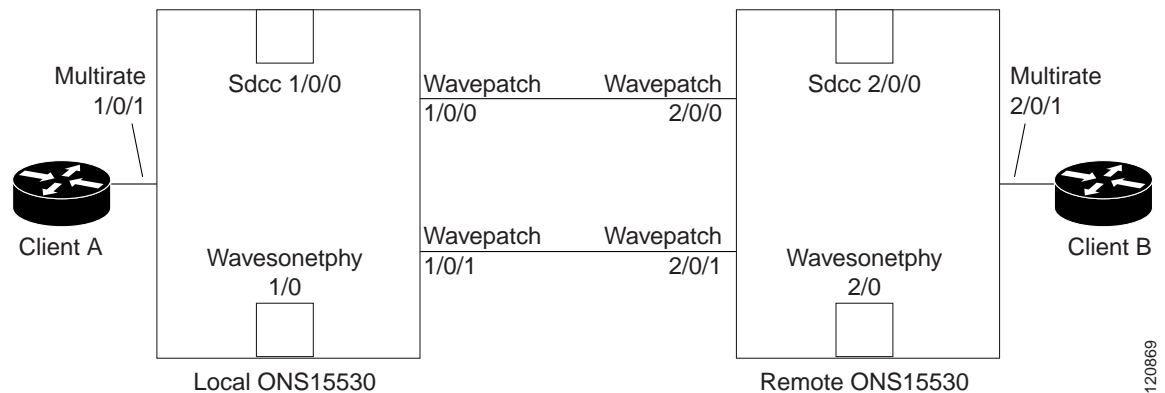
Figure 7-6 shows an example of 8-port multi-serve muxponders connected end-to-end. The following procedure describes the process of troubleshooting protocol level errors (for example, CRC errors on a Fastethernet interface) using loopbacks. Assume that the trunk connection between wavepatch 1/0/0 and wavepatch 2/0/0 is active.

Figure 7-6 8-Port Multi-Service Muxponders in an End-to-End Configuration

Step 1 Issue a **loopback facility** command on multirate interface 1/0/1 of client A. Verify that traffic comes back to client A without errors. If errors are seen, one of the following may be the cause:

- Client A itself is sending traffic with errors.
- The optical connectors between client A and the local Cisco ONS 15530 are dirty or need to be replaced.
- The SFP on the multirate interface is faulty.

Step 3 Issue a **no loopback terminal** command on wavesonetphy 1/0 of the local Cisco ONS 15530 and issue a **loopback facility** command on wavesonetphy 2/0 of the remote Cisco ONS 15530. If errors are seen on client A, one of the following may be the cause:
