Troubleshooting 10-GE Transponder Module Problems

This chapter describes how to troubleshoot 10-GE transponder module problems. This document contains the following sections:

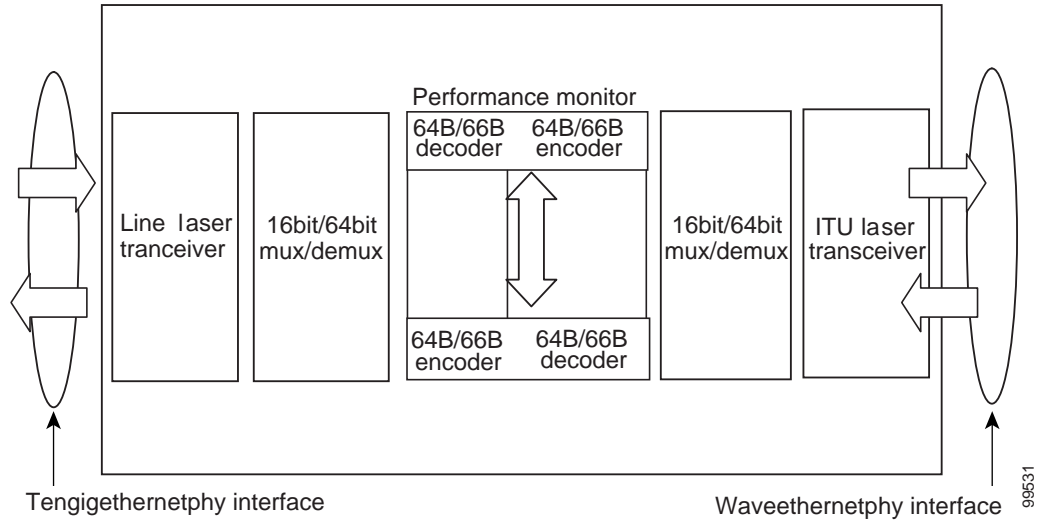
Figure 6-1 10-GE Transponder Module Architecture

[Figure 6-1](#) shows the architecture of the 10-GE transponder module.

The 10-GE transponder module on the Cisco ONS 15540 ESPx implements the 10GBASE-LR IEEE 802.3ae standard. It supports connections to a Cisco ONS 15530 1310-nm 10-Gbps uplink card acting as a downlink and connections to a native 10GBASE-LR or a 10GBASE-ER IEEE 802.3ae MAC implementation. The 10-GE transponder module has one short reach 1310-nm laser on the client side and an ITU DWDM 1550-nm laser at the trunk side.

The 10-Gbps line card motherboard has two half-sized subslots that can accommodate two 10-GE transponder modules. There are two types of 10-Gbps line card motherboards, splitter and nonsplitter.

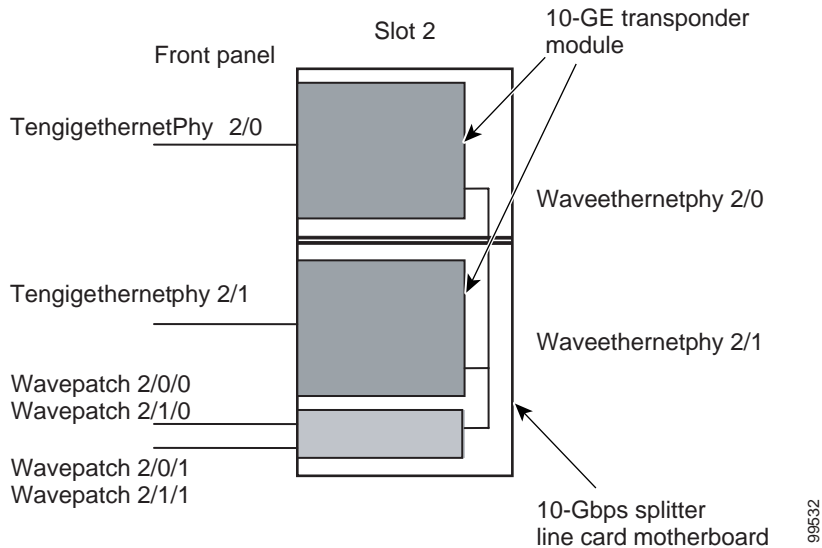
Figure 6-2 10-GE Transponder Module and 10-Gbps Splitter Line Card Motherboard Interfaces

Figure 6-2 shows an example of the interfaces for the 10-GE transponder module and the splitter 10-Gbps line card motherboard.

The 10-Gbps nonsplitter line card motherboard has only two wavepatch interfaces, wavepatch *slot/0/0* and wavepatch *slot/1/0*.

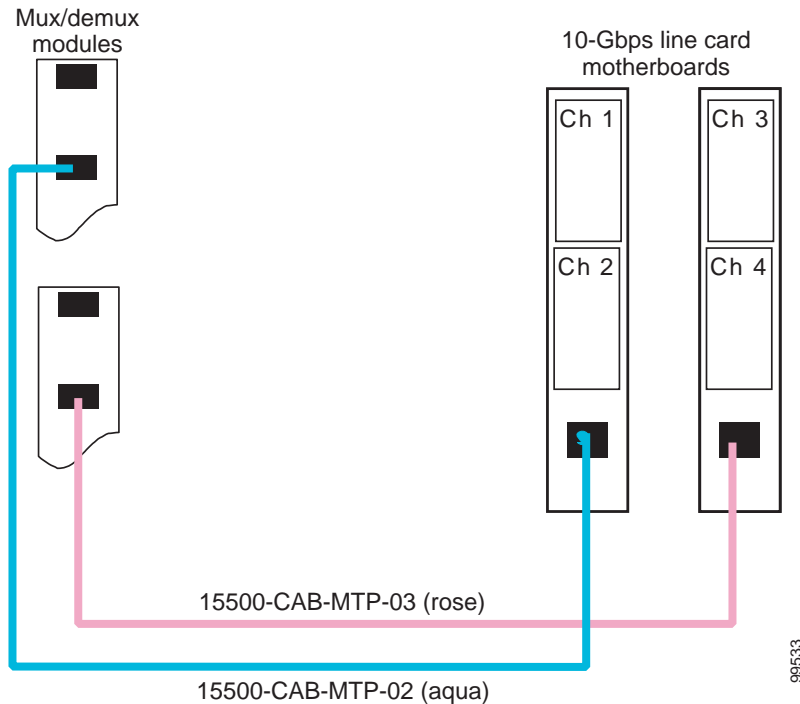
Figure 6-3 MTP-to-MTP Cabling Example

[Figure 6-3](#) shows the aqua colored cable connecting a lower channel 10-GE transponder module (for example, channels 1/2, 5/6, 9/10, 13/14, 17/18, 21/22, 25/26, or 29/30) and the rose colored cable connecting a higher channel 10-GE transponder module (for example, channels 3/4, 7/8, 11/12, 15/16, 19/20, 23/24, 27/28, or 31/32).

The MTP-to-MTP cables for the 10-Gbps line card motherboard are the 15500-CAB-MTP-02 (aqua) and the 15500-CAB-MTP-03 (rose) cables. Use the aqua colored cable to directly connect the lower channel 10-GE transponder modules to the mux/demux module. Use the rose colored cable to directly connect a higher channel 10-GE transponder module to the mux/demux module.

The 10-GE transponder modules must be in increasing order in the 10-Gbps line card motherboard for these connections to function correctly. Be sure that the modules supporting the first channel in the channel pair is in the top subslot and the module supporting the second channel in the channel pair is in the bottom subslot.

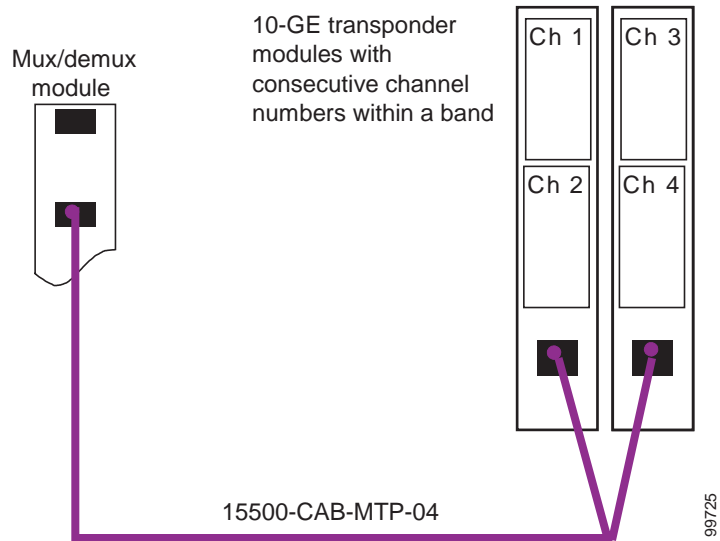
Figure 6-4 MTP-to-2-MTP Cabling Example

The MTP-to-2-MTP cable can be used to directly connect two 10-Gbps line card motherboards to a mux/demux module. Use this cable when you want to connect two 10-Gbps line card motherboards, containing four transponder modules supporting consecutive channels in the band, to a mux/demux module. Figure 6-5 shows an example of how you can connect two 10-Gbps line card motherboard to one mux/demux module with an MTP-to-2-MTP cable.

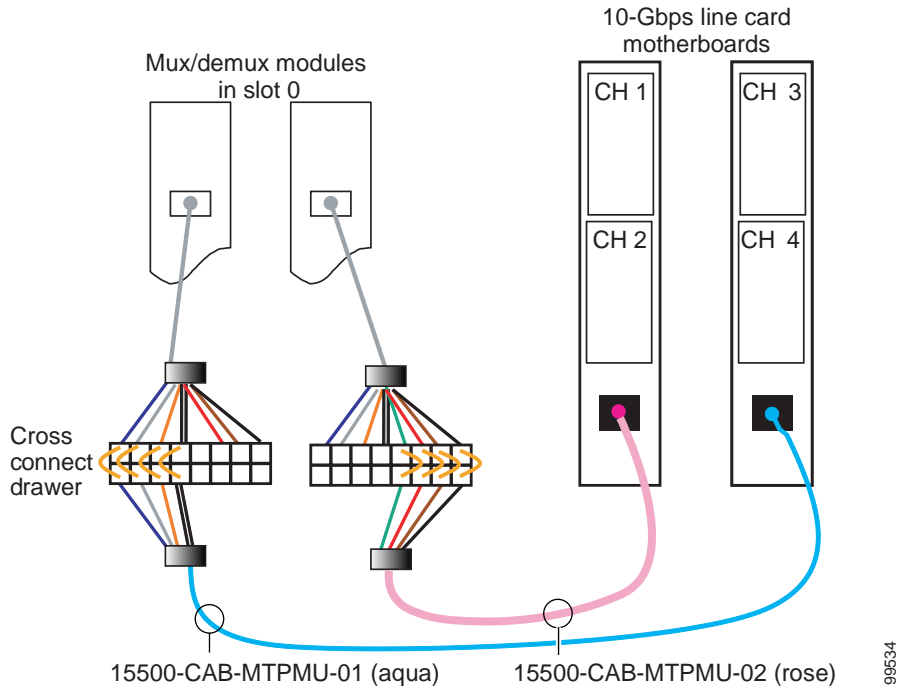
Figure 6-5 Connecting 10-Gbps Line Card Motherboard to the Cross Connect Drawer

The MTP-to-4-MU cables for the 10-Gbps line card motherboard are the 15500-CAB-MTPMU-1 (aqua) and the 15500-CAB-MTPMU-2 (rose) cables. [Figure 6-5](#) shows an example of how you can connect the 10-Gbps line card motherboard to the cross connect drawer.

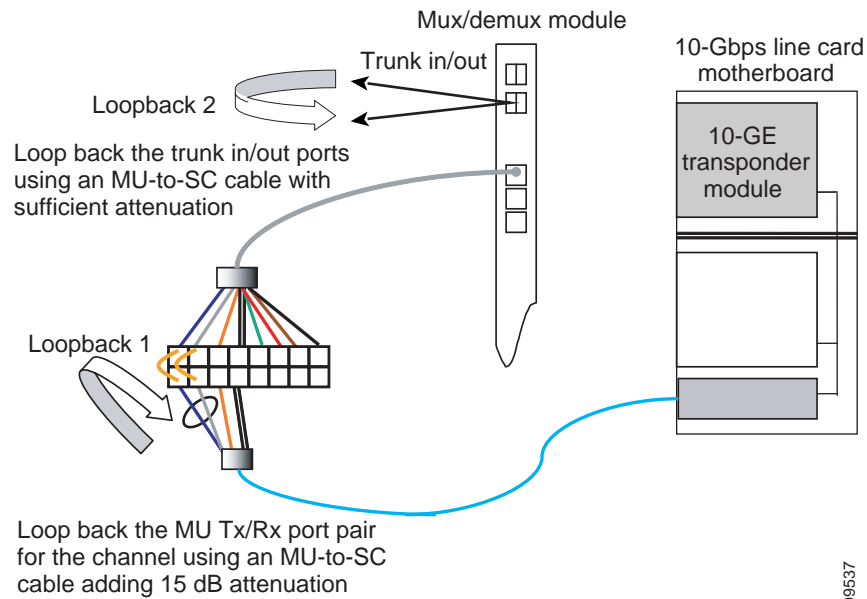
Figure 6-8 Physical Fiber Loopback Examples

You can use physical fiber loopbacks at various places to check the connectivity and isolate a bad or dirty fiber. Using an SC-to-MU cable with a 15 dB attenuator, you can set up a loopback in the cross connect drawer for the MU pair of the channel being verified. This ensures that the connectivity between the 10-GE transponder module through the 10-Gbps line card motherboard onto the MTP-to-4-MU fiber is good (see Loopback 1 in the example in Figure 6-8). You can also loop back the multiplexed trunk fiber coming out of the trunk port in/out interfaces of the mux/demux module. This loopback verifies the connectivity from the 10-GE transponder module through the cross connect drawer and the mux/demux module (see Loopback 2 in the example in Figure 6-8).

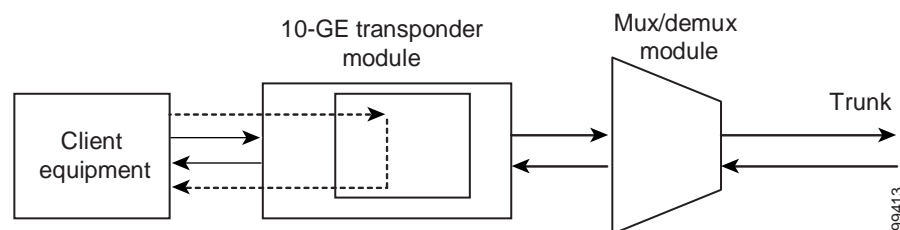
Figure 6-9 Client Signal Loopback Example on a 10-GE Transponder Module

A client signal software loopback verifies the functioning between the client equipment and the 10-GE transponder module (see Figure 6-9).

-
- Step 1 Issue a **loopback** command on the tengigethernetphy interface.
 - Step 2 Check that the signal reaches the local client equipment.
 - Step 3 If the signal does not reach the local client equipment, check the trunk fiber and the interfaces along the signal path. If the fiber is intact, contact Cisco Systems technical support.
-

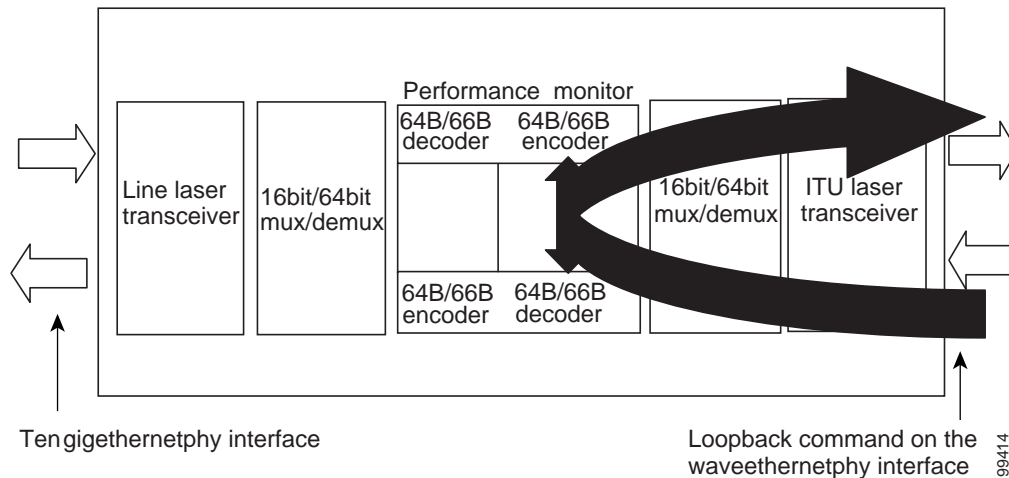
Figure 6-10 Trunk Side Loopback Example on a 10-GE Transponder Module

A trunk software loopback verifies the functioning of the 10-GE transponder module on the trunk side (see Figure 6-10). With this feature, you can verify the communication between two 10-GE transponder modules.

-
- Step 1 Issue a **loopback** command on the waveethernetphy interface.
 - Step 2 Check that the signal reaches the system at the far end.
 - Step 3 If the signal does not reach the far end, check the trunk fiber and the interfaces along the signal path. If the fiber is intact, contact Cisco Systems technical support.
-
