Troubleshooting Mux/Demux Module Problems

3.1 Overview

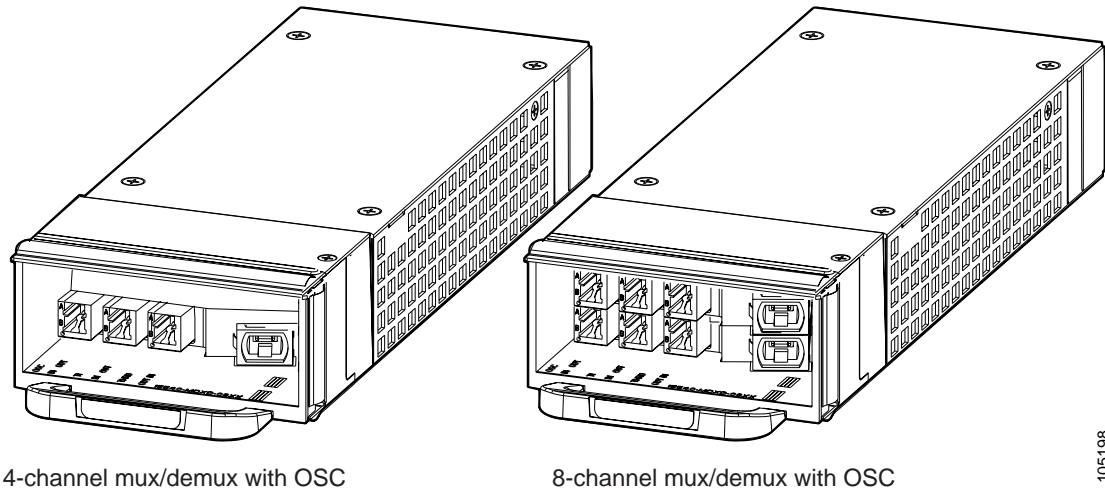
Figure 3-1 4- and 8-Channel Mux/Demux Modules with OSC

4-channel mux/demux with OSC

8-channel mux/demux with OSC

Channels not filtered are passed on to the next mux/demux module. (See [Figure 3-1](#).)
