Troubleshooting 2.5-Gbps Transponder Module Problems

This chapter describes how to troubleshoot 2.5-Gbps transponder module problems. This document contains the following sections:

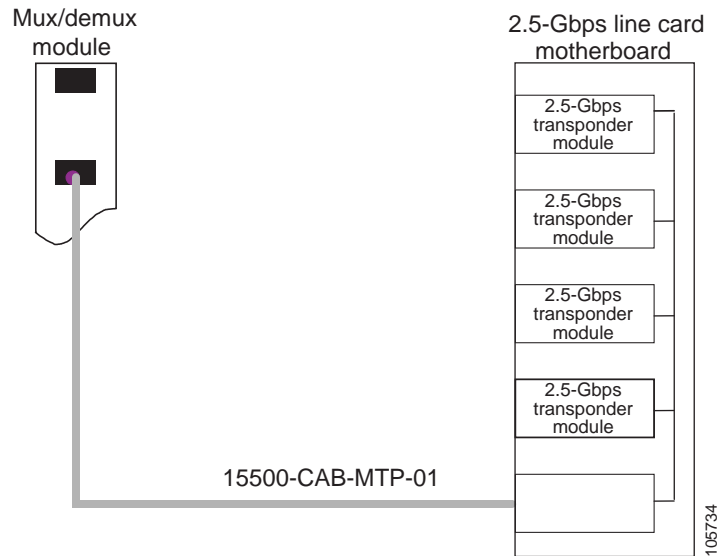
Figure 5-1 MTP-to-MTP Cabling Example

The MTP-to-MTP cable for the 2.5-Gbps line card motherboard is the 15500-CAB-MTP-01 (blue) cable. Use it to directly connect the 2.5-Gbps transponder modules to the mux/demux module. See [Figure 5-1](#).

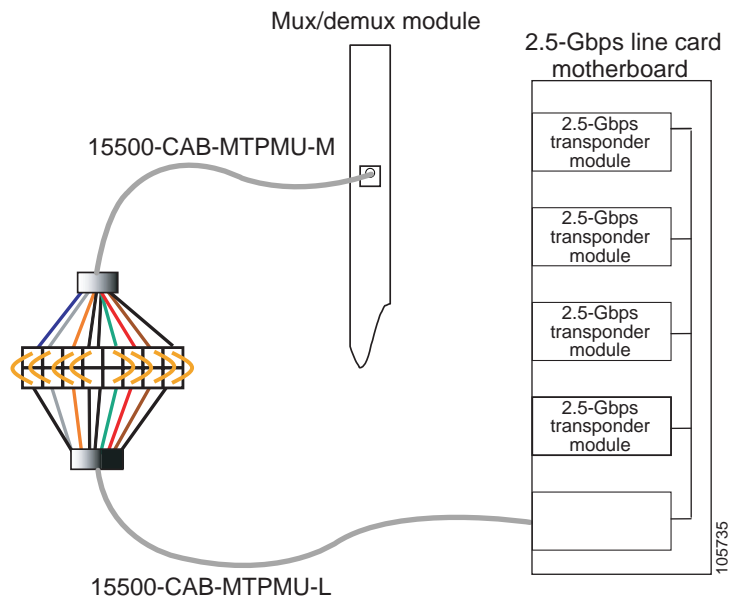
Figure 5-2 Cross Connect Drawer Cabling Using MTP-to-8-MU Cables

The MTP-to-8-MU cables for the 2.5-Gbps line card motherboard are the 15500-CAB-MTPMU-M (grey) and the 15500-CAB-MTPMU-L (green) cables. [Figure 5-2](#) shows an example of how to connect the 2.5-Gbps line card motherboard to the cross connect drawer.

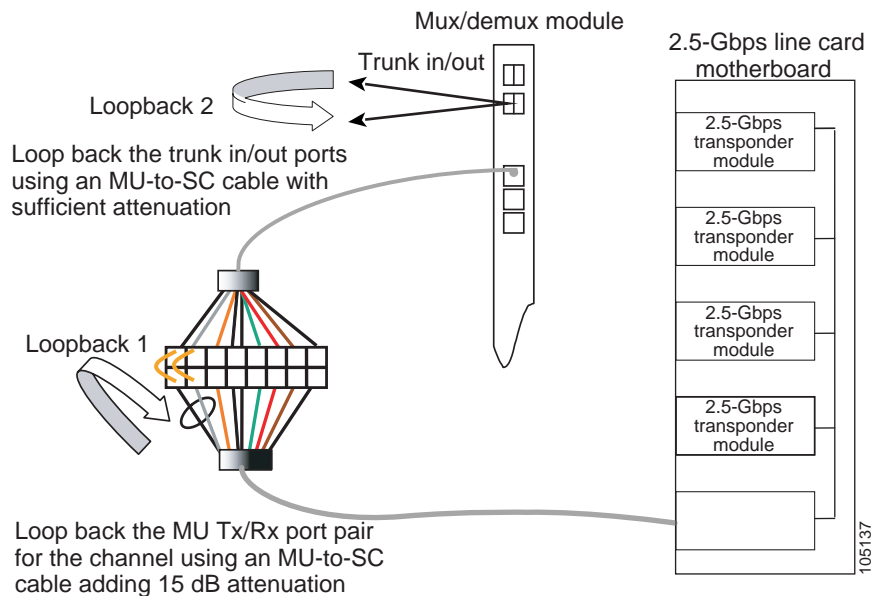
Figure 5-3 Physical Fiber Loopback Examples

You can use physical fiber loopbacks at various places to check the connectivity and isolate a bad or dirty fiber. Using an SC-to-MU cable with a 15 dB attenuator, you can set up a loopback in the cross connect drawer for the MU pair of the channel being verified. This ensures that the connectivity between the 2.5-Gbps transponder module through the 2.5-Gbps line card motherboard onto the MTP-to-8-MU fiber is good (see Loopback 1 in the example in [Figure 5-3](#)). You can also loop back the multiplexed trunk fiber coming out of the trunk port in/out interfaces of the mux/demux module. This loopback verifies the connectivity from the 2.5-Gbps transponder module through the cross connect drawer and the mux/demux module (see Loopback 2 in the example in [Figure 5-3](#)).

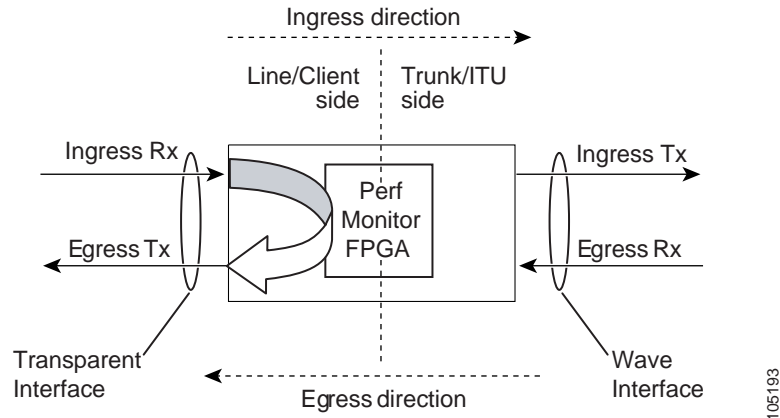
Figure 5-4 Client Signal Loopback Example on a 2.5-Gbps Transponder Module

A client signal software loopback verifies the functioning between the client equipment and the 2.5-Gbps transponder module (see [Figure 5-4](#)).

-
- Step 1** Issue a **loopback** command on the transparent interface.
 - Step 2** Check that the signal reaches the local client equipment.
 - Step 3** If the signal does not reach the local client equipment, check the trunk fiber and the interfaces along the signal path. If the fiber is intact, contact Cisco Systems technical support.
-

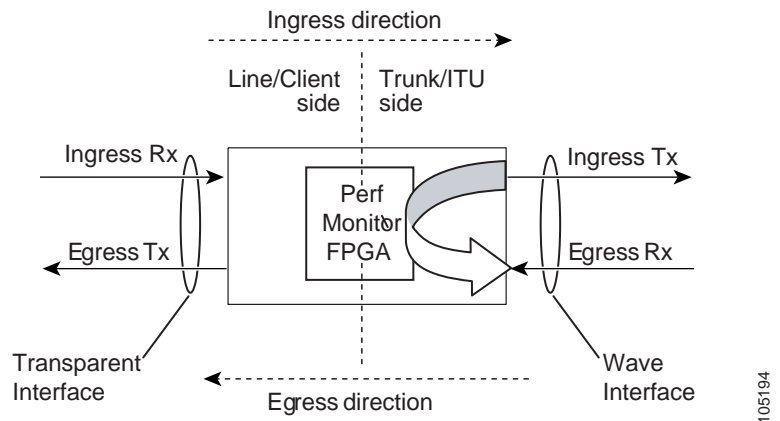
Figure 5-5 Trunk Side Loopback Example on a 2.5-Gbps Transponder Module

A trunk software loopback verifies the functioning of the 2.5-Gbps transponder module on the trunk side (see [Figure 5-5](#)). With this feature, you can verify the communication between two 2.5-Gbps transponder modules.

-
- Step 1 Issue a **loopback** command on the wave interface.
 - Step 2 Check that the signal reaches the system at the far end.
 - Step 3 If the signal does not reach the far end, check the trunk fiber and the interfaces along the signal path. If the fiber is intact, contact Cisco Systems technical support.
-
