Optical Power Level Troubleshooting for the Cisco ONS 15216-MD16-2-Red/Blue 100-GHz Mux/Demux Module

This document provides procedures for troubleshooting the most common power problems encountered with the Cisco ONS 15216-MD16-2-Red/Blue 100-GHz mux/demux optical filters. It contains the following sections:

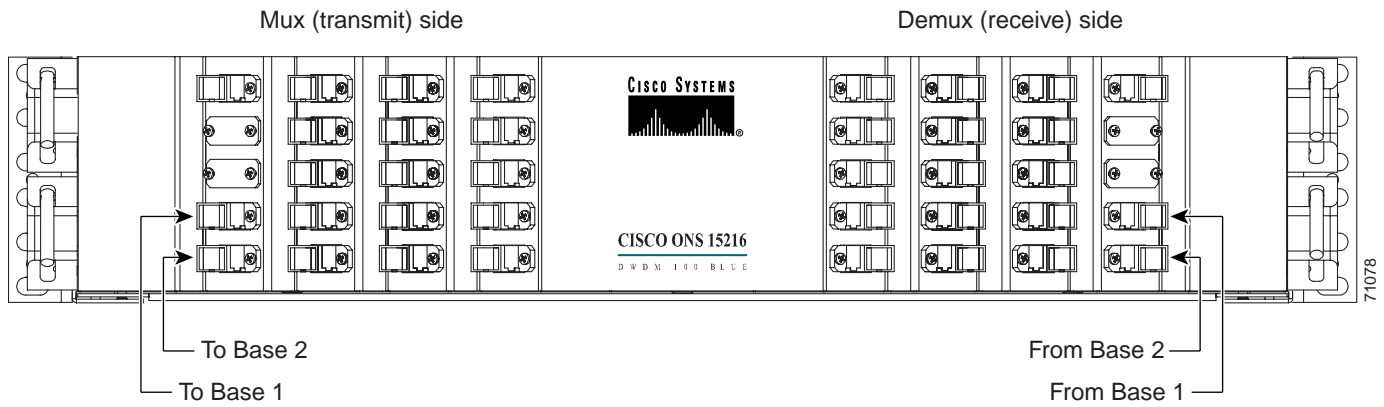
Figure 2 Front Panel of the ONS 15216 Blue DWDM Upgrade Unit

- Step 3** After you verify the fiber type and the connectors of the patch cords used to connect the base module to the upgrade module, ensure that the bottom connector in the far left column (Port 5: From upgrade 2) of the base module is connected to the bottom connector in the far left column (Port 5: To base 2) of the upgrade module. Also verify that the second-from-the-bottom connector in the far left column (Port 4: From upgrade 1) of the base module is connected to the second-from-the-bottom connector in the far left column (Port four: To base 1) of the upgrade module. See [Figure 1](#) and [Figure 2](#).

- Step 3** After you verify the fiber type and the connectors of the patch cords used to connect the base module to the upgrade module, ensure that the bottom connector in the far right column (Port 40: To upgrade 2) of the base module is connected to the bottom connector in the far right column (Port 40: From base 2) of the upgrade module. Also verify that the second-from-the-bottom connector in the far right column of the base module (Port 39: To upgrade 1) is connected to the second-from-the-bottom connector in the far right column (Port 39: From base 1) of the upgrade module. See [Figure 1](#) and [Figure 2](#).
-
