## **Cisco ONS 15454 Troubleshooting Guide**

Product and Documentation Release 3.3  
Last Updated: January 10, 2005

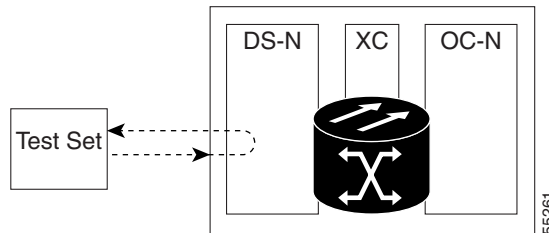
**Figure 2-1** The facility loopback process on a DS-N card

A facility loopback tests the line interface unit (LIU) of a card, the EIA (electrical interface assembly), and related cabling. After applying a facility loopback on a card, use a test set to run traffic over the loopback. A successful facility loopback eliminates the LIU, the EIA, or cabling plant as the potential cause of a network problem. [Figure 2-1](#) shows a facility loopback on a DS-N card.

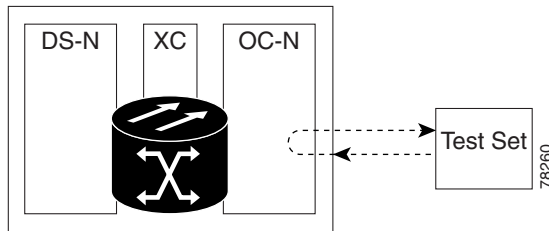
**Figure 2-2** The facility loopback process on an OC-N card

[Figure 2-2](#) shows a facility loopback on an OC-N card.

Before performing a facility loopback on an OC-N card, make sure the card contains at least two SDCC paths to the node where the card is installed. A second SDCC path provides a non-looped path to log into the node after the loopback is applied, thus enabling you to remove the facility loopback. Ensuring a second SDCC is not necessary if you are directly connected to the ONS 15454 containing the loopback OC-N card.

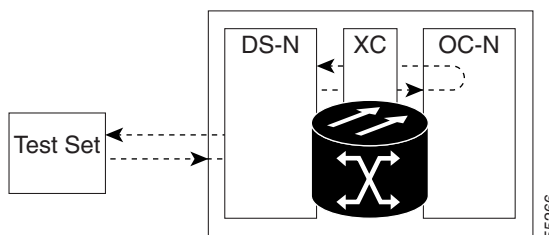
**Figure 2-3** The terminal loopback process on an OC-N card

A terminal loopback tests a circuit path as it passes through the cross-connect card (XC, XCVT, or XC10G) and as it loops back from the card being tested. [Figure 2-3](#) shows a terminal loopback on an OC-N card. The test-set traffic comes in on the DS-N card and goes through the cross-connect card to the OC-N card. The terminal loopback on the OC-N card turns the signal around before it reaches the LIU and sends it through the cross-connect card to the DS-N card. This test verifies that the cross-connect card and circuit paths are valid, but does not test the LIU on the OC-N card.

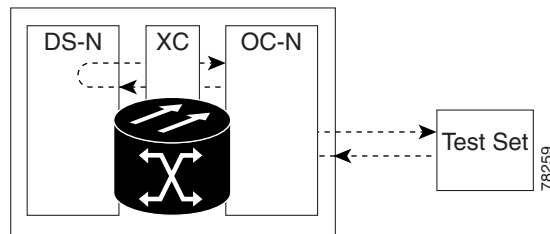
**Figure 2-4** The terminal loopback process on a DS-N card

To test the LIU on an OC-N card, connect an optical test set to the OC-N card ports and perform a facility loopback or use a loopback or hairpin on a card that is farther along the circuit path. Figure 2-4 shows a terminal loopback on a DS-N card. The test-set traffic comes in on the OC-N card and goes through the cross-connect card to the DS-N card. The terminal loopback on the DS-N card turns the signal around before it reaches the LIU and sends it through the cross-connect card to the OC-N card. This test verifies that the cross-connect card and circuit paths are valid, but does not test the LIU on the DS-N card.

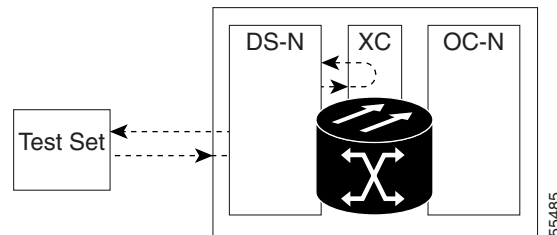
**Figure 2-5** The hairpin circuit process on an OC-N card

A hairpin circuit brings traffic in and out on a DS-N port rather than sending the traffic onto the OC-N card. A hairpin loops back only the specific STS or VT circuit and does not cause an entire OC-N port to loop back, thus preventing a drop of all traffic on the OC-N port. The hairpin allows you to test a circuit on nodes running live traffic.

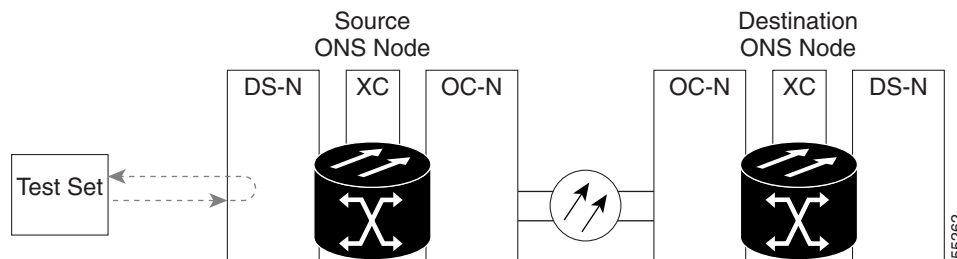
**Figure 2-6** A facility loopback on a circuit source DS-N card

The facility loopback test is performed on the source card in the network circuit, in this example, the DS-N card in the source node. Completing a successful facility loopback on this card eliminates the cabling, the DS-N card, and the EIA as possible failure points. Figure 2-6 shows an example of a facility loopback on a source DS-N card.

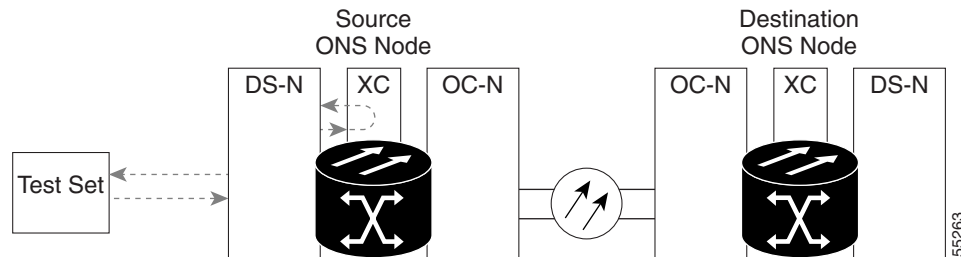
Figure 2-7 Hairpin on a source node

The hairpin test is performed on the cross-connect card in the network circuit. A hairpin circuit uses the same port for both source and destination. Completing a successful hairpin through the card eliminates the possibility that the cross-connect card is the cause of the faulty circuit. Figure 2-7 shows an example of a hairpin loopback on a source node.

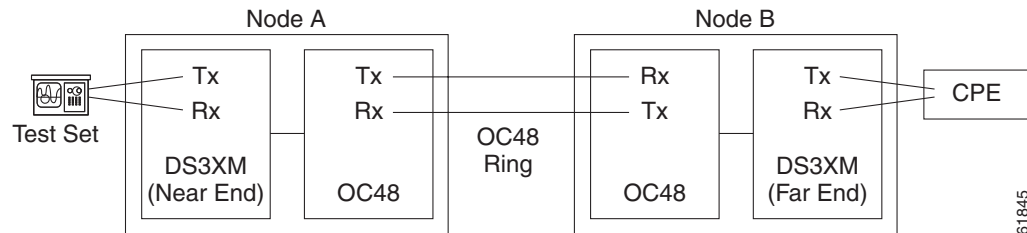
Figure 2-11 Diagram of far end action code

The far end in FEAC refers to the piece of equipment that is connected to the DS3XM-6 card and not the far end of a circuit. In Figure 2-11, if a DS3XM-6 (near-end) port is configured to send a Line Loop Code, the code will be sent to the connected test set, not the DS3XM-6 (far-end) port.

The Send Code column on the maintenance tab of a DS3XM-6 port only applies to in-service ports configured for CBIT framing. The column lets a user select No Code (the default) or Line Loop Code. Selecting Line Loop Code inserts a line loop activate FEAC (Far End Alarm and Control) in the CBIT overhead transmitting to the connected facility. This code initiates a loopback from the facility to the ONS 15454. Selecting No Code sends a line-loop-deactivate FEAC code to the connected equipment, which will remove the loopback. You can also insert a FEAC for the 28 individual DS-1 circuits transmuted into a DS-3 circuit.

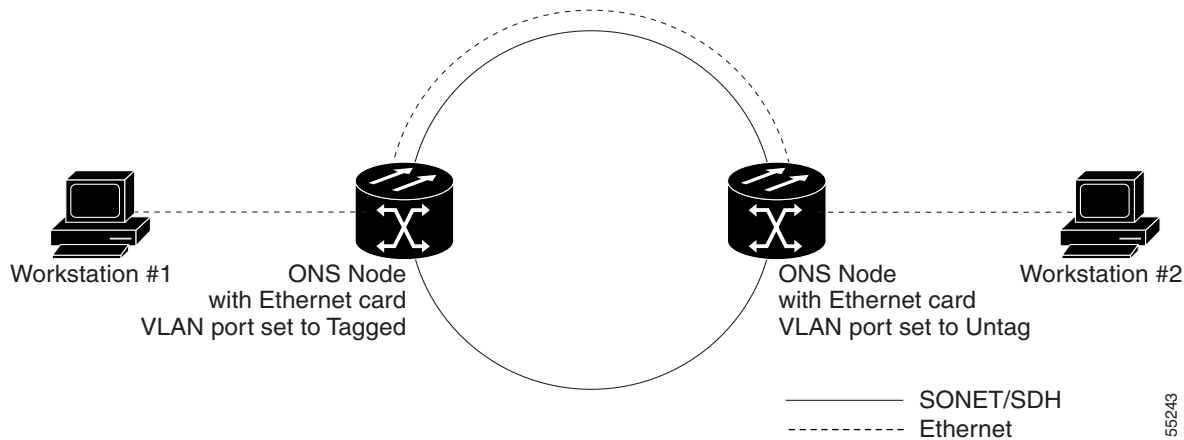
**Figure 2-14** A VLAN with Ethernet ports at Tagged and Untag

**Symptom:** Networks that have a VLAN with one ONS 15454 Ethernet card port set to Tagged and one ONS 15454 Ethernet card set to Untag may have difficulty implementing Address Resolution Protocol (ARP) for a network device attached to the Untag port ([Figure 2-14](#)). They may also see a higher than normal runt packets count at the network device attached to the Untag port.

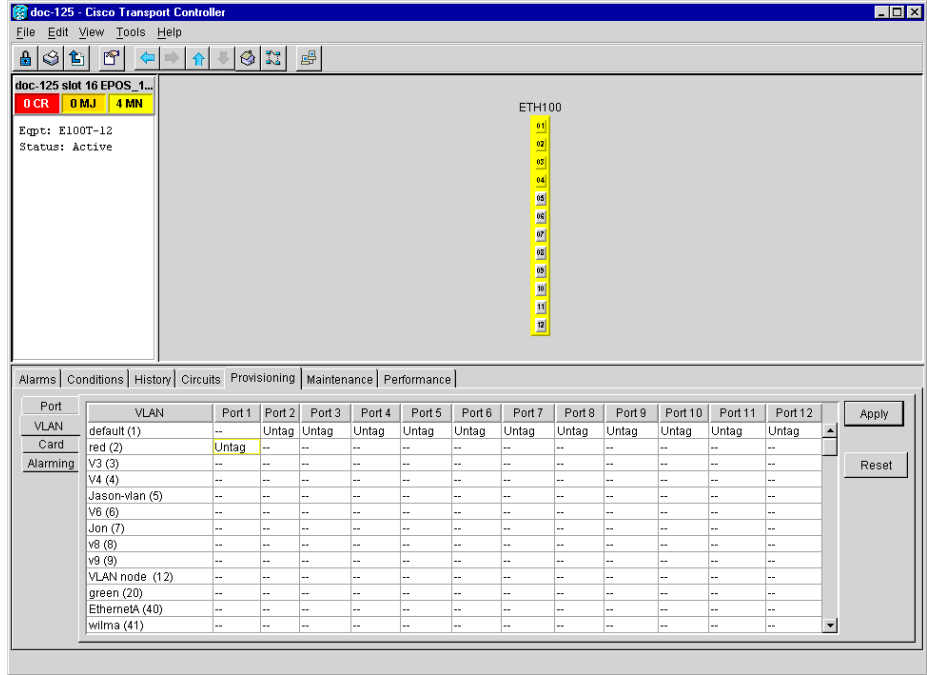
Figure 2-15 Configuring VLAN membership for individual Ethernet ports

- 
- Step 1** Display the CTC card view for the Ethernet card involved in the problem VLAN.
- Step 2** Click the **Provisioning > VLAN** tabs ([Figure 2-15](#)).

- Step 3** If the port is set to **Tagged**, continue to look at other cards and their ports in the VLAN until you find the port that is set to **Untag**.
- Step 4** At the VLAN port set to **Untag**, click the port and choose **Tagged**.

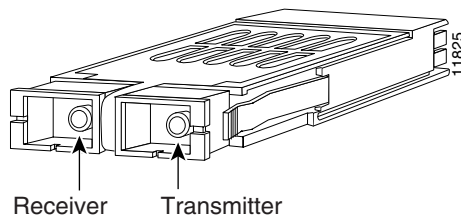
**Figure 2-16** A gigabit interface converter (GBIC)

GBICs can be installed or removed while the card and shelf assembly are powered and running. GBIC transmit failure is characterized by a steadily blinking Fail LED on the Gigabit Ethernet (E1000-2/E1000-2-G) card. [Figure 2-16](#) shows a GBIC.

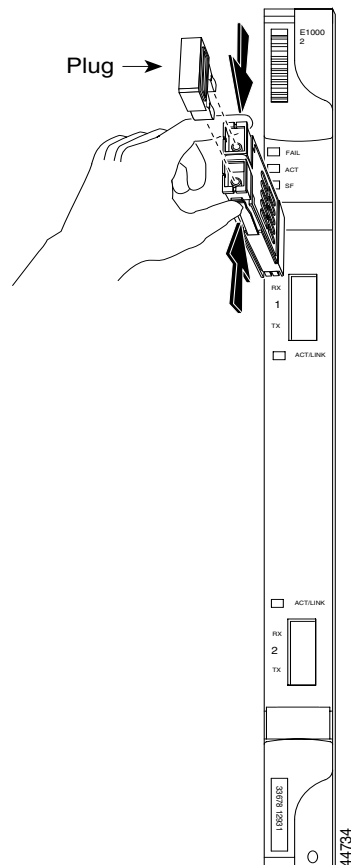
**Figure 2-17** Installing a GBIC on the E1000-2/E1000-2-G card

**Note** GBICs are keyed to prevent incorrect installation.

**Step 7** Slide the GBIC through the front flap until you hear a click.

The click indicates that the GBIC is locked into the slot.

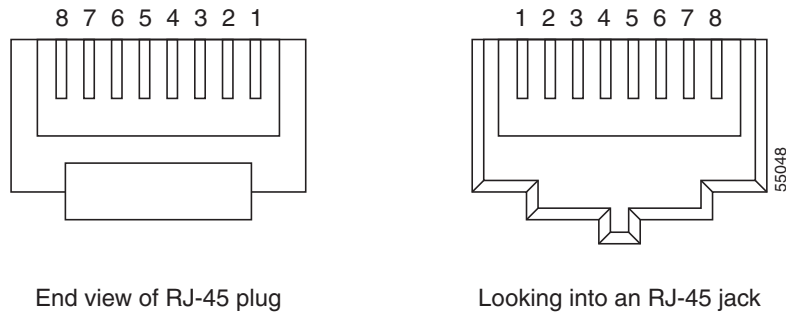
**Figure 2-18 RJ-45 pin numbers**

End view of RJ-45 plug

Looking into an RJ-45 jack

You can crimp your own CAT-5 cables for use with the ONS 15454. Use a cross-over cable when connecting an ONS 15454 to a hub, LAN modem, or switch, and use a straight-through cable when connecting an ONS 15454 to a router or workstation. Use CAT 5 cable RJ-45 T-568B, Color Code (100 Mbps), and a crimping tool. [Figure 2-18](#) shows the layout of an RJ-45 connector. [Figure 2-19](#) shows the layout of a straight-through cable and [Figure 2-20](#) shows the layout of a cross-over cable.

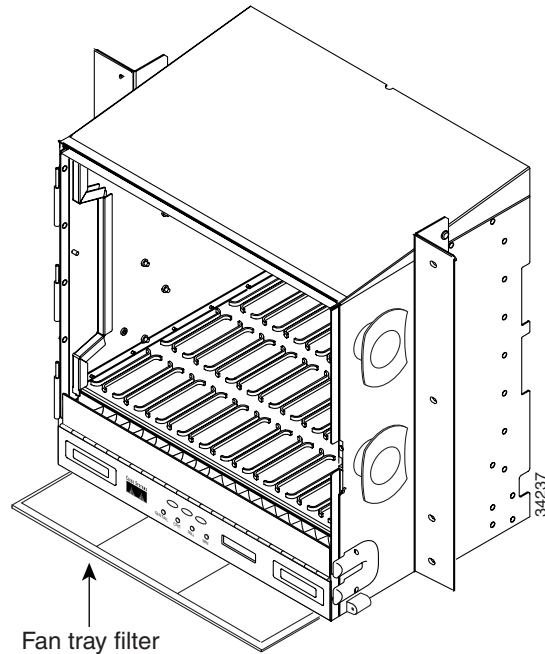
**Figure 3-1** A reusable fan-tray air filter in an external filter bracket (front door removed)

- Step 2** If the air filter is installed in the external filter brackets, slide the filter out of the brackets while being careful not to dislodge any dust that may have collected on the filter and proceed to [Step 5](#). [Figure 3-1](#) illustrates a reusable fan-tray air filter in an external filter bracket. If the filter is installed beneath the fan tray and not in the external filter brackets:

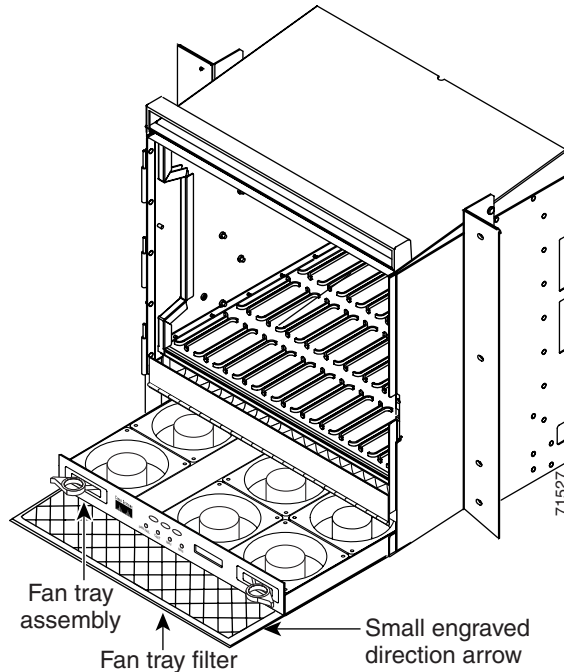
**Figure 3-2** Inserting or removing the fan-tray assembly (front door removed)

- Step 5** Pull the handles and slide the fan-tray assembly one inch out of the shelf assembly and wait until the fans stop.
- Step 6** When the fans have stopped, pull the fan-tray assembly completely out of the shelf assembly (Figure 3-2).

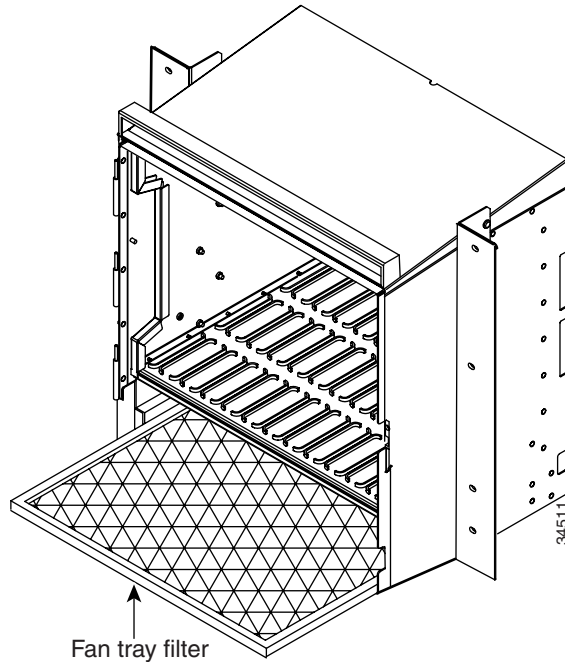
**Figure 3-3** Inserting or removing a disposable fan-tray air filter (front door removed)

- Step 7** Gently remove the air filter from the shelf assembly (Figure 3-3). Be careful not to dislodge any dust that may have collected on the filter.
- Step 8** Visually inspect the white filter material for dirt and dust.
- Step 9** If the air filter shows a heavy concentration of dirt and dust, replace it with a new filter by sliding the filter into the bottom of the shelf assembly. Make sure that the front of the filter is flush with the front of the shelf assembly and that the air flow indicators on the filter point upwards.

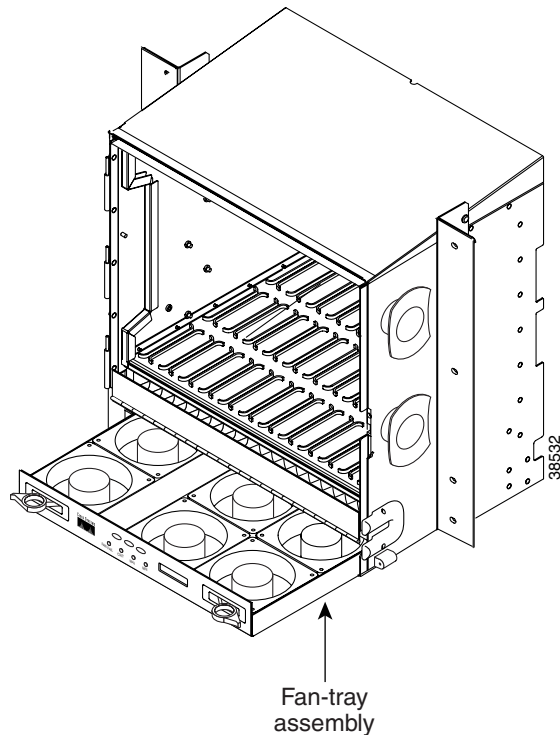
**Figure 3-4** Removing or replacing the fan-tray assembly (front door removed)

- Step 6** When the fans have stopped, pull the fan-tray assembly completely out of the shelf assembly. [Figure 3-4](#) shows the location of the fan tray.

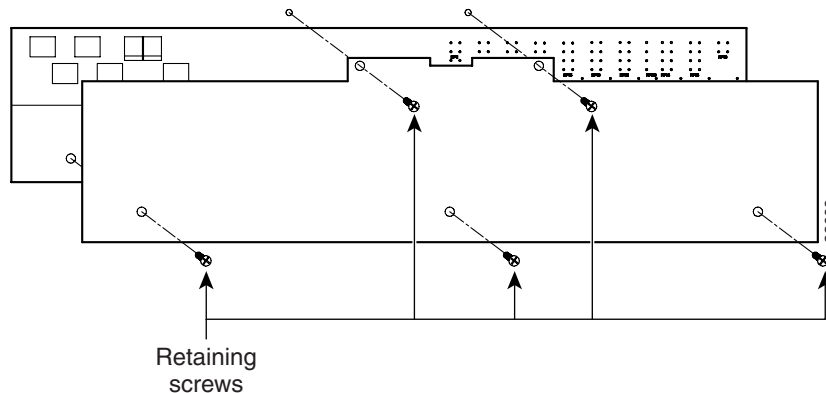
Figure 3-6 Lower backplane cover

- Step 3** Call Cisco TAC at 877-323-7368 for assistance in replacing the AIP and maintaining the original MAC address.
- Step 4** Unscrew the five screws that hold the lower backplane cover in place (Figure 3-6).
- Step 5** Grip the lower backplane cover and gently pull away from the backplane.

- Step 1** To remove the lower backplane cover, loosen the five screws that secure it to the ONS 15454 and pull it away from the shelf assembly (Figure 3-6).
- Step 2** Loosen the nine perimeter screws that hold the backplane sheet metal cover or EIA in place. Do not remove the interior screws.

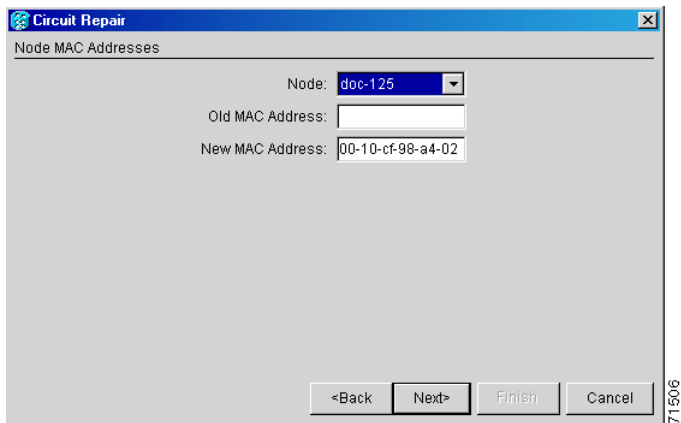
**Figure 3-9** Recording the old MAC address before replacing the AIP

**Step 24** The Node MAC Addresses dialog box displays (Figure 3-9):

- a. From the Node pull down menu, choose the name of the node where you replaced the AIP.
- b. In the Old MAC Address field, enter the old MAC address that was recorded in Step 2.
- c. Click **Next**.
