Cisco ONS 15454 Troubleshooting Guide

Product and Documentation Release 3.4
Last Updated: December 30, 2004

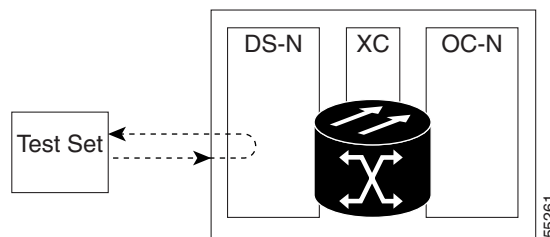
Figure 1-1 The facility loopback process on a DS-N card

A facility loopback tests the line interface unit (LIU) of a card, the EIA (electrical interface assembly), and related cabling. After applying a facility loopback on a port, use a test set to run traffic over the loopback. A successful facility loopback isolates the LIU, the EIA, or cabling plant as the potential cause of a network problem. [Figure 1-1](#) shows a facility loopback on a DS-N card.

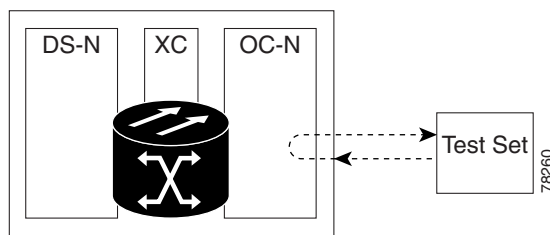
Figure 1-2 The facility loopback process on an OC-N card

To test the LIU on an OC-N card, connect an optical test set to the OC-N port and perform a facility loopback or use a loopback or hairpin on a card that is farther along the circuit path. [Figure 1-2](#) shows a facility loopback on an OC-N card.

Before performing a facility loopback on an OC-N card, make sure the card contains at least two DCC paths to the node where the card is installed. A second DCC provides a non-looped path to log into the node after the loopback is applied, thus enabling you to remove the facility loopback. Ensuring a second DCC is not necessary if you are directly connected to the ONS 15454 containing the loopback OC-N card.

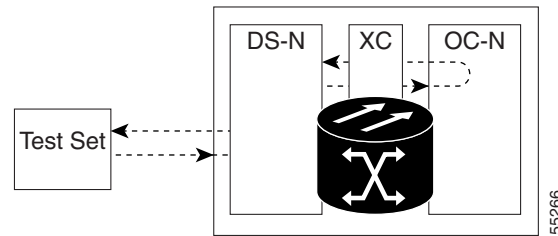
Figure 1-3 The terminal loopback process on an OC-N card

A terminal loopback tests a circuit path as it passes through the cross-connect card (XC, XCVT, or XC10G) and loops back from the card with the loopback. [Figure 1-3](#) shows a terminal loopback on an OC-N card. The test-set traffic comes in on the DS-N card and goes through the cross-connect card to

the OC-N card. The terminal loopback on the OC-N card turns the signal around before it reaches the LIU and sends it back through the cross-connect card to the DS-N card. This test verifies that the cross-connect card and terminal circuit paths are valid, but does not test the LIU on the OC-N card.

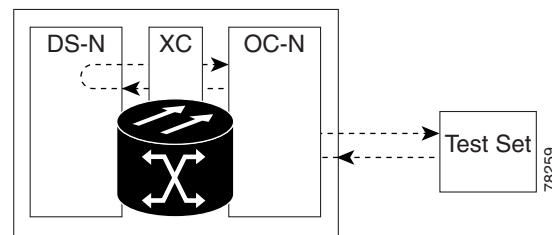
Figure 1-4 The terminal loopback process on a DS-N card

Figure 1-4 shows a terminal loopback on a DS-N card. The test-set traffic comes in on the OC-N card and goes through the cross-connect card to the DS-N card. The terminal loopback on the DS-N card turns the signal around before it reaches the LIU and sends it back through the cross-connect card to the OC-N card. This test verifies that the cross-connect card and terminal circuit paths are valid, but does not test the LIU on the DS-N card.

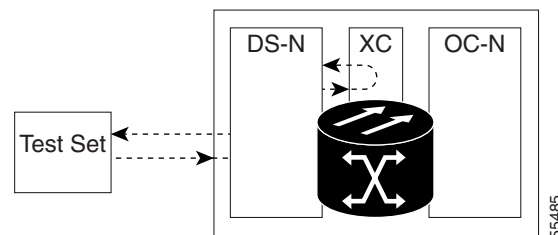
Figure 1-5 The hairpin circuit process on a DS-N card

A hairpin circuit brings traffic in and out on a DS-N port rather than sending the traffic onto the OC-N card. A hairpin loops back only the specific STS or VT circuit and does not cause an entire OC-N port to loop back, thus preventing a drop of all traffic on the OC-N port. The hairpin allows you to test a specific STS or VT circuit on nodes running live traffic.

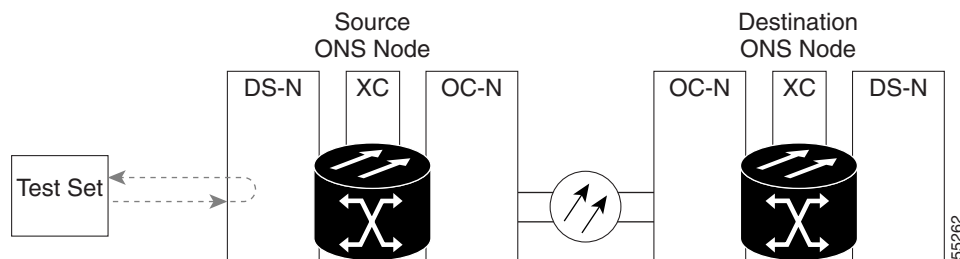
Figure 1-6 A facility loopback on a circuit source DS-N port

The facility loopback test is performed on the node source port in the network circuit, in this example, the DS-N port in the source node. Completing a successful facility loopback on this port isolates the cabling, the DS-N card, and the EIA as possible failure points. [Figure 1-6](#) shows an example of a facility loopback on a source DS-N port.

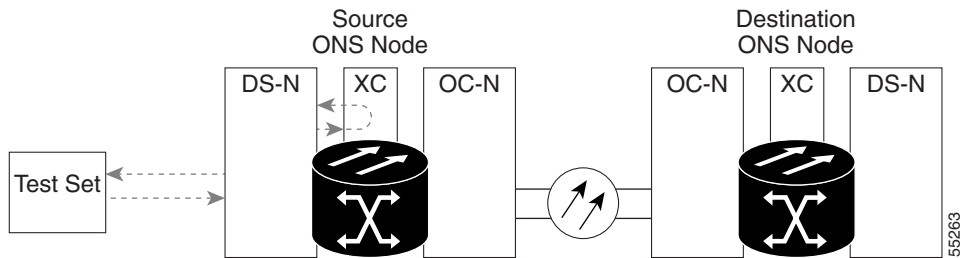
Figure 1-7 Hairpin on a source node port

The hairpin test is performed on the cross-connect card in the network circuit. A hairpin circuit uses the same port for both source and destination. Completing a successful hairpin through the card isolates the possibility that the cross-connect card is the cause of the faulty circuit. [Figure 1-7](#) shows an example of a hairpin loopback on a source node port.

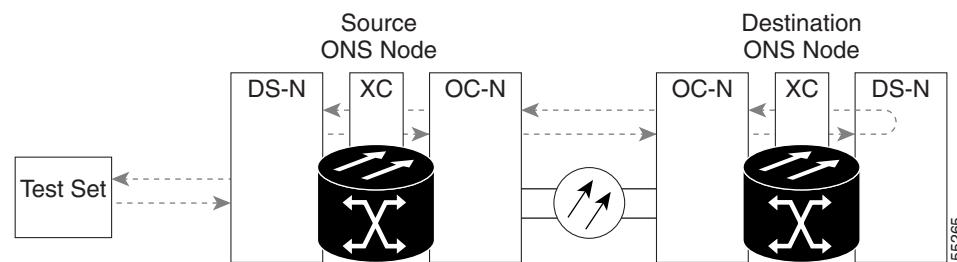
Figure 1-8 Terminal loopback on a destination DS-N port

The terminal loopback test is performed on the node destination port in the circuit, in this example, the DS-N port in the destination node. First, create a bidirectional circuit that starts on the source node DS-N port and loops back on the destination node DS-N port. Then proceed with the terminal loopback test. Completing a successful terminal loopback to a destination node DS-N port verifies that the circuit is good up to the destination DS-N. [Figure 1-8](#) shows an example of a terminal loopback on a destination DS-N port.

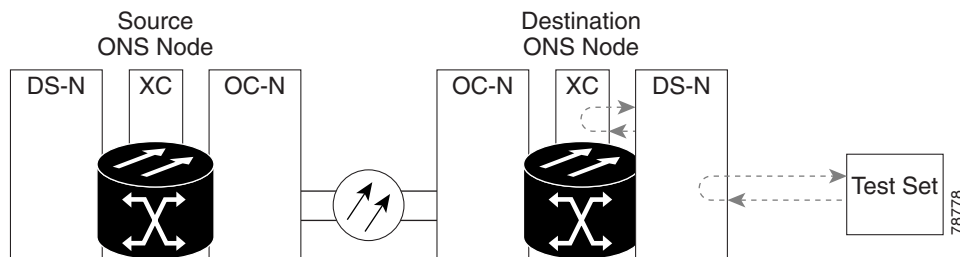
Figure 1-9 Hairpin on a destination node

The hairpin test is performed on the cross-connect card in the network circuit. A hairpin circuit uses the same port for both source and destination. Completing a successful hairpin through the card isolates the possibility that the cross-connect card is the cause of the faulty circuit. [Figure 1-7](#) shows an example of a hairpin loopback on a destination node.

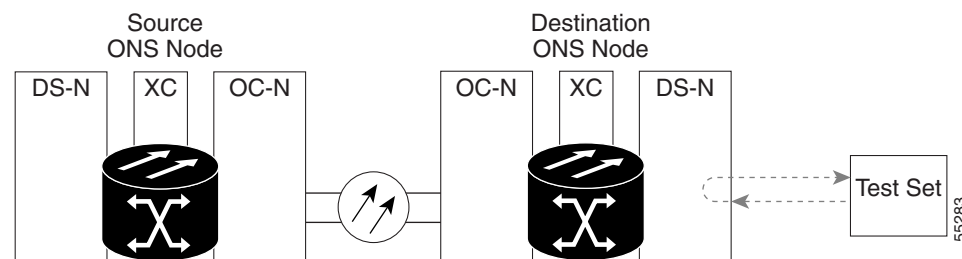
Figure 1-10 Facility loopback on a destination DS-N port

The facility loopback test is performed on the node source port in the circuit, in this example, the destination DS-N port in the destination node. Completing a successful facility loopback on this port isolates the possibility that the destination node cabling, DS-N card, LIU, or EIA is responsible for a faulty circuit. [Figure 1-10](#) shows an example of a facility loopback on a destination DS-N port.

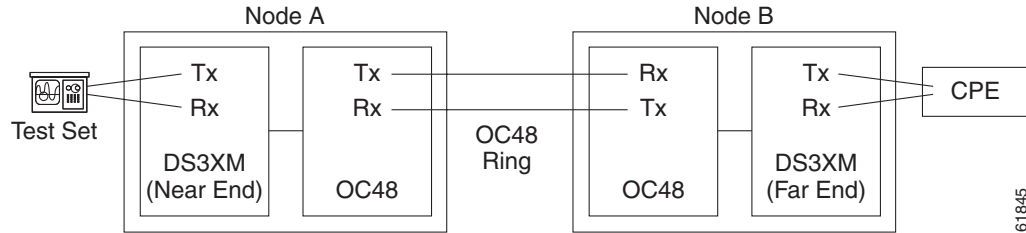
Figure 1-12 Diagram of FEAC

The far end in FEAC refers to the piece of equipment that is connected to the DS3XM-6 card and not the far end of a circuit. In [Figure 1-12](#), if a DS3XM-6 (near-end) port is configured to send a Line Loop Code, the code will be sent to the connected test set, not the DS3XM-6 (far-end) port.

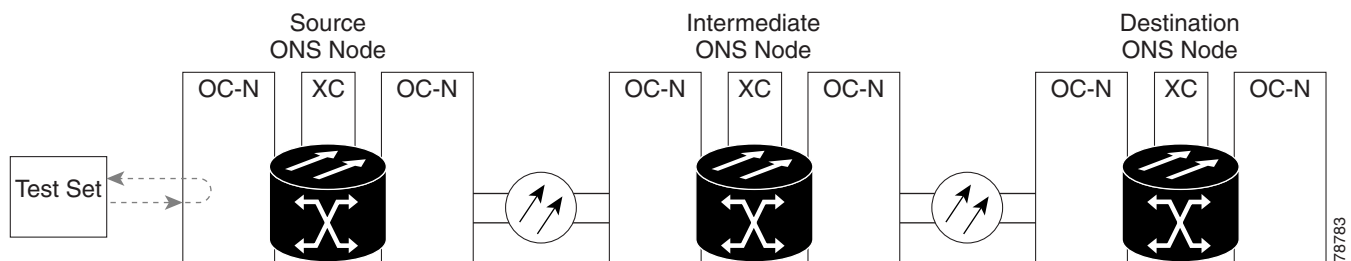
Figure 1-13 A facility loopback on a circuit source OC-N port

The facility loopback test is performed on the node source port in the network circuit, in this example, the source OC-N port in the source node. Completing a successful facility loopback on this port isolates the OC-N port as a possible failure point. Figure 1-6 shows an example of a facility loopback on a circuit source OC-N port.

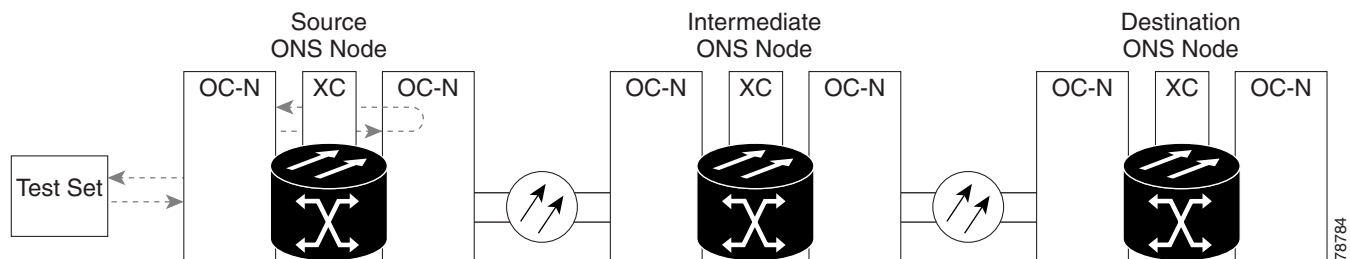
Figure 1-14 Terminal loopback on a source-node OC-N port

The terminal loopback test is performed on the node destination port in the circuit, in this example, the destination OC-N port in the source node. First, create a bidirectional circuit that starts on the node source OC-N port and loops back on the node destination OC-N port. Then proceed with the terminal loopback test. Completing a successful terminal loopback to a node destination OC-N port verifies that the circuit is good up to the destination OC-N. [Figure 1-8](#) shows an example of a terminal loopback on a destination OC-N port.

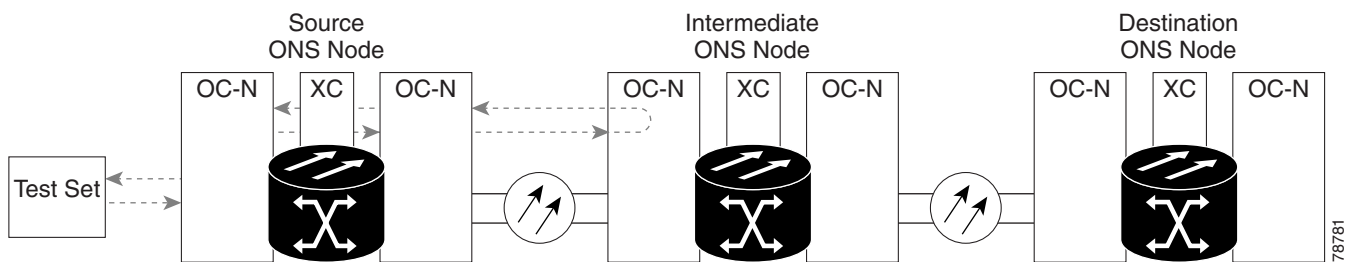
Figure 1-15 Facility loopback on an intermediate-node OC-N port

The facility loopback test is performed on the node source port in the network circuit, in this example, the source OC-N port in the intermediate node. Completing a successful facility loopback on this port isolates the OC-N port as a possible failure point. [Figure 1-15](#) shows an example of a facility loopback on a intermediate node circuit source OC-N port.

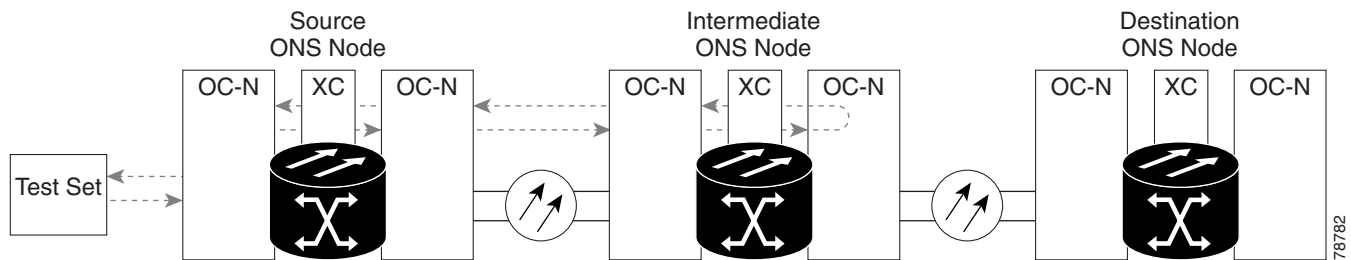
Figure 1-16 Terminal loopback on an intermediate-node OC-N port

The terminal loopback test is performed on the node destination port in the circuit, in this example, the destination OC-N port in the intermediate node. First, create a bidirectional circuit that starts on the node source OC-N port and loops back on the node destination OC-N port. Then proceed with the terminal loopback test. Completing a successful terminal loopback to a node destination OC-N port verifies that the circuit is good up to the destination OC-N. Figure 1-16 shows an example of a terminal loopback on an intermediate node destination OC-N port.

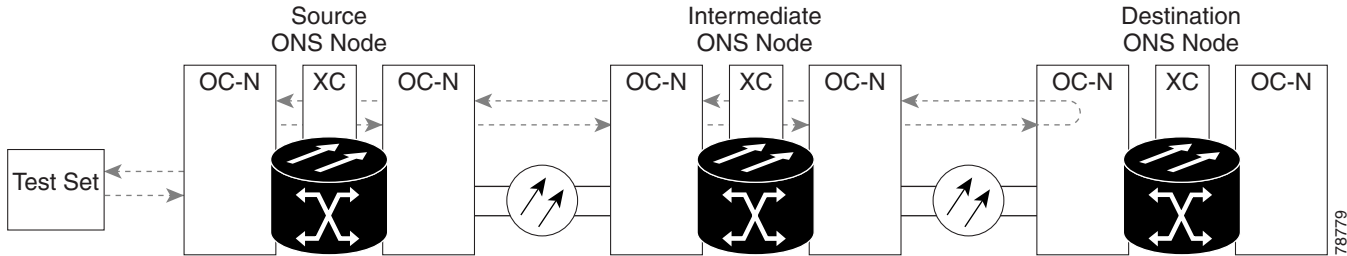
Figure 1-17 Facility loopback on a destination-node OC-N port

The facility loopback test is performed on the node source port in the network circuit, in this example, the source OC-N port in the destination node. Completing a successful facility loopback on this port isolates the OC-N port as a possible failure point. [Figure 1-17](#) shows an example of a facility loopback on a destination node circuit source OC-N port.

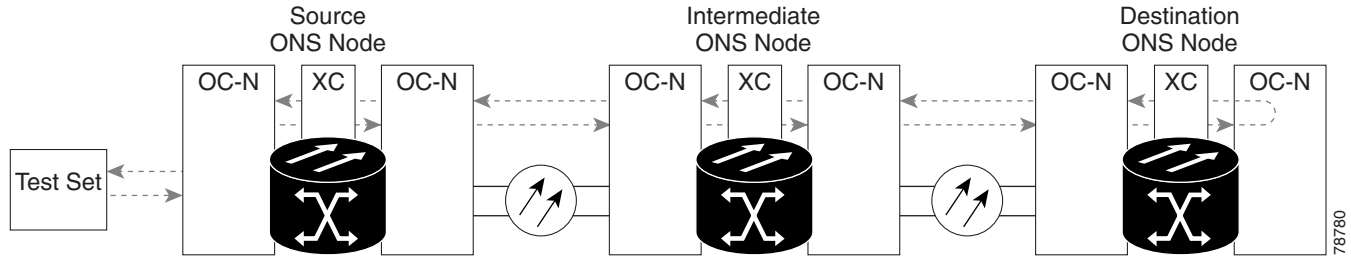
Figure 1-18 Terminal loopback on a destination-node OC-N port

The terminal loopback test is performed on the node destination port in the circuit, in this example, the destination OC-N port in the destination node. First, create a bidirectional circuit that starts on the node source OC-N port and loops back on the node destination OC-N port. Then proceed with the terminal loopback test. Completing a successful terminal loopback to a node destination OC-N port verifies that the circuit is good up to the destination OC-N. [Figure 1-18](#) shows an example of a terminal loopback on an intermediate node destination OC-N port.

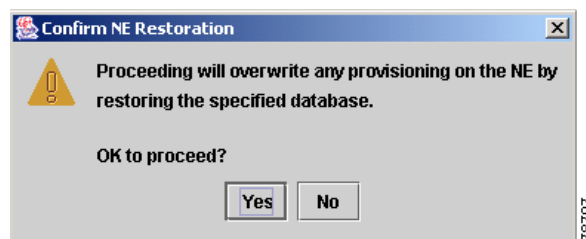
Figure 1-20 Confirm NE Restoration

- Step 9** Click **Go**.
- Step 10** A confirmation dialog box opens (Figure 1-20). Click **Yes**.
- Step 11** The status bar at the bottom of the screen will display Complete when the node has activated the software and uploaded the database.

- Step 8** Click **Go**.
- Step 9** A confirmation dialog box opens (Figure 1-20 on page 1-43). Click **Yes**.

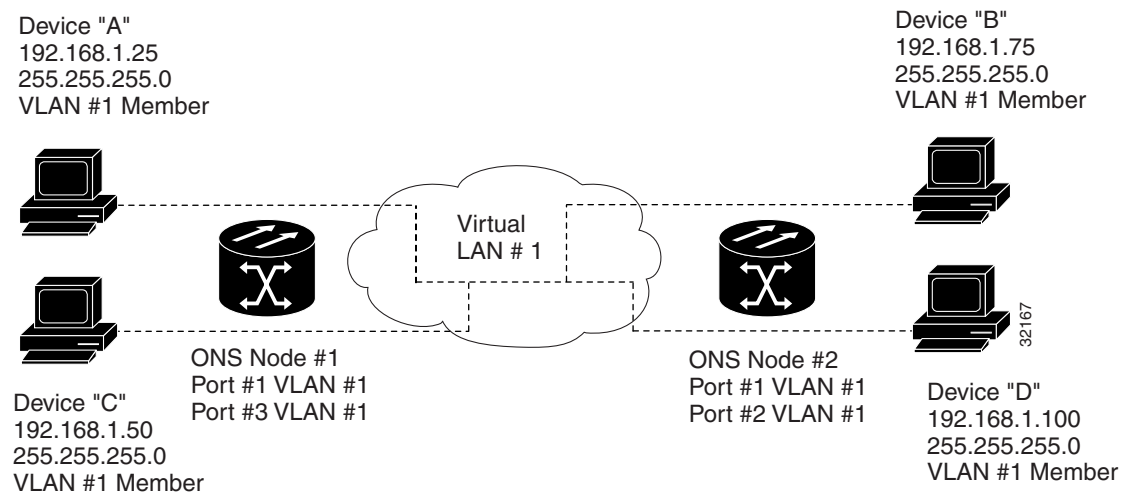
**Figure 1-23 Ethernet connectivity reference**

| Possible Problem | Solution |
|---|---|
| Improperly seated connections. | You can fix most connectivity problems in an Ethernet network by following a few guidelines. See <a href="#">Figure 1-23</a> when consulting the steps in the “ <a href="#">Verify Ethernet Connections</a> ” section on page 1-59. |

- Step 1** Check for SONET alarms on the STS-N that carries the VLAN #1 Ethernet circuit. Clear any alarms by looking them up in [Chapter 2, “Alarm Troubleshooting.”](#)
- Step 2** Check for Ethernet-specific alarms. Clear any raised alarms by looking up that alarm in [Chapter 2, “Alarm Troubleshooting.”](#)
- Step 3** Verify that the ACT LED on the Ethernet card is green.
- Step 4** Verify that Ports 1 and 3 on ONS 15454 #1 and Ports 1 and 2 on ONS 15454 #2 have green link-integrity LEDs illuminated.
- Step 5** If no green link-integrity LED is illuminated for any of these ports:
  - a. Verify physical connectivity between the ONS 15454s and the attached device.
  - b. Verify that the ports are enabled on the Ethernet cards.
  - c. Verify that you are using the proper Ethernet cable and that it is wired correctly, or replace the cable with a known-good Ethernet cable.

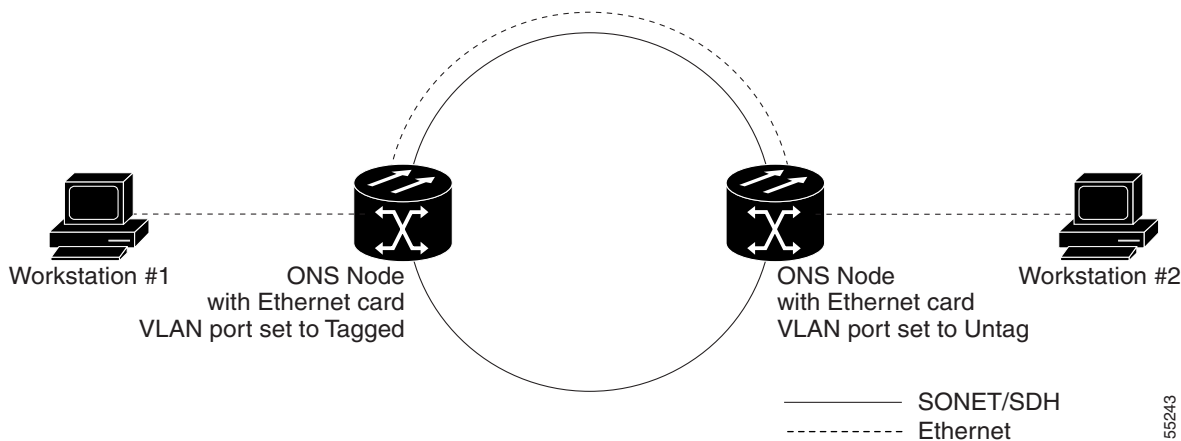
**Figure 1-24** A VLAN with Ethernet ports at Tagged and Untag

**Symptom** Networks that have a VLAN with one ONS 15454 Ethernet card port set to Tagged and one ONS 15454 Ethernet card set to Untag may have difficulty implementing Address Resolution Protocol (ARP) for a network device attached to the Untag port ([Figure 1-24](#)). They may also see a higher than normal runt packets count at the network device attached to the Untag port.

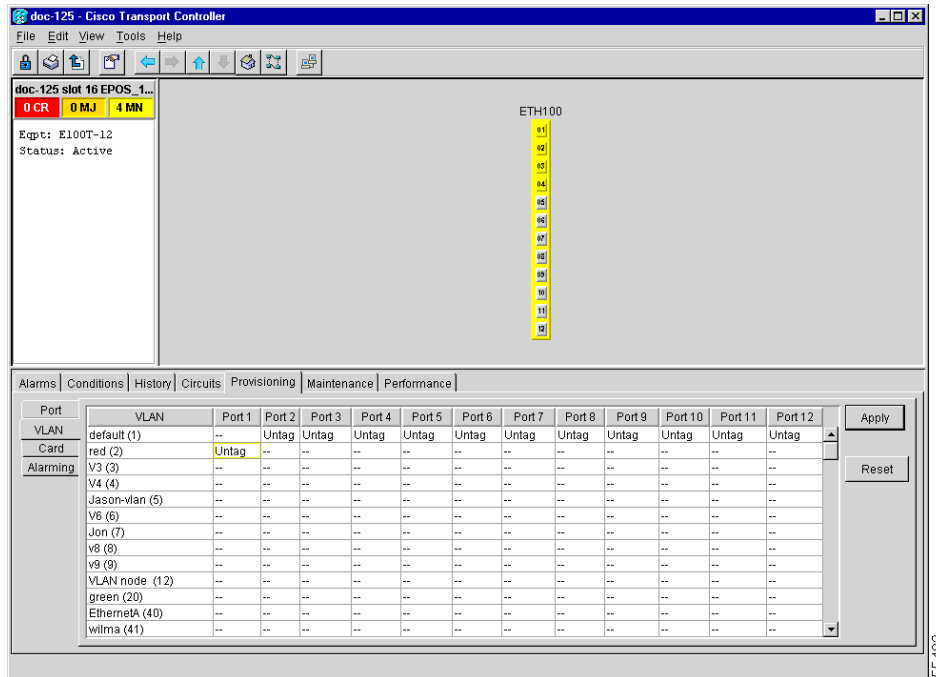
Figure 1-25 Configuring VLAN membership for individual Ethernet ports

- 
- Step 1** Display the CTC card view for the Ethernet card involved in the problem VLAN.
- Step 2** Click the **Provisioning > VLAN** tabs ([Figure 1-25](#)).

- Step 3** If the port is set to **Tagged**, continue to look at other cards and their ports in the VLAN until you find the port that is set to **Untag**.
- Step 4** At the VLAN port set to **Untag**, click the port and choose **Tagged**.

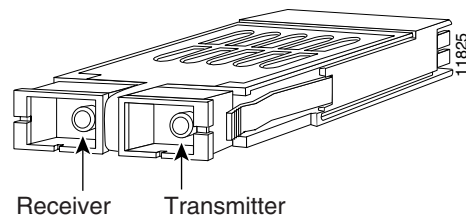
**Figure 1-26** A gigabit interface converter (GBIC)

GBICs can be installed or removed while the card and shelf assembly are powered and running. GBIC transmit failure is characterized by a steadily blinking Fail LED on the Gigabit Ethernet (E1000-2/E1000-2-G) card. [Figure 1-26](#) shows a GBIC.

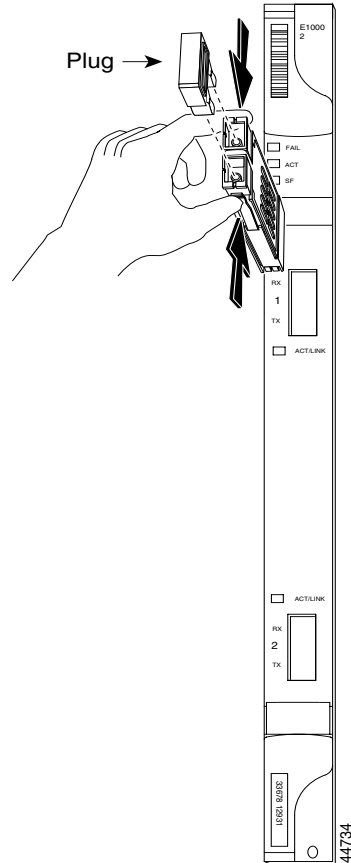
**Figure 1-27** Installing a GBIC on the E1000-2/E1000-2-G card

- Step 7** Slide the GBIC through the front flap until you hear a click. The click indicates that the GBIC is locked into the slot.
- Step 8** When you are ready to attach the network interface fiber-optic cable, remove the protective plug from the GBIC and save the plug for future use.

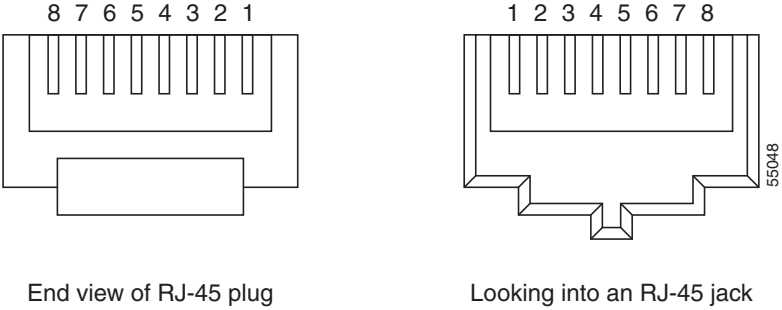
Figure 1-28 RJ-45 pin numbers

You can crimp your own LAN cables for use with the ONS 15454. Use a cross-over cable when connecting an ONS 15454 to a hub, LAN modem, or switch, and use a LAN cable when connecting an ONS 15454 to a router or workstation. Use Category 5 cable RJ-45 T-568B, Color Code (100 Mbps), and a crimping tool. [Figure 1-28](#) shows the layout of an RJ-45 connector. [Figure 1-29](#) shows the layout of a LAN cable and [Figure 1-30](#) shows the layout of a cross-over cable.

End view of RJ-45 plug

Looking into an RJ-45 jack

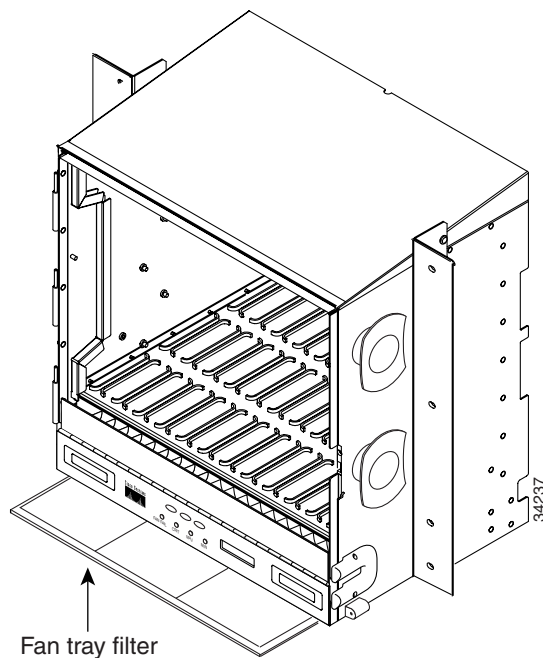
**Figure 3-1** A reusable fan-tray air filter in an external filter bracket (front door removed)

- Step 2** If the air filter is installed in the external filter brackets, slide the filter out of the brackets while being careful not to dislodge any dust that may have collected on the filter and proceed to [Step 3](#). [Figure 3-1](#) illustrates a reusable fan-tray air filter in an external filter bracket. If the filter is installed beneath the fan tray and not in the external filter brackets:
- a. Open the front door of the shelf assembly.
    - Open the front door lock.

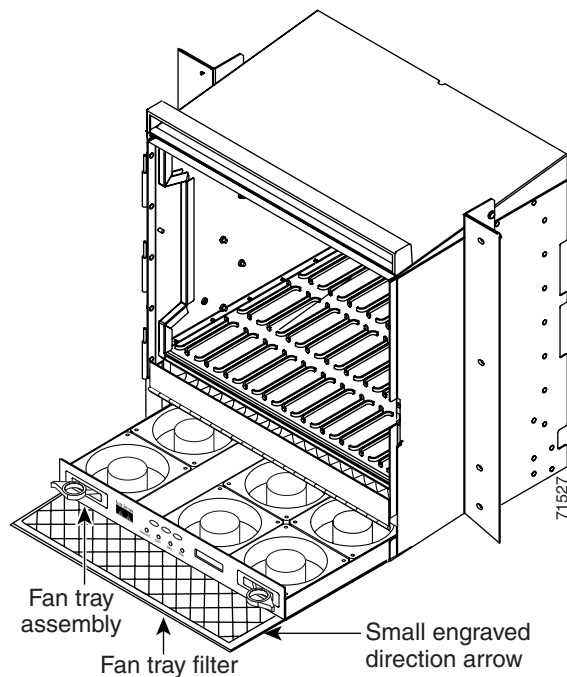
**Figure 3-2** Inserting or removing the fan-tray assembly (front door removed)

- Step 5** Pull the handles and slide the fan-tray assembly one inch out of the shelf assembly and wait until the fans stop.
- Step 6** When the fans have stopped, pull the fan-tray assembly completely out of the shelf assembly ([Figure 3-2](#)).

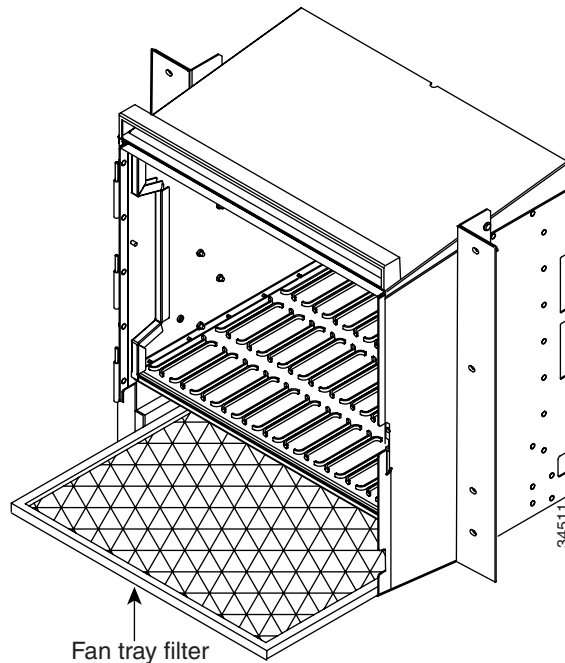
**Figure 3-3** Inserting or removing a disposable fan-tray air filter (front door removed)

- Step 7** Gently remove the air filter from the shelf assembly (Figure 3-3). Be careful not to dislodge any dust that may have collected on the filter.
- Step 8** Visually inspect the white filter material for dirt and dust.
- Step 9** If the air filter shows a heavy concentration of dirt and dust, replace it with a new filter by sliding the filter into the bottom of the shelf assembly. Make sure that the front of the filter is flush with the front of the shelf assembly and that the air flow indicators on the filter point upwards.

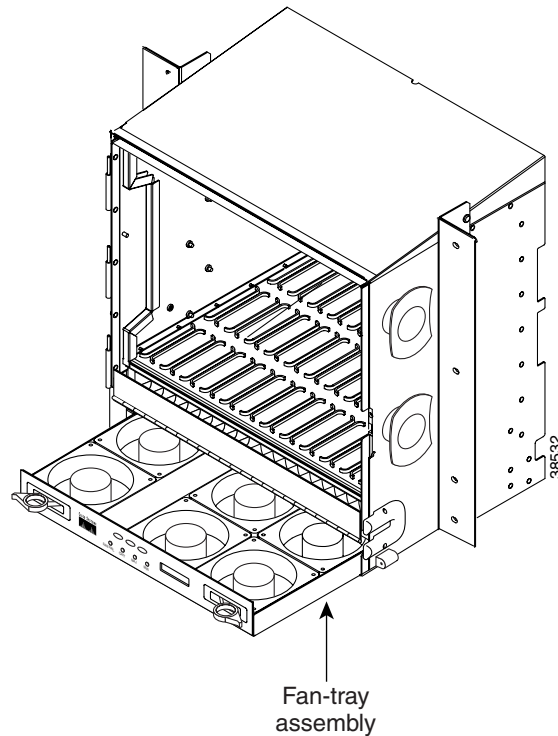
**Figure 3-4** Removing or replacing the fan-tray assembly (front door removed)

- Step 6** When the fans have stopped, pull the fan-tray assembly completely out of the shelf assembly. [Figure 3-4](#) shows the location of the fan tray.

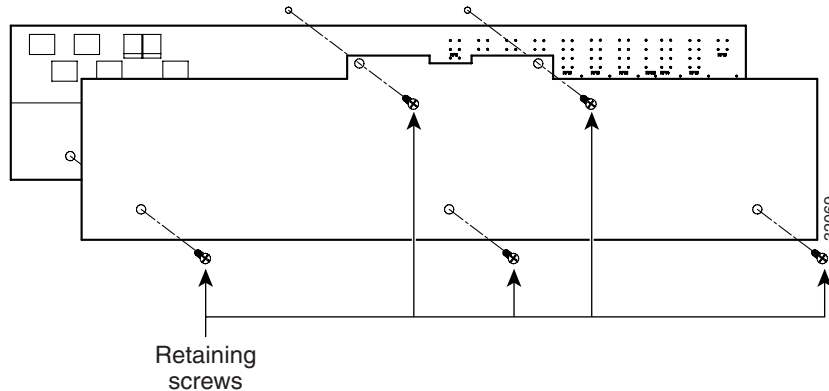
**Figure 3-6 Lower backplane cover**

- Step 4** Unscrew the five screws that hold the lower backplane cover in place (Figure 3-6).
- Step 5** Grip the lower backplane cover and gently pull away from the backplane.

**Step 1** To remove the lower backplane cover, loosen the five screws that secure it to the ONS 15454 and pull it away from the shelf assembly (Figure 3-6).
