Release Note for Cisco Universal Gateway Manager Version 2.1

This release note contains important information and caveats for the Cisco Universal Gateway Manager Version 2.1. Information in this document supplements information in these documents:

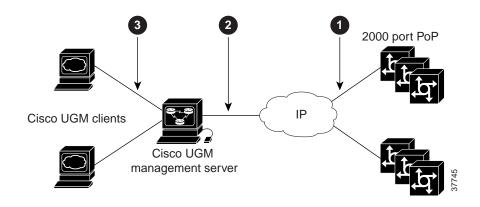
The following table and figure shows the minimum bandwidth requirements for managing a network.

Network Point	Minimum Bandwidth Required	
1	56 kbps	
2	1544 kbps	
3	56 kbps
