Release Notes for Cisco MGX 8880 Software Release 5.3.10

Part Number OL-11148-01 Revision C0, April 2007

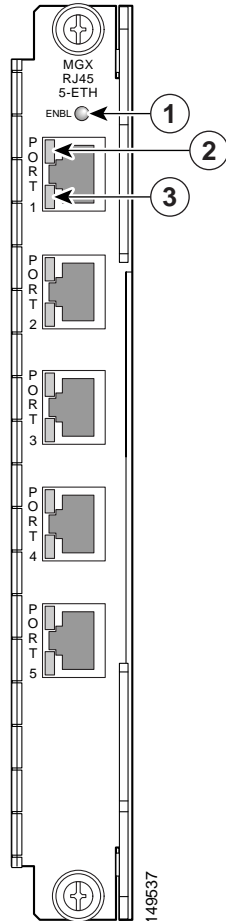
Figure 1 MGX-RJ45-5-ETH Back Card

The MGX-RJ45-5-ETH is a single-height back card for the RPM-PR that provides five RJ-45 connectors for Gigabit Ethernet, Fast Ethernet, or Ethernet lines. [Figure 1](#) shows the MGX-RJ45-5-ETH faceplate.

<p>1 ENABLE LED</p> <ul style="list-style-type: none"> Green—The back card is active. Off—The back card is not active. 	<p>3 Port 0 status LED</p> <ul style="list-style-type: none"> Green—Data present (flashing). Orange—The link is up.
<p>2 Port 0 speed LED</p> <ul style="list-style-type: none"> Green—1000 Mbps. Orange—10 Mbps or 100 Mbps.
